EGRESS WINDOW CRANK HANDLE

Bulletin Type:	Safety Recall
Bulletin #:	19V-691 US 2019-501 Canada
Job Code:	9901441
Flat Rate:	.3 hour

Publication Date:	October 2019
Make:	JAYCO
Model:	Jay Feather HY
Model Year:	2019-2020

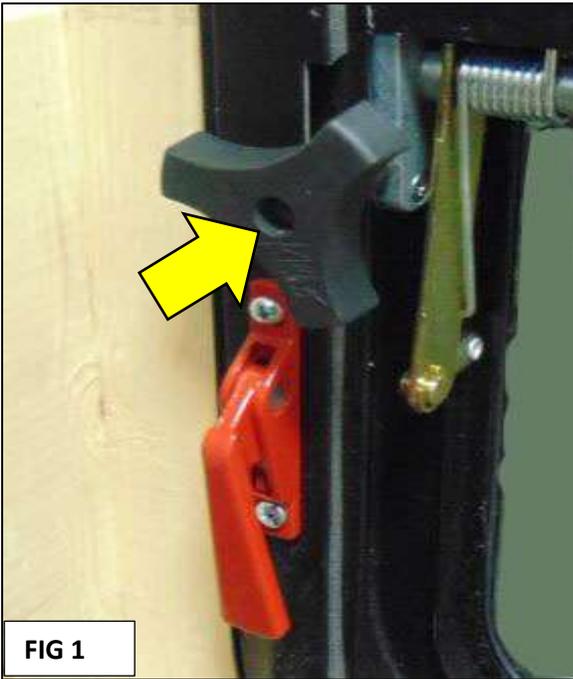
FIG 1:

Incident:	Crank handle on emergency window prevents opening to the extent required for an egress.
Affected Units:	2019 Jay Feather HY K1JH0185-0274 2020 Jay Feather HY L1JH0051-0080
Parts Kit:	Parts Kit #: 19V-691
	Red Z shaped handle
Misc. Tools & Supplies:	Screw gun with long #2 Philips bit

- Remove the philips screw in the black knob on the egress window
Save screw to install new handle – remove knob and discard.
