OVERCURRENT FUSE PROTECTION

Bulletin Type:	Safety Recall
Recall #:	19V-699 US 2019-502 CN
Job Code:	9902439
Flat Rate:	.4 Hour

Publication Date:	October 2019
Make:	Starcraft
Models:	Please note listing on last page of Instructions
Model Years:	2018-2019

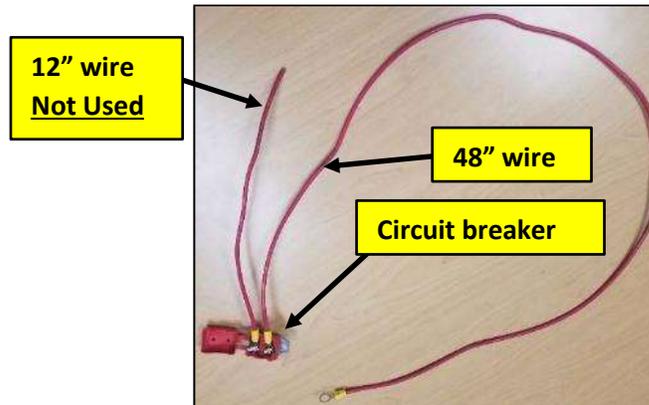
Fuse Harness Assembly

Incident:	Test for overcurrent protection. If 30A fuse is not protecting the circuit, follow the repair instructions below.
Affected Units:	Please note listing on last page of Instructions
Parts Kit #19V-699	1 Fuse Harness assembly 4 Wire ties black 2 Screw Pan Quad #8 x .75 TEK 1 Terminal – Ring 8ga #10 stud
Misc. Tools & Supplies:	Screw gun with #2 square drive bit Wire Strippers Wire Crimpers

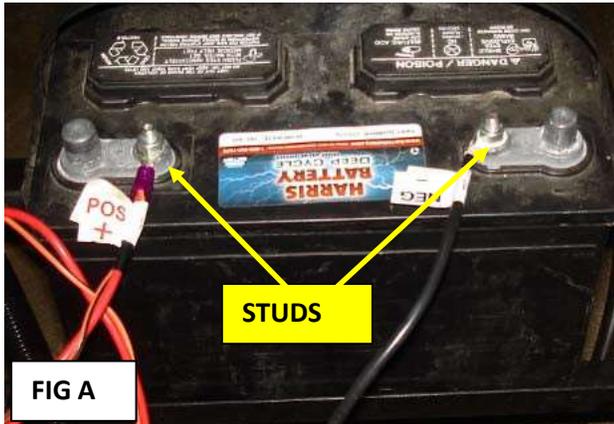
FIG A: Temporarily install a 12-volt battery to the trailer battery wires.
Battery wires labeled **POS+** and **NEG -**

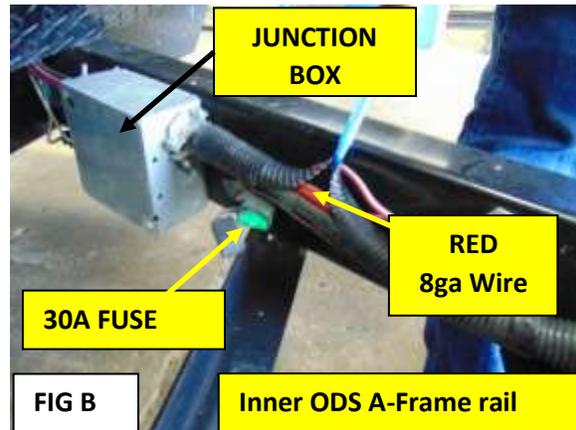
FIG B: Locate the 30A fuse at the front of the trailer.
Fuse is beside the junction box mounted to the ODS inner A-Frame rail.

Pull the 30A fuse out of the fuse holder at the front of the trailer (**Fig 2**).

If the interior lights go **OFF**, overcurrent protection is working properly - ***no further action necessary.*** Replace the fuse and disconnect the battery.

If the interior lights stay ON, continue with the following repair instructions.
