Recall Campaign

June 2020
FL832A
NHTSA #19V-712
Transport Canada #2019-497

Subject: TBB SynTec S3B/S3C Seat Kneeforms

Models Affected: Specific Model Year 2015-2020 Thomas Built Buses Minotour and Saf-T-Liner C2, EFX, and HDX model school buses manufactured August 18, 2014, through August 15, 2019, with certain SynTec S3B or S3C seats.

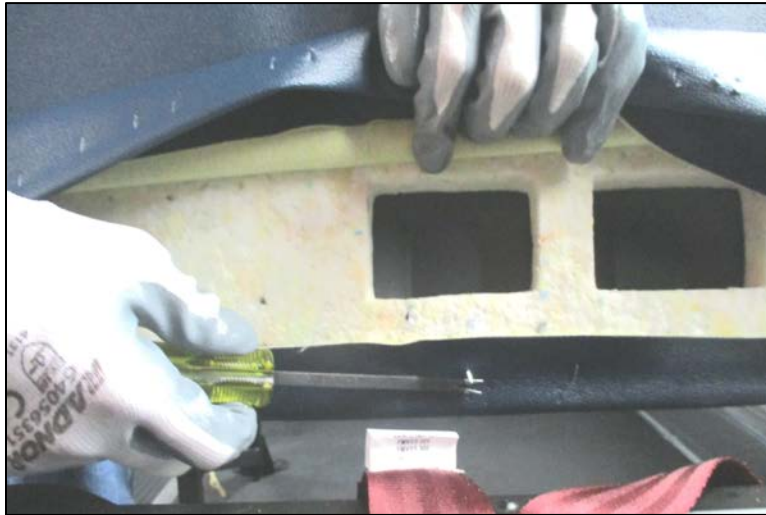
Figure 2: Removing Staples from the Reverse Side of the Vinyl

5. From the front of the seat, using a staple remover or wide-nose pliers, remove the staples from the reverse side of the vinyl. See **Figure 2**.

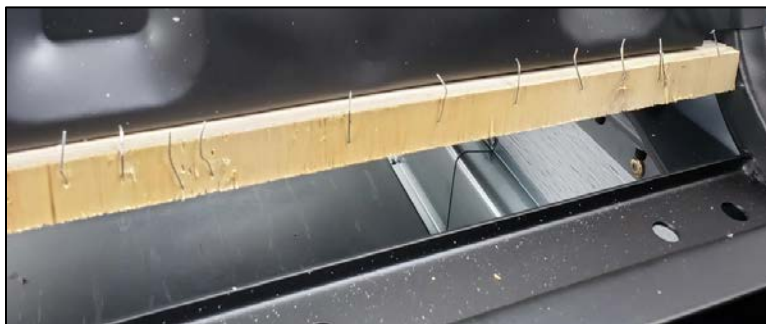
Figure 3: Remove Staples from Wood Strip

6. Using pliers, bend all staples shown in **Figure 3** to ensure there are no sharp points. This will be covered with two layers of vinyl in later steps.

13. Pull the vinyl cover on the back of the seat under the seat and pull tight. Staple to the original wood strip. See **Figure 3**, **Figure 11**, and **Figure 12**.

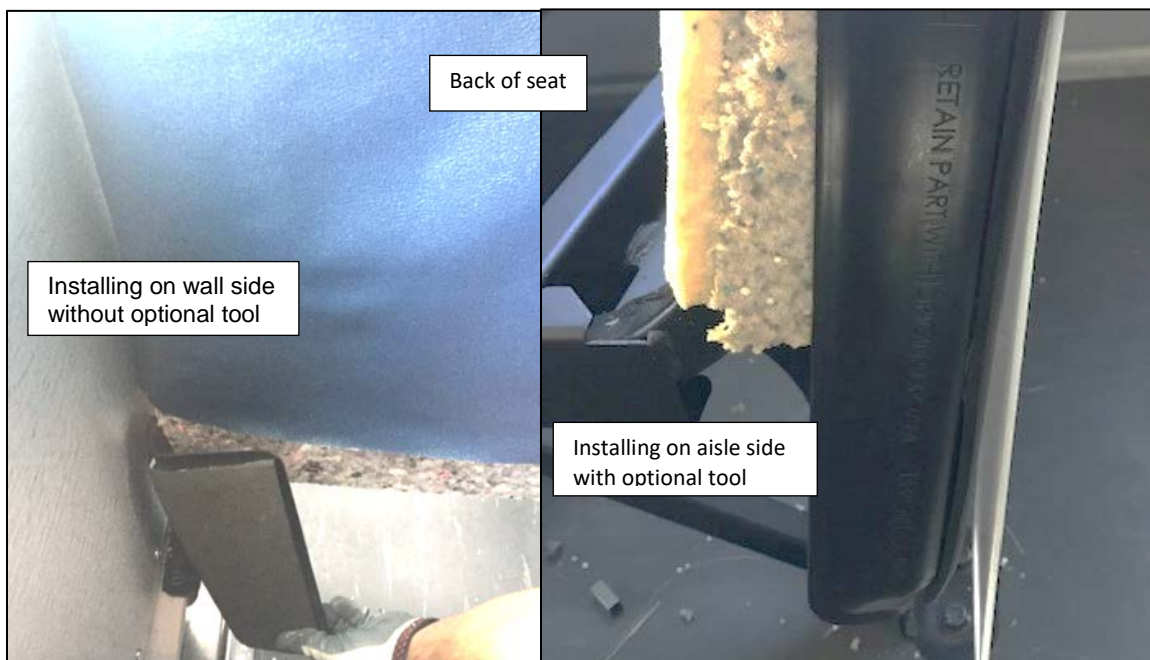
Figure 6: Positioning the Insert

NOTE: An optional tool, provided with new impact material inserts ("insert") shipped to dealers, may be used. It slides up with the insert between the existing foam and the vinyl cover. Once in position, slide the tool out.

9. Place the Insert between the vinyl and the existing foam. The narrower side of the insert is positioned toward the side of the seat and the wider side is positioned toward the back of the seat. See **Figure 6**, **Figure 7**, and **Figure 8**.

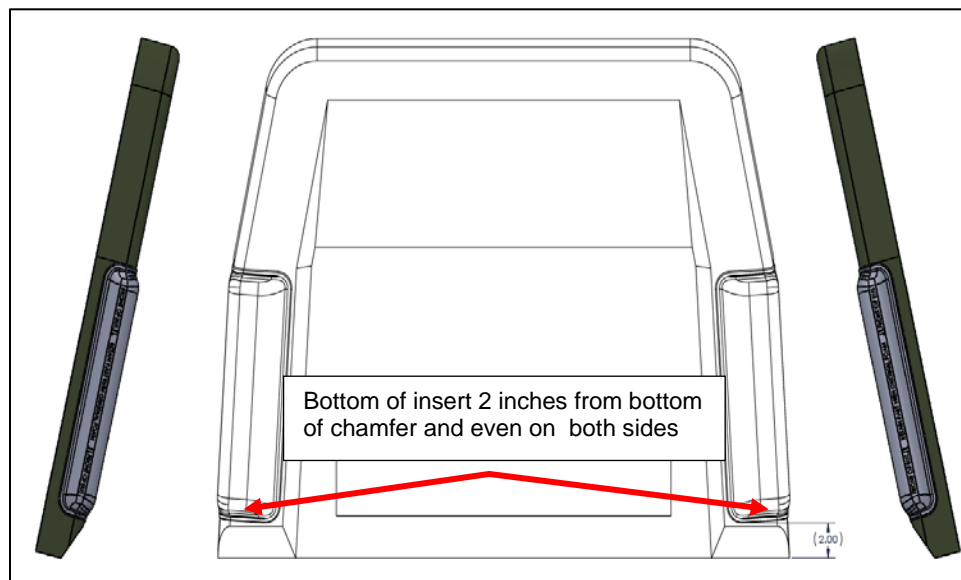
Figure 9: Alignment with Seat Foam

10. After both inserts are in place between the vinyl and foam, make sure the top edge of the foam has not folded over. Flatten the top edge of the foam by hand or slide the tool up to smooth any rolls, if required. Then, pull the vinyl down over the repair on both sides evenly. Do not pull one side down then the other, pull down both sides at the same time.
11. Check the bottom edge of both inserts. They should remain even with the foam chamfer, approximately 2 inches from the bottom of the foam. If either insert has shifted, adjust as necessary by sliding it up or down as needed to maintain the 2-inch distance from the bottom of the foam. See **Figure 9**.

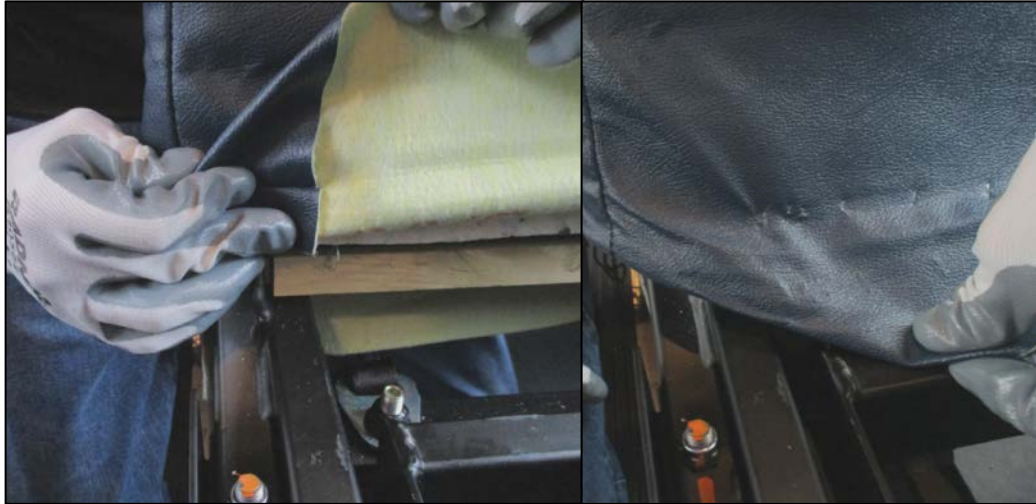
Figure 10: Folding and Tucking the Vinyl Seat Cover

12. Tuck and fold the front and back corners of the seat cover around the rear seat leg. See **Figure 10**.

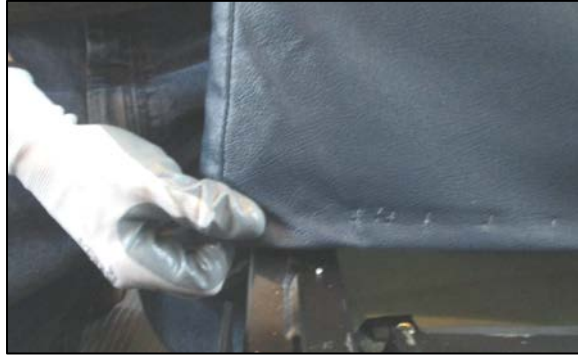
Figure 13: Front Seat Cover When Folded and Stapled

14. Pull the vinyl cover on the front of the seat down. Make sure it is straight and there are no wrinkles.
15. Fold the vinyl underneath itself to match the crease from the original installation.
16. Staple the front vinyl cover to the wood strip (that it was removed from earlier). Ensure no restraint belts are obstructed by the vinyl or staples. See **Figure 13**.
