**TECHNICAL INSTRUCTIONS**  
**FOR**  
**SAFETY RECALL J0A/J0B/J0C**  
**FRONT PASSENGER AIRBAG INFLATOR MODULE**  
**CERTAIN 2009 –2010 MODEL YEAR MATRIX**

## I. OPERATION FLOW CHART

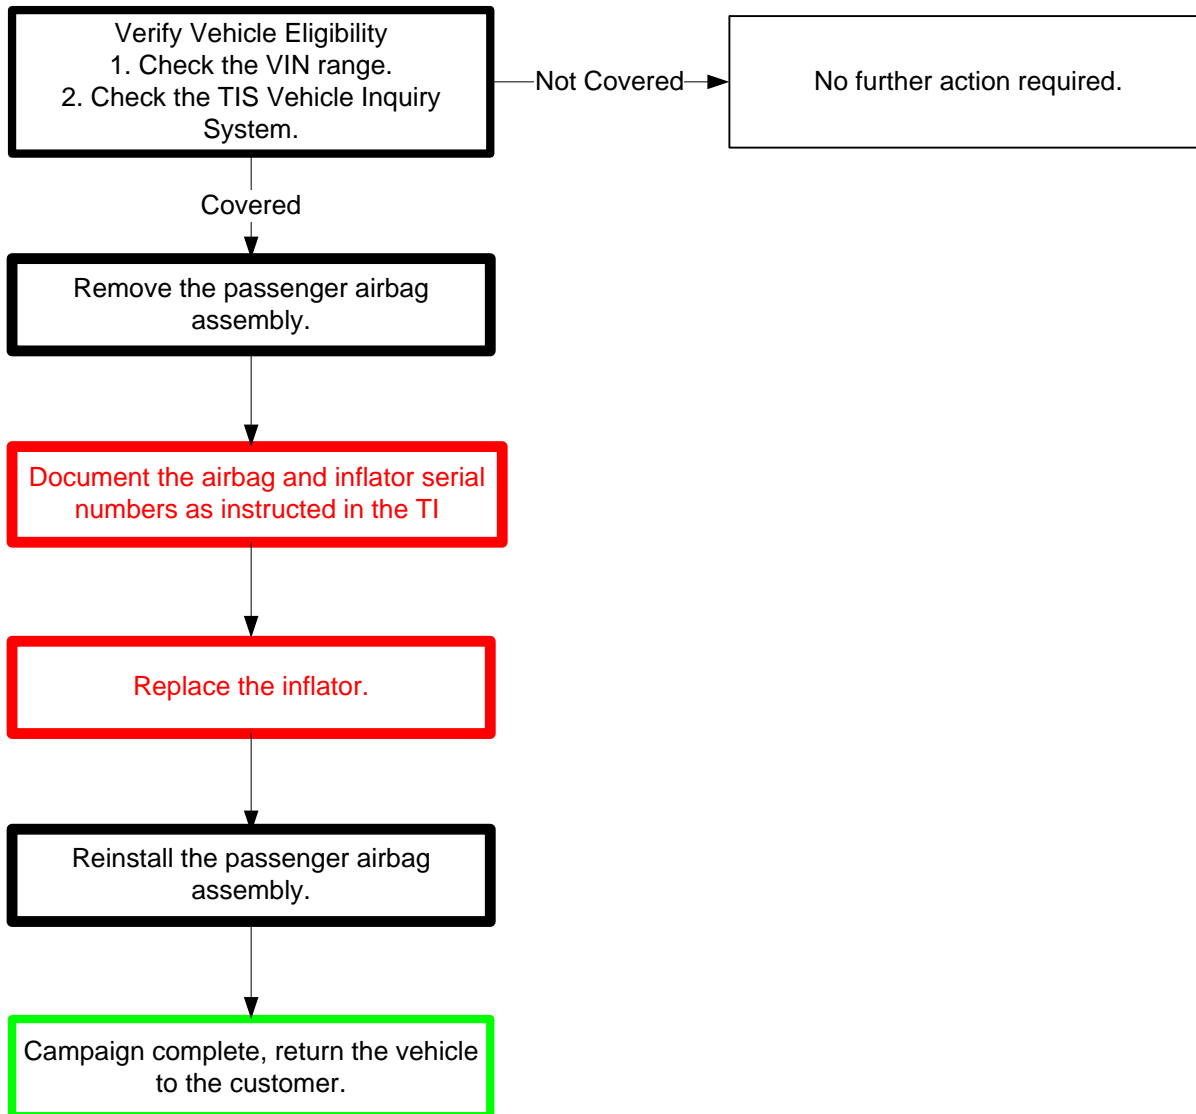
The flow chart is for reference only. **DO NOT** use it in place of the full technical instructions. Follow **ALL** steps as outlined in the full technical instructions to confirm the campaign is completed correctly.

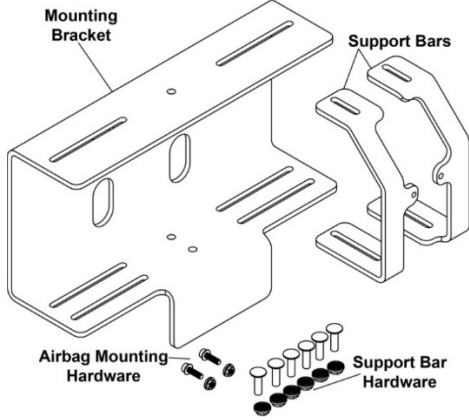
Airbag Mounting Bracket & hardware	1

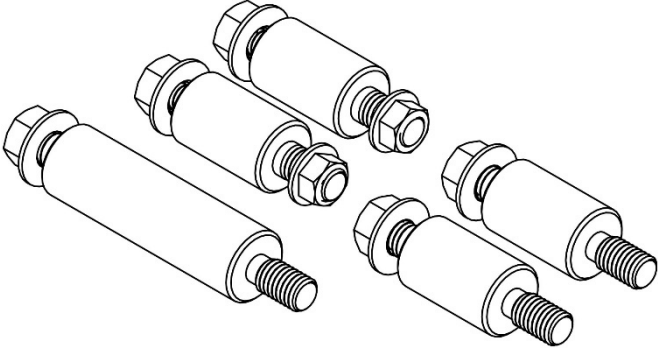
Adaptor set*	1

\*The adaptor set was sent to dealers at the start of this campaign.

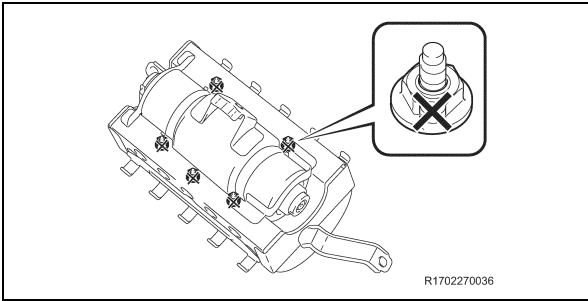
a) Use a screwdriver to release the lock button.

b) Disconnect the connector.

c) Disconnect the wire harness clamps.

**NOTE: Disconnect the connector where the fixed stop plate is located.**

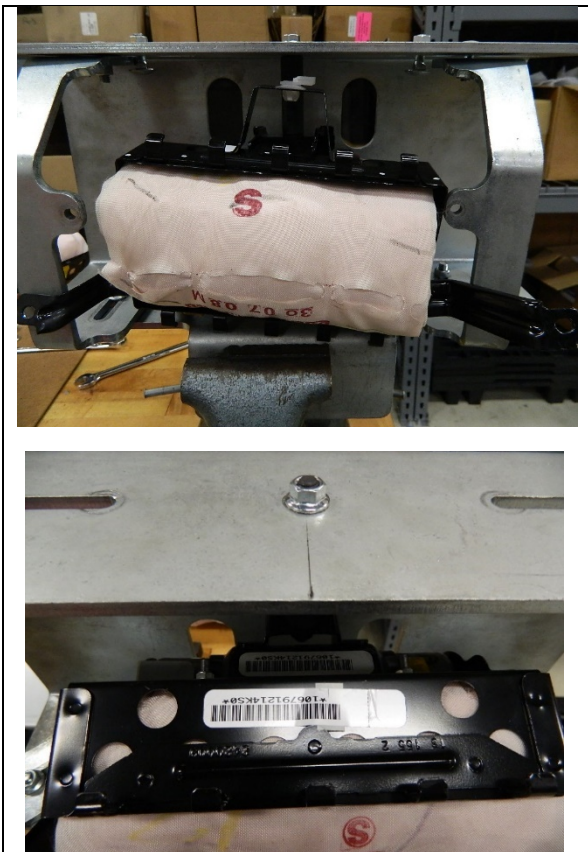
e) Use the long adaptor shown.

f) Thread the adaptor into the airbag as shown.  
**Note: Use the same mounting nut on the airbag that attaches the airbag to the vehicles cross tube.**

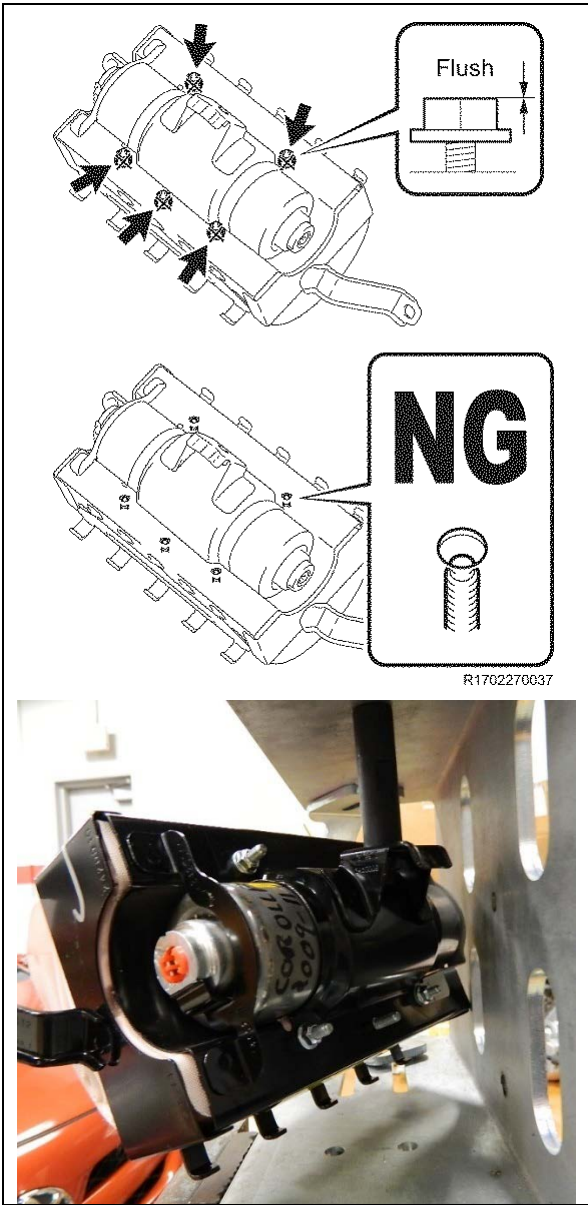
g) Mount the airbag into the mounting bracket as shown. Pass the stud on the adaptor through the hole in the middle of the bracket with the nut.

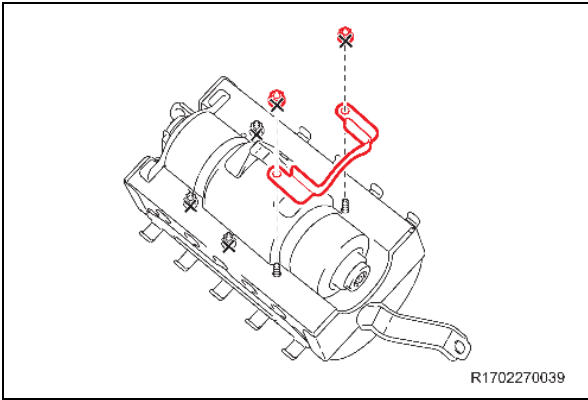
- a) Loosen the 5 nuts until the nuts are at the top of the studs as shown, through the openings in the mounting bracket.

**Note:** The airbag may need to be turned to the left or right to access the center nut.

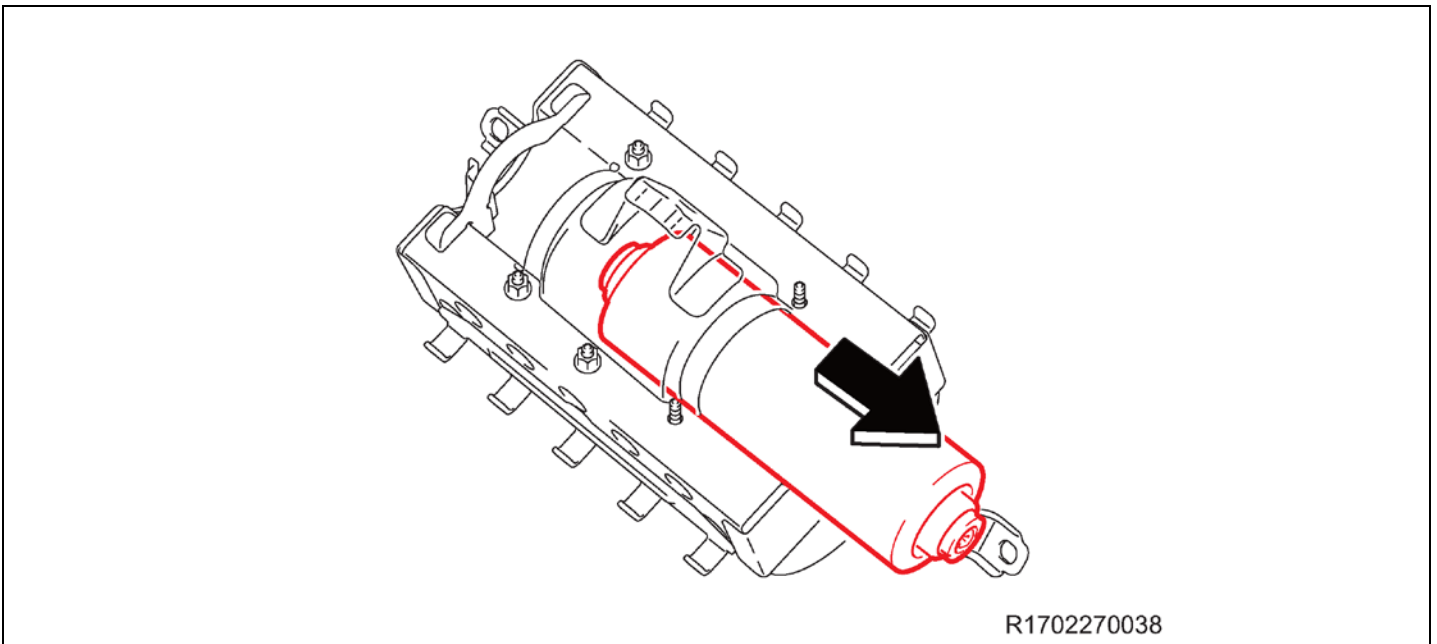
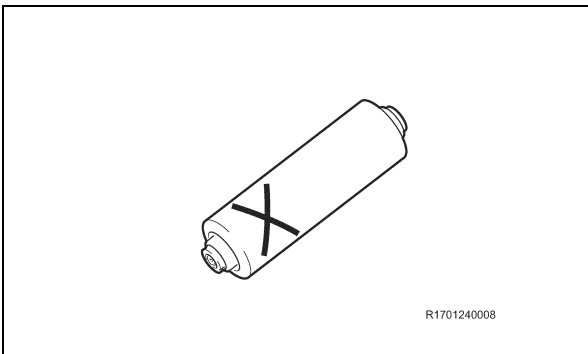
- a) Gently push in the studs until the nuts make contact with the housing to loosen the inflator for removal.

- b) Remove the inflator from the airbag assembly and place it on a safe work surface.
- c) Mark the old inflator so it is not reused.

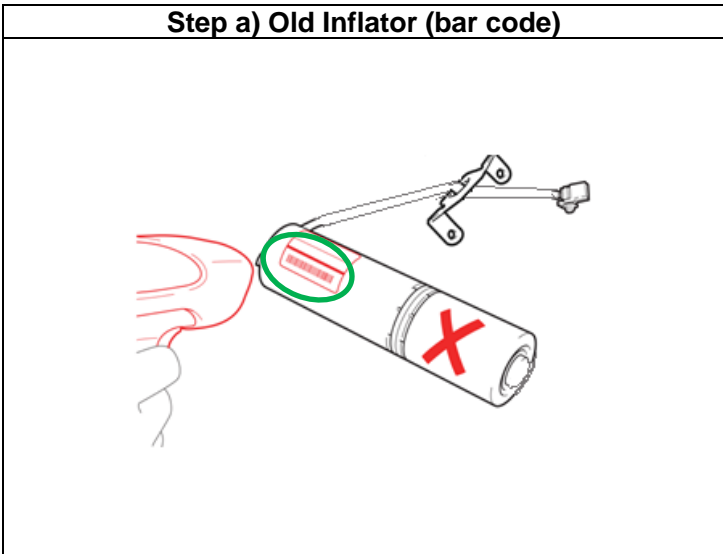
Step a) Old Inflator (bar code)

- Scan the **OLD** inflator bar code.
- Scan the **NEW** inflator QR code.

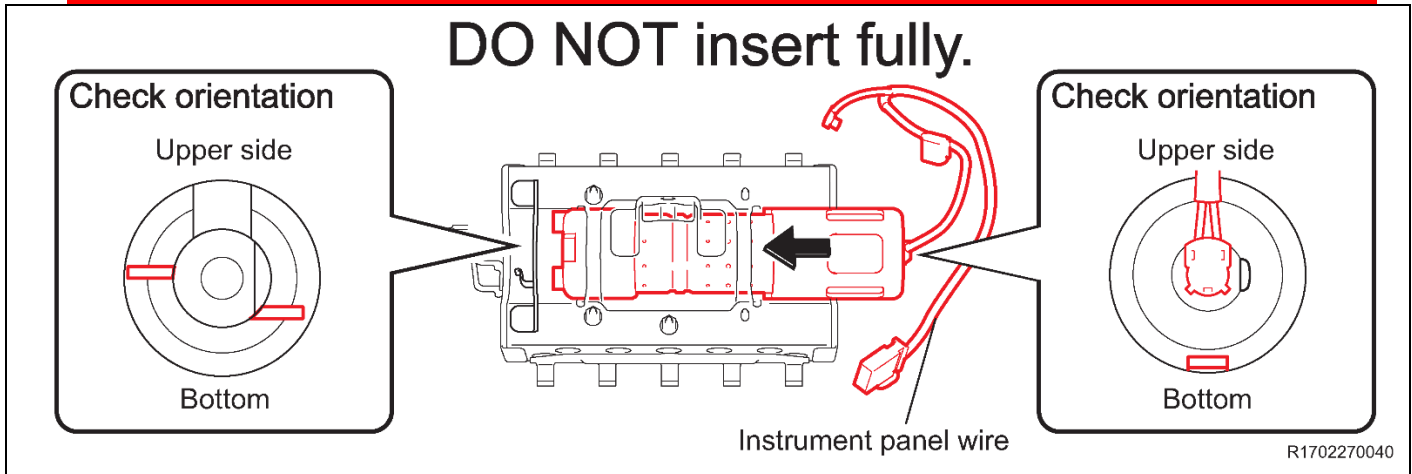
a) Carefully slide the new inflator into the airbag assembly and align as shown.

- **DO NOT** connect the inflator harness at this time. It is **CRITICAL** to first confirm that the inflator is installed in the correct position before connecting the harness.

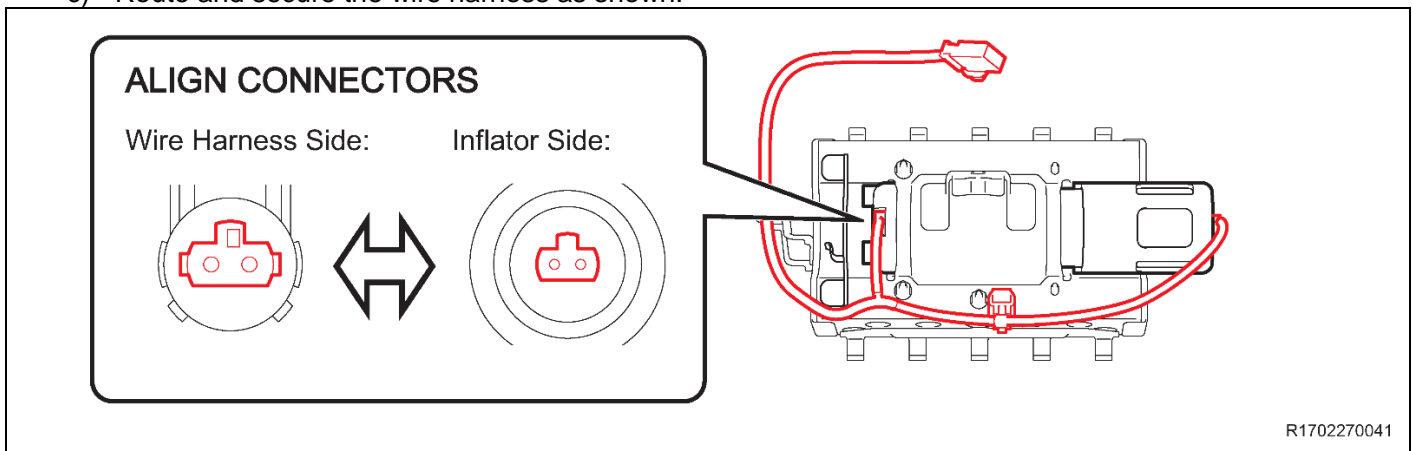
b) Connect the connector to the inflator and ensure that the connector lock is fully engaged as shown.

c) Route and secure the wire harness as shown.

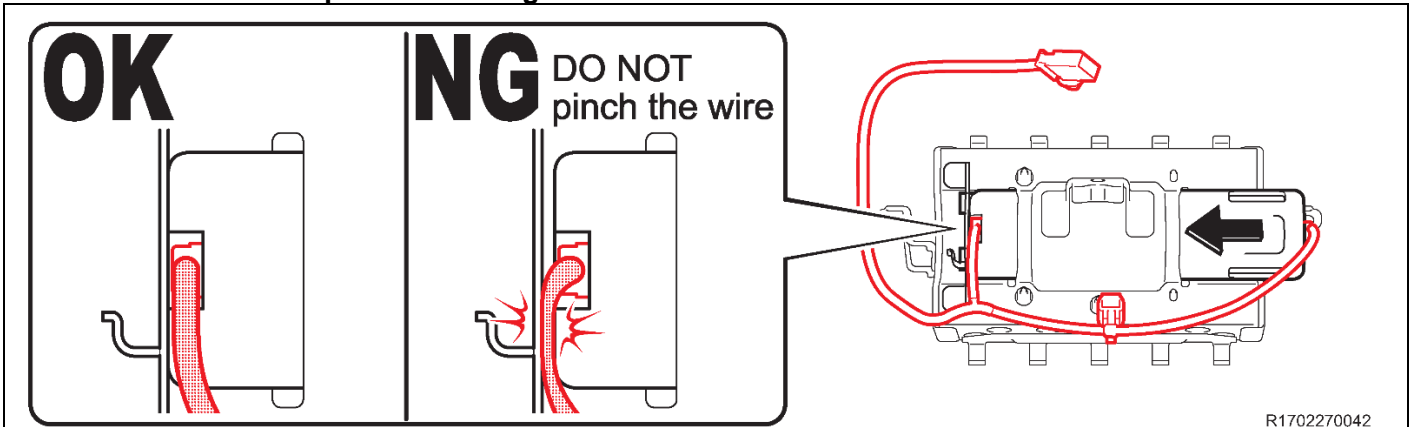
R1702270042

- d) Fully insert the inflator and ensure that the inflator is correctly oriented as shown.  
**NOTE: DO NOT pinch the wiring between the bracket and the inflator.**

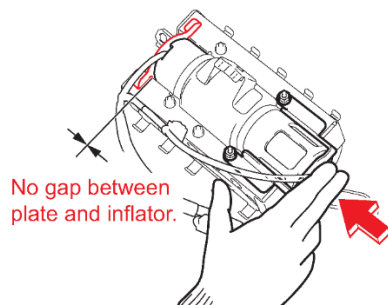
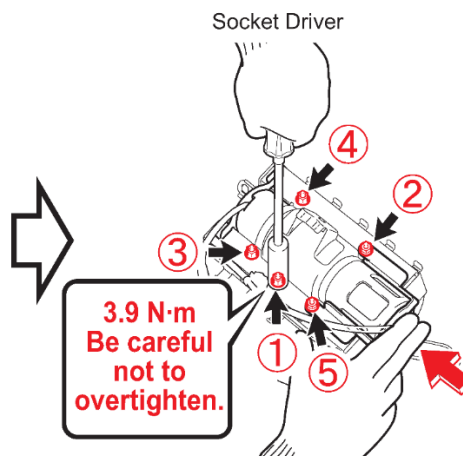
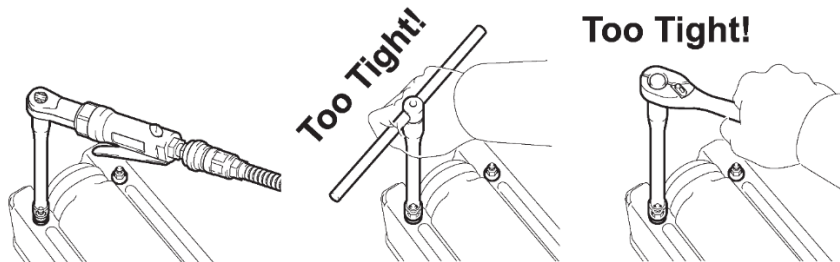
R1702270046

- a) Tighten the 5 nuts evenly in several increments in the sequence shown. Use a socket driver or torque wrench to tighten the nuts.

**Torque: 35in. lbf (3.9N·m)**

- There will be some resistance when tightening the nuts because they are self-locking, confirm the nuts are tightened correctly.
- **DO NOT** use a power tool, T-handle, or ratchet when tightening the nuts to avoid over torqueing and deforming the studs.
- You may need to turn the airbag to the left or right with in the mounting bracket to access the center nut.

**These tools cause overtightening !**

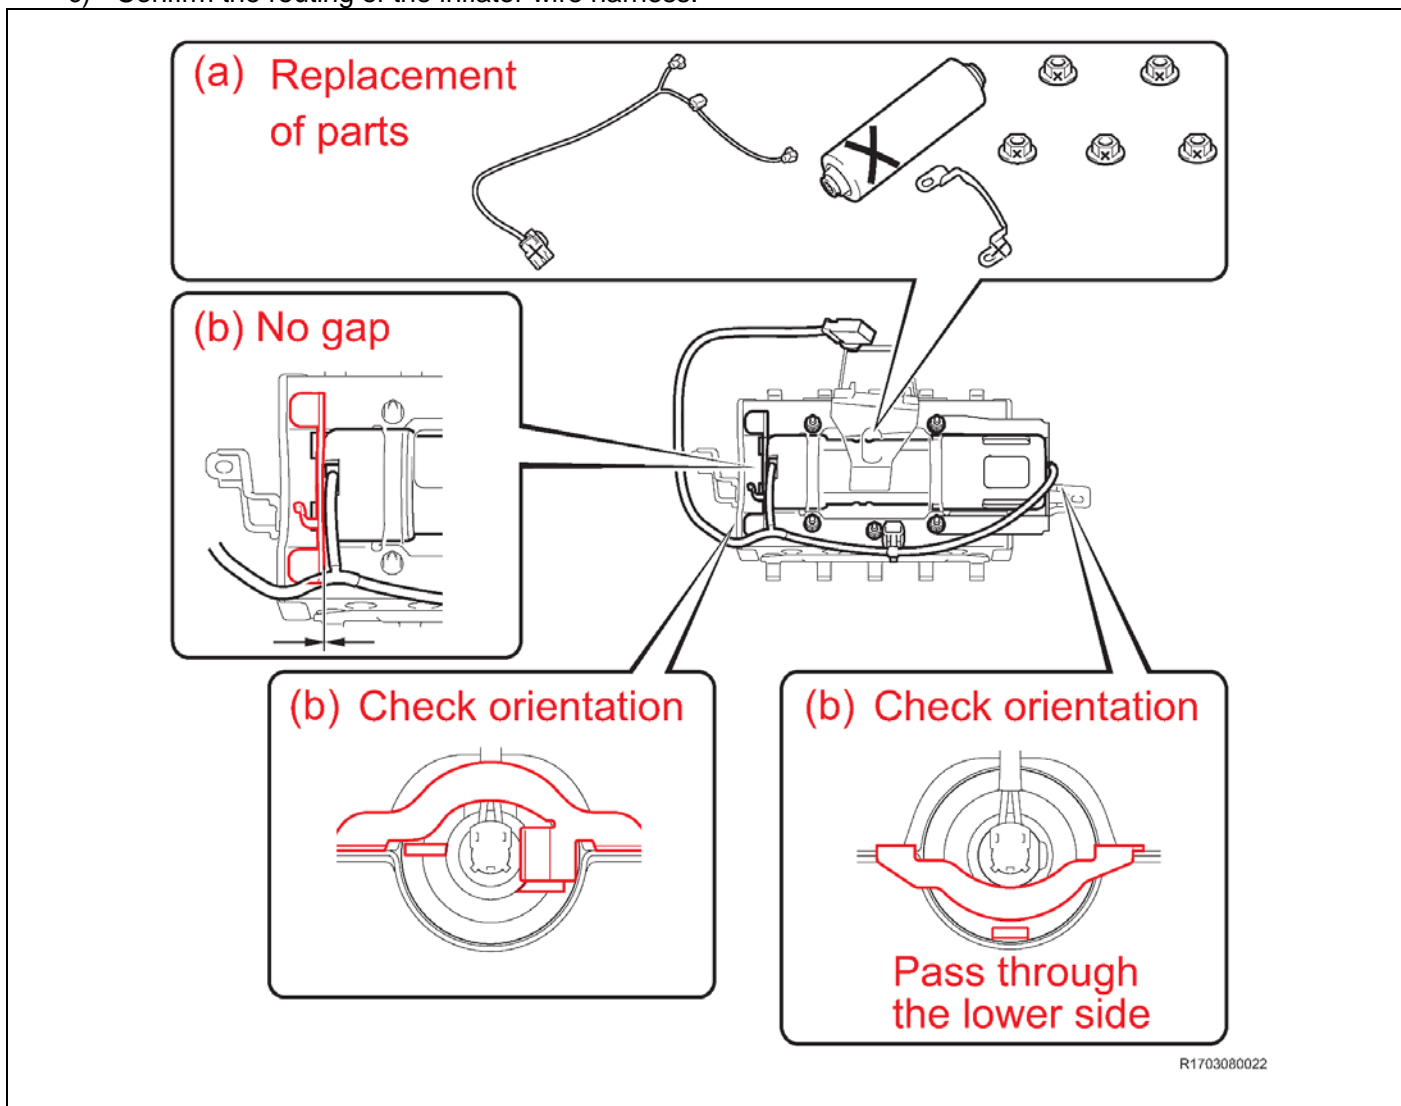
- a) Confirm the **NEW** inflator and 5 **NEW** nuts have been installed.
- b) Confirm the position of the inflator and position determining plates are correct.
- c) Confirm the routing of the inflator wire harness.
