# IMPORTANT UPDATE

## TECHNICAL INSTRUCTIONS FOR SAFETY RECALL JLI/JLJ/JLK FRONT PASSENGER AIRBAG MODULE CERTAIN 2010-2017 MY GX 460

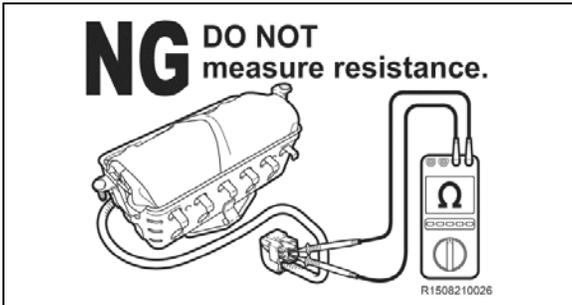
#### 2. DO NOT MEASURE RESISTANCE

- a) **NEVER** measure the resistance of an airbag, this may cause accidental activation.

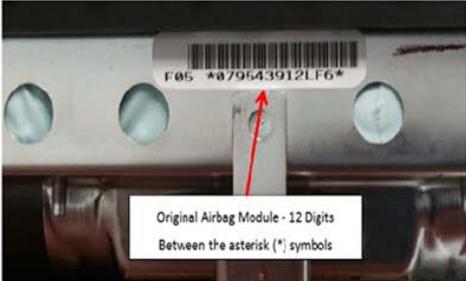
#### Airbag Serial Number Label Example

- The airbag serial number is **ALWAYS** the 12 **DIGITS** located between the asterisks.
- The 3 digits before the asterisk **ARE NOT** part of the serial number, and **SHOULD NOT** be entered or an inaccurate response may be returned.

Original Airbag Module - 12 Digits  
Between the asterisk (\*) symbols

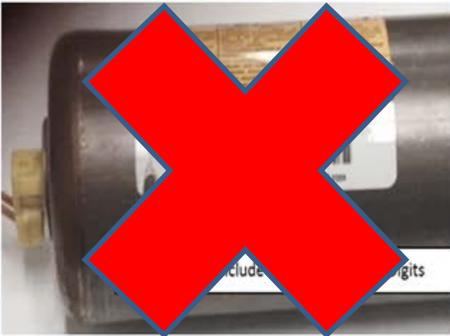
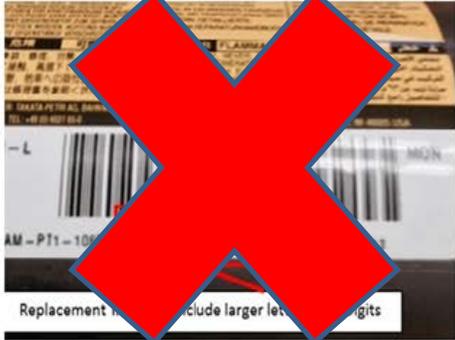
How to Identify the Inflator serial code on the Original and Replacement Inflator can?

The Inflator serial code is an **11 digit code** on the Inflator can. It can be found with a bar code on removing the Inflator can from the Airbag Assembly unit.

The first two characters of the **Original Inflator Serial code** will be from [AA, AB, AJ, FD or JD].

The first two characters of the **Replacement Inflator Serial code** will be either 'LT' or 'LR'.
