# Product Safety Recall

## N192278300 Front Seat Crossmember Improperly Welded

**Revision:** 02

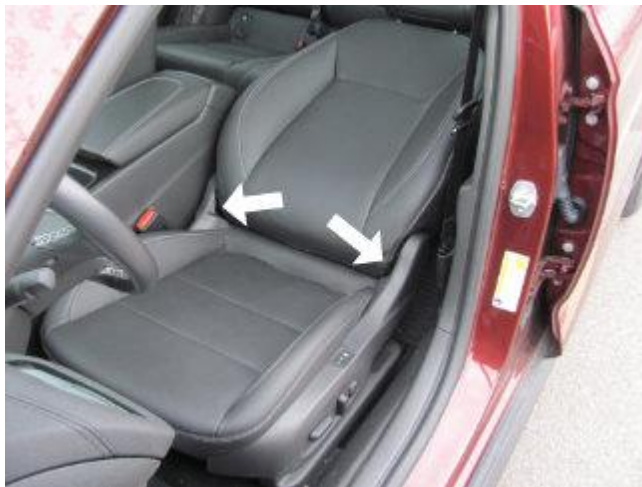
5429380

1. Fully recline the front driver side seat. Locate the two inspection areas.

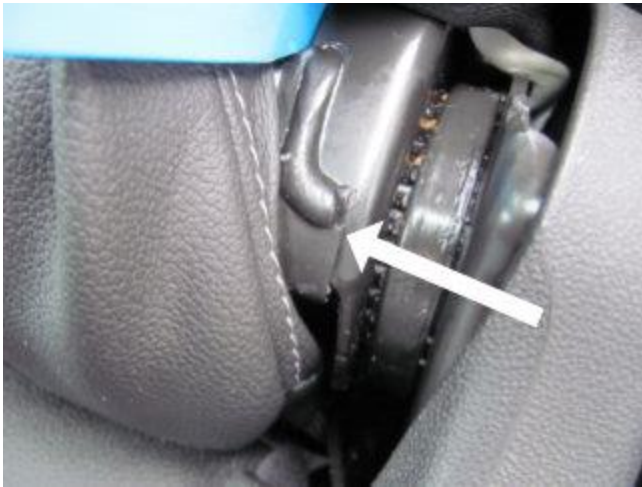
5429383

**TIP:** If the outboard edge of the seat cross bar is visible as shown, the seat is correctly assembled.
