**SUBJECT: NEW VEHICLE DEMONSTRATION / DELIVERY HOLD - Safety Recall 19S38**  
**– Supplement #1**  
Certain 2015-2017 Transit Vehicles  
Driveshaft Flexible Coupling

## CERTAIN 2015-2017 TRANSIT VEHICLES EQUIPPED WITH A DRIVESHAFT FLEXIBLE COUPLING — DRIVESHAFT FLEXIBLE COUPLING REPAIR

### ENHANCED DRIVESHAFT FLEXIBLE COUPLING INSTALLATION

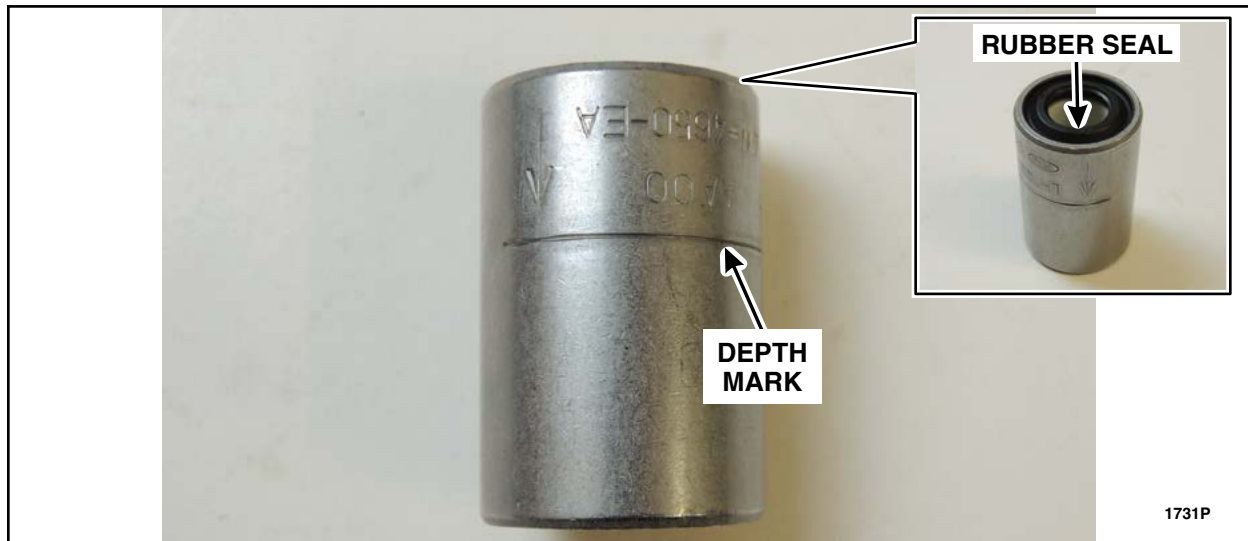
FIGURE 4

5. **NOTE:** Prior to installation of the *new* driveshaft pilot bushing, make sure the rubber seal end of the bushing is facing outward and the capped end is pressed into the driveshaft. See Figure 4.

Using a 3-jaw puller and a suitable flat piece of metal, press in the *new* pilot bushing until the depth mark on the pilot bushing has been reached. See Figures 4 and 5.

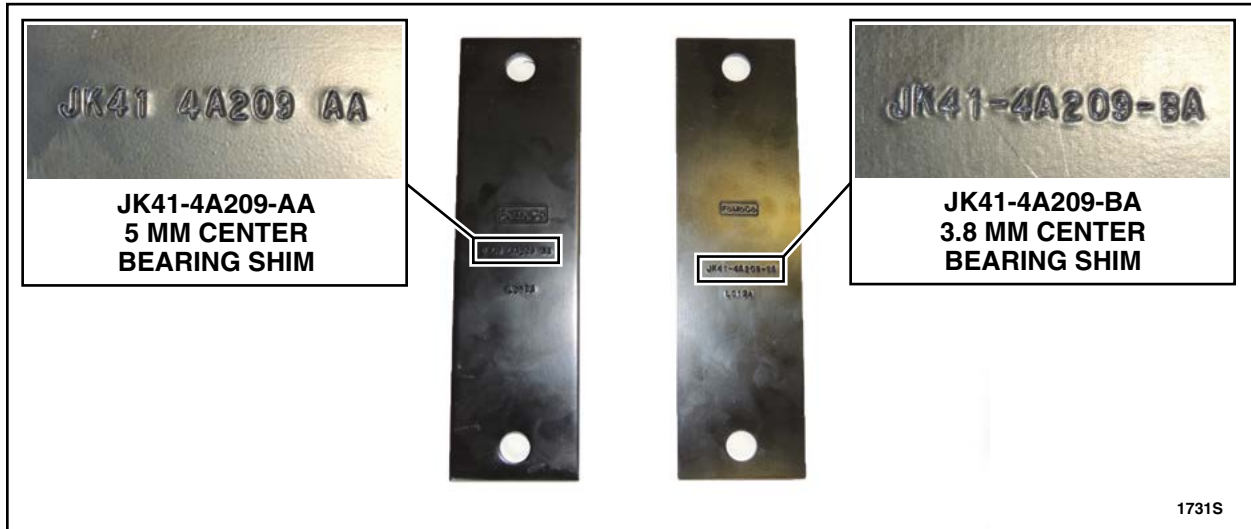
FIGURE 13

SHIM	WHEEL BASE	ENGINE	SRW/DRW
3.8MM SHIM JK41-4A209-BA	129"	3.5L	SRW
5MM SHIM JK41-4A209-AA	148"	3.5L	ALL
		3.7L	
NO SHIM	All Others

12. Reinstall the driveshaft with the appropriate center bearing shim according to the chart in Figure 13. Please follow the Driveshaft Removal and Installation Workshop Manual (WSM) procedure in Section 205-01. See Figures 12, 13 and 14.

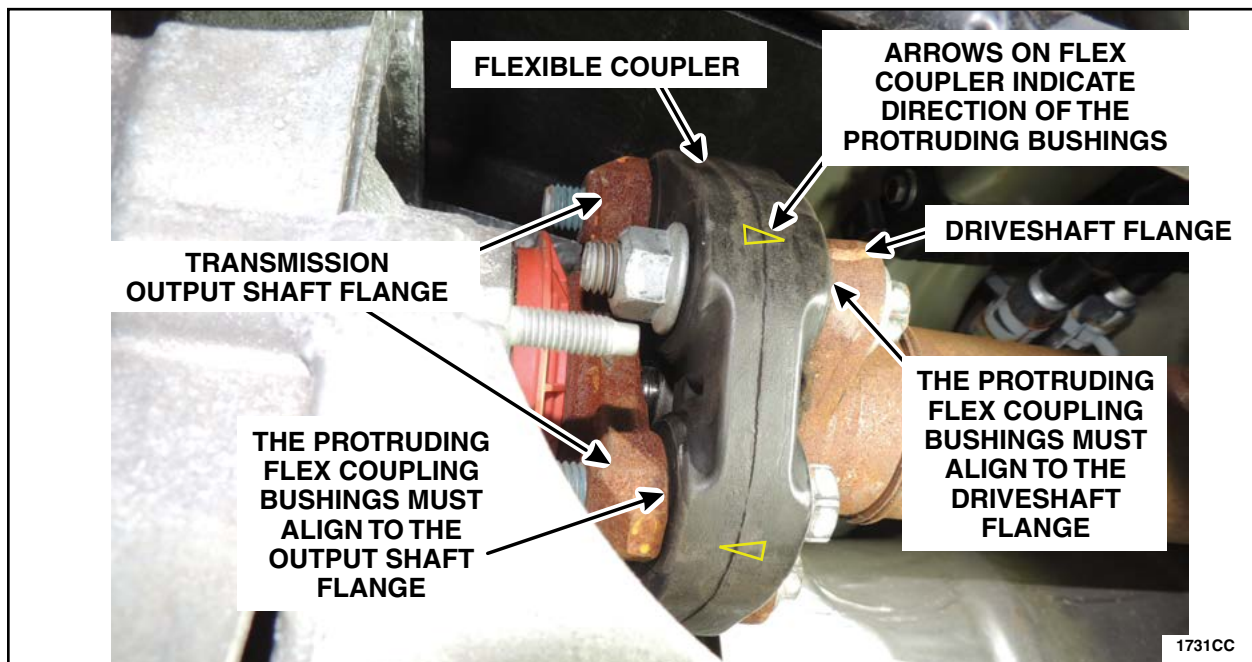
**FIGURE 17**

**NOTICE:** The flex coupler must be installed with the blue paint mark facing the transmission output flange. The protruding flex coupler bushings must align with the driveshaft flange and transmission output flange. Arrows should point at the ears of each flange shown in Figure 17.
