SAFETY RECALL BULLETIN

SUBJECT:			No: SR-19-002
i-MiEV BRAKE VACUUM PUMP- SAFETY RECALL CAMPAIGN			DATE: January 2020
			MODEL: 2012-2017 i-MiEV
CIRCULATE TO:	<input checked="" type="checkbox"/> GENERAL MANAGER	<input checked="" type="checkbox"/> PARTS MANAGER	<input checked="" type="checkbox"/> TECHNICIAN
<input checked="" type="checkbox"/> SERVICE ADVISOR	<input checked="" type="checkbox"/> SERVICE MANAGER	<input checked="" type="checkbox"/> WARRANTY PROCESSOR	<input checked="" type="checkbox"/> SALES MANAGER

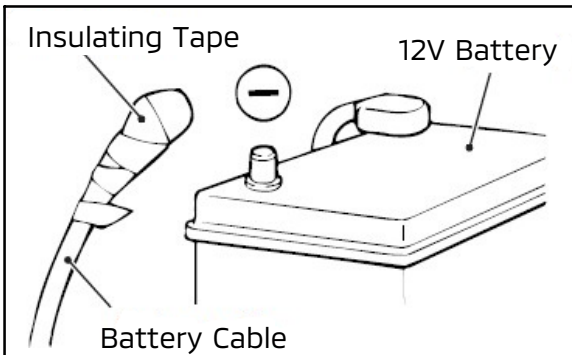
1. **REMINDER:** If the vehicle is not equipped with the optional OEM navigation unit, please record all radio station presets and reprogram them when repairs are completed.
2. With the electric motor switch in the "OFF" position, set the parking brake and open the hood. Remove the 12V battery cover and disconnect the negative (-) terminal of the battery. Wait at least 60 seconds. Insulate the disconnected negative (-) terminal with electrical tape.

⚠ WARNING To avoid damaging the electric motor unit components, do not disconnect the 12V battery negative (-) terminal for 1 minute after turning the electric motor switch to "LOCK" (OFF).

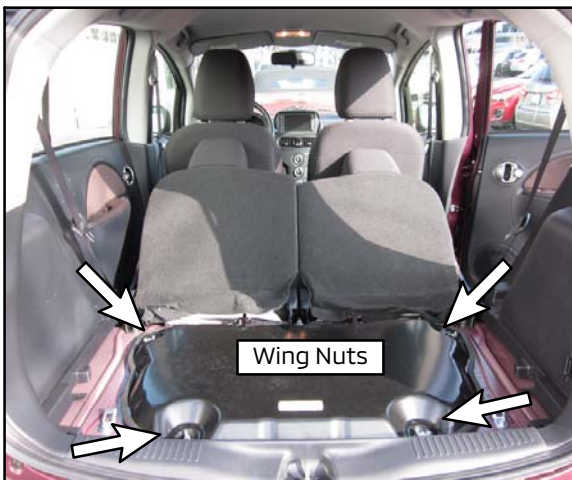
3. Open the liftgate.
4. Fold the rear seatbacks forward into the passenger compartment.
5. Remove and store the rear access cover.
6. Unscrew the four wing nuts from the power unit inspection lid and open the lid to gain access to the brake vacuum pump.

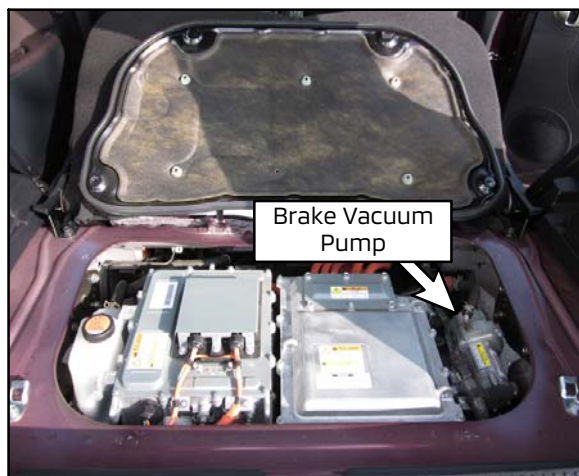
7. The brake vacuum pump is located on the right side of the motor compartment.

The pump assembly fitted to 2010 - early 2012 models is an all-metal construction.

For late 2012 models and later, the pump assembly can be all metal or have a black metal motor housing with a black plastic pump housing and cover.

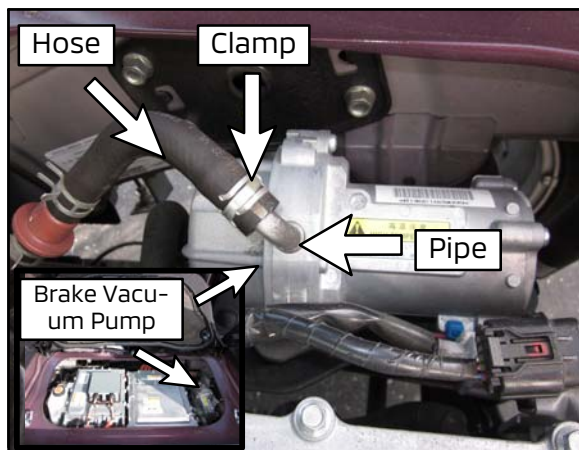
8. Squeeze the vacuum hose clamp and slide it to the center of the vacuum hose.

REMINDER: For re-installation, note the position of the vacuum hose clamp on the vacuum hose.

9. Gently pull vacuum hose off of the brake vacuum pump pipe.

REMINDER: For re-installation, note position of the vacuum hose on the brake vacuum pump pipe.

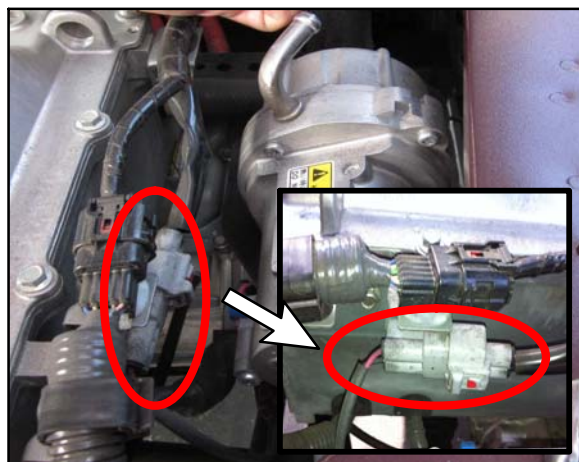
10. Disconnect the brake vacuum pump electrical connector.

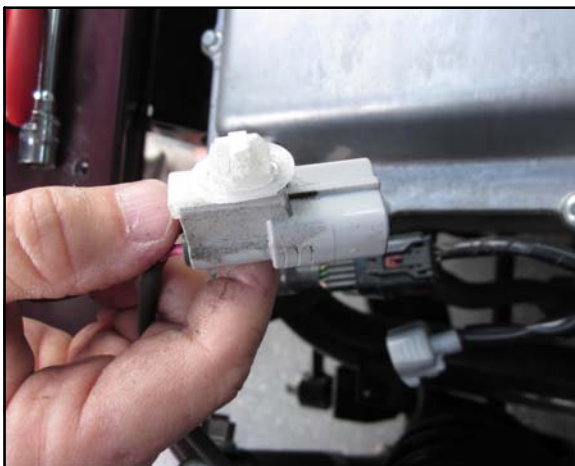
11. Unclip the brake vacuum pump electrical connector mount from the vehicle's body.

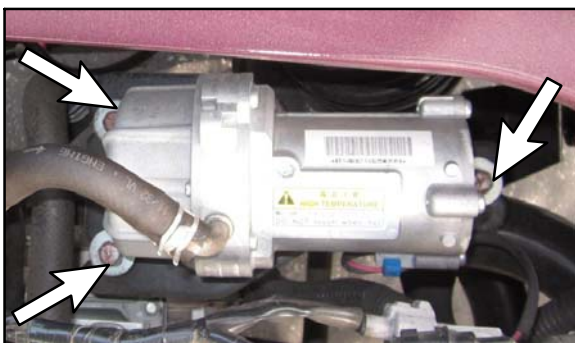
12. Remove three 12 mm bolts to disconnect the brake vacuum pump assembly.

To prevent damage to the brake vacuum pump electrical connector, make sure it is disconnected from the brake vacuum pump prior to removal.

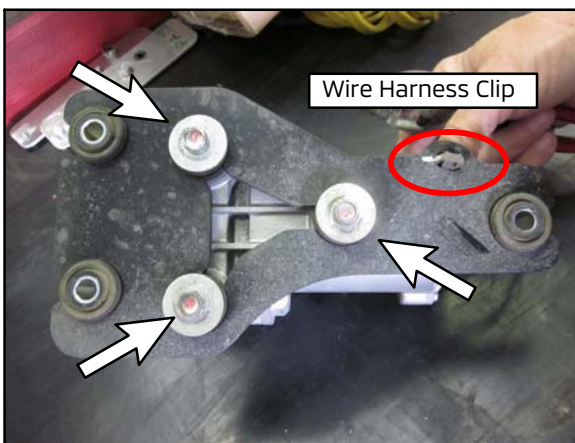
13. Remove three 10 mm bolts and unclip the wire harness to disconnect the brake vacuum pump from its bracket.

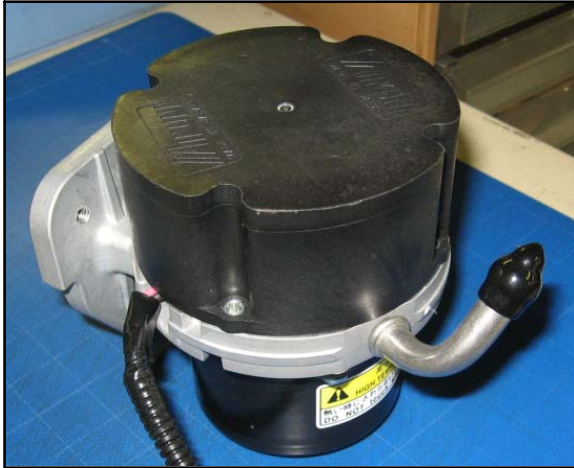
14. Replace the brake vacuum pump with the new unit.

The affected brake vacuum pump can be all metal or have a black metal motor housing and a plastic pump housing. Replacement pumps have a black metal motor housing and a plastic pump housing.

15. Reattach the wire harness clip to the bracket first, then reinstall the three 10mm bolts. Doing so will ensure the brake vacuum pump is installed correctly to the bracket.

NOTE: Use hand tools only. Torque specification is 44 ± 8 in-lb (5 ± 1 N-m).
