Models Affected 2017 Winnebago Vista

INSTRUCTIONS TO PERFORM RECALL CAMPAIGN 160 FOR LP REFRIGERATOR APPLICATIONS

Recall Repair Kit # RC 7645-20-760

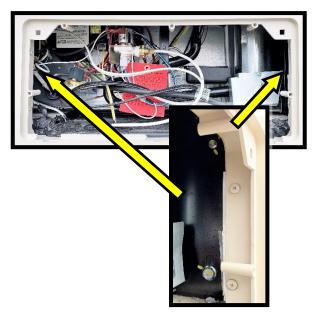
- Through the exterior access, remove fasteners located at brackets to the front and rear. Retain and set these fasteners aside for later use.

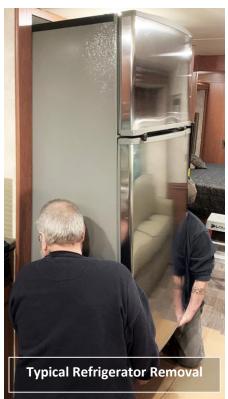
- Remove the refrigerator
 - This step will require more than one person.
 Practice safe lifting techniques when maneuvering the refrigerator out of the opening and on to the floor.

Be aware of the potential for damage to the refrigerator cabinet face frame and use safeguards to prevent damage from happening.

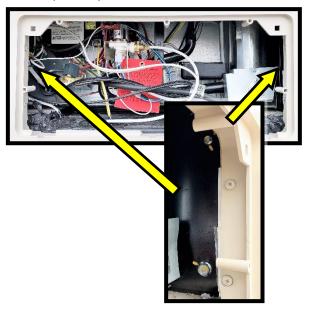
Through the exterior access, reinstall fasteners removed earlier which are located at brackets to the front and rear. Retorque these fasteners to 27 N-M (20 ft lb)

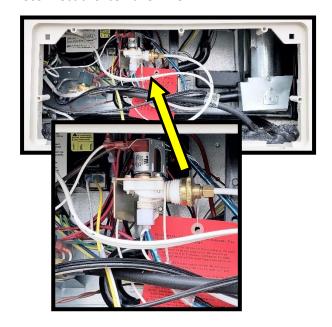
- Reconnect the icemaker line

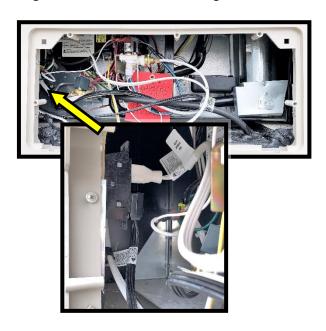
- Plug in the icemaker and the refrigerator
