Models Affected 2	2017	Winnebago Vista	Itasca Sunstar
-------------------	------	-----------------	----------------

INSTRUCTIONS TO PERFORM RECALL CAMPAIGN 160 FOR RESIDENTIAL REFRIGERATOR APPLICATIONS

Recall Repair Kit # RC 7645-20-760

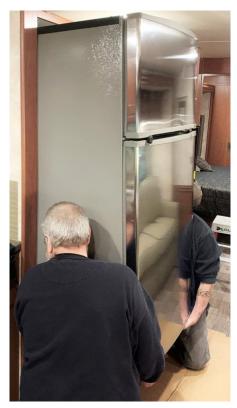
- Remove the refrigerator
 - This step will require more than one person.
 Practice safe lifting techniques when maneuvering the refrigerator out of the opening and on to the floor.

Be aware of the potential for damage to the refrigerator cabinet face frame and use safeguards to prevent damage from happening.
