# Safety Recall V62 / NHTSA 19V-813

## Fuel Pump Relay

**2011 - 2013 (WD) Dodge Durango  
(WK) Jeep® Grand Cherokee**

The fuel pump relay on about 582,000 of the above vehicles may have had a fuel pump relay installed as a recall remedy that is susceptible to silicon contamination of the relay contacts, that can cause the relay to fail. A fuel pump relay failure can result in a no-start condition or an engine stall condition if the vehicle is running. A vehicle engine stall while driving can cause a vehicle crash without prior warning

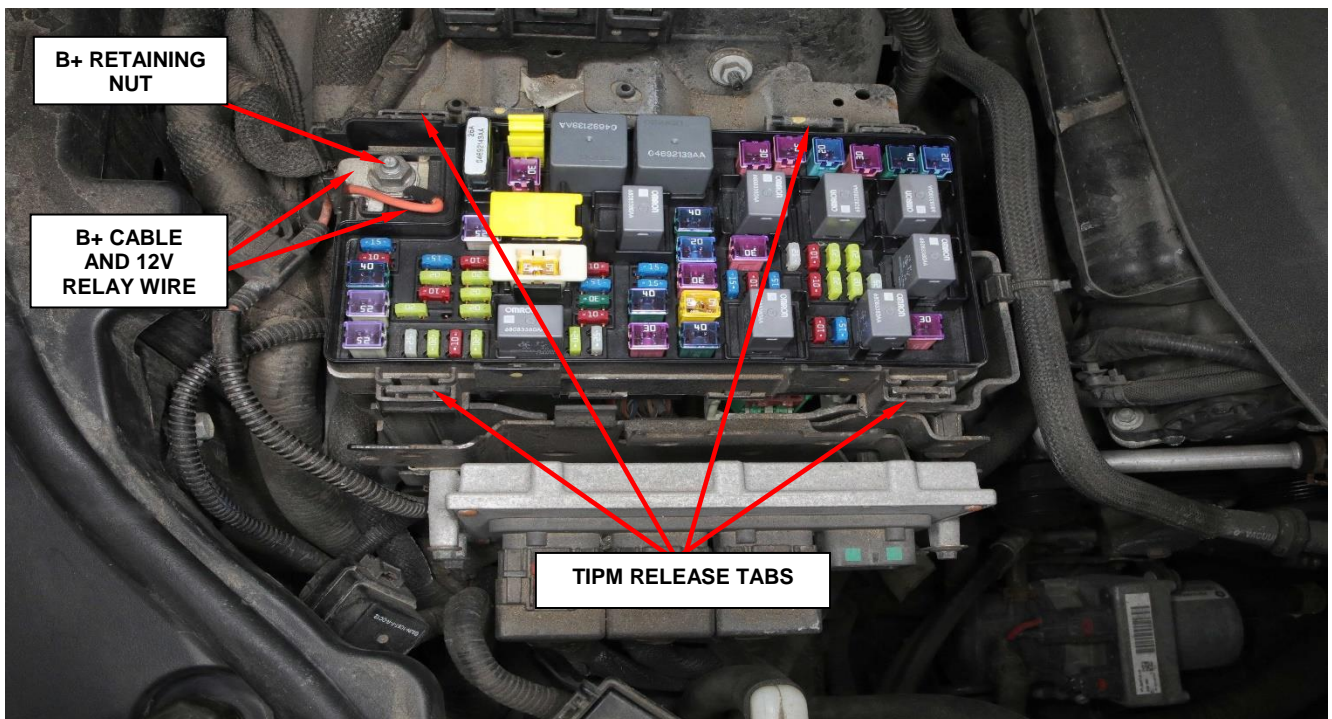
**Figure 3 – TIPM Release Tabs**

7. Push the four TIPM retaining tabs and separate the TIPM from the TIPM support bracket (Figure 3).

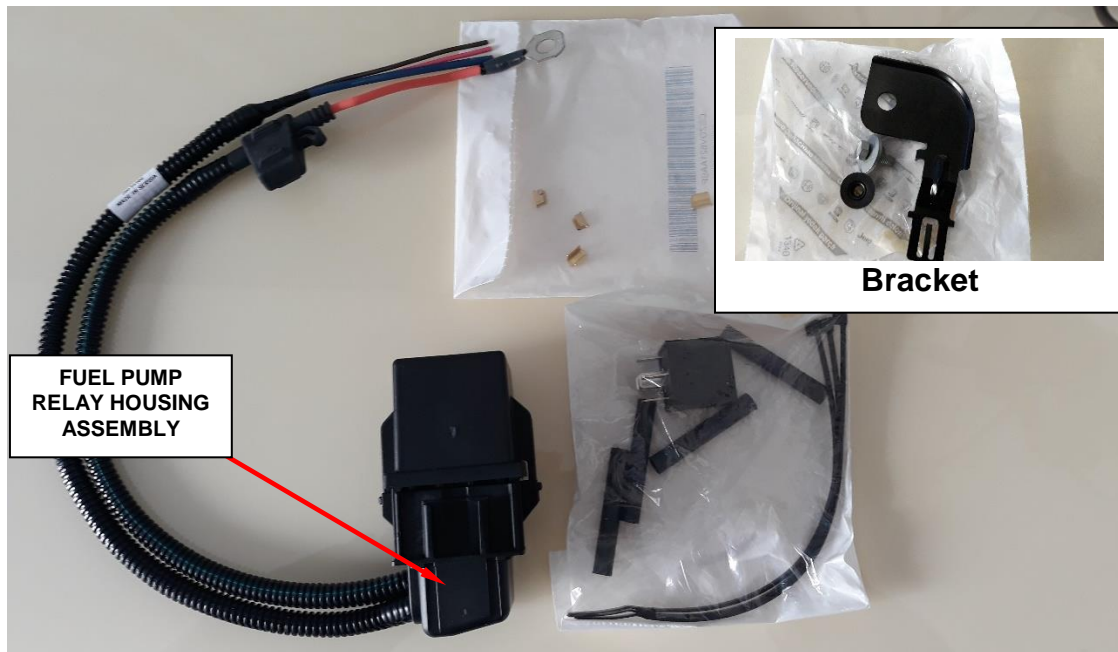
**Figure 6 – Fuel Pump Relay Repair Kit**

10. Remove the relay housing from the repair package (Figure 6).

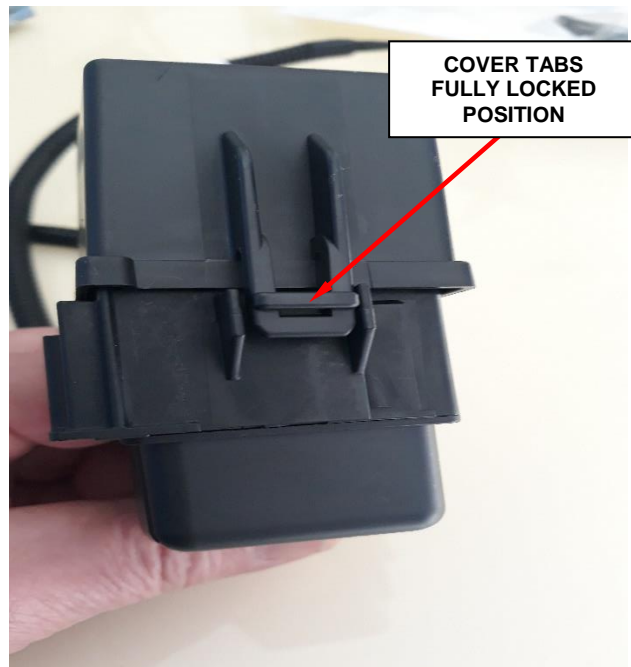
**Figure 9 – Cover Guides**

13. Align the cover keys to the fuel pump relay housing cover assuring the tabs are fully locked (Figure 9 and Figure 10).

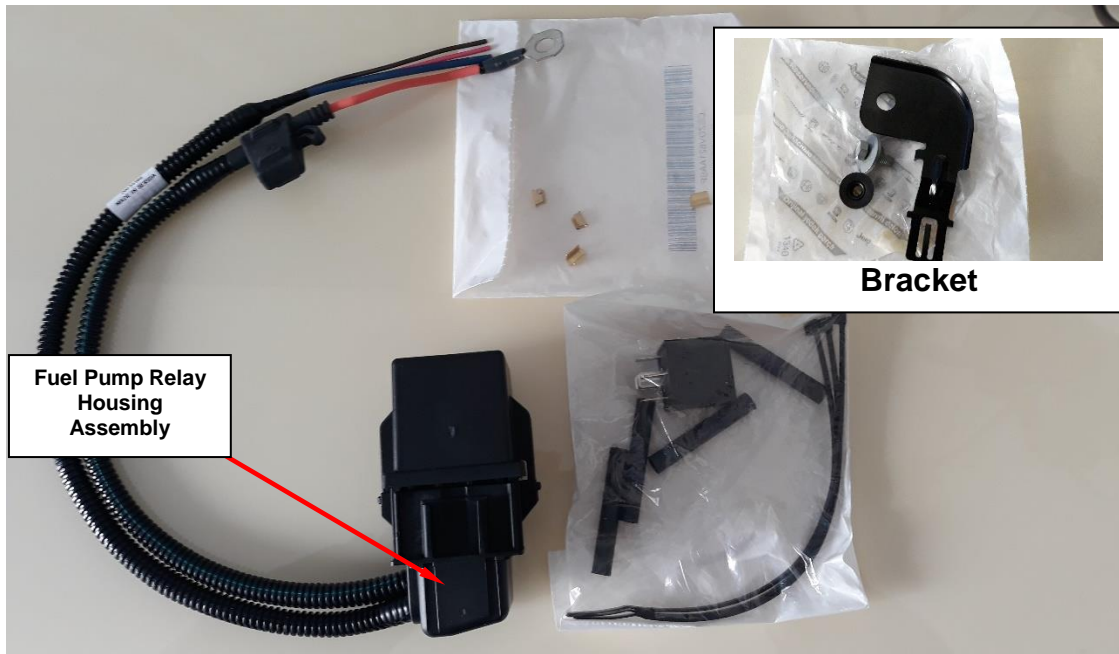
**Figure 16 – Fuel Pump Relay Repair Kit**

1. Remove the relay housing from the repair package (Figure 16).

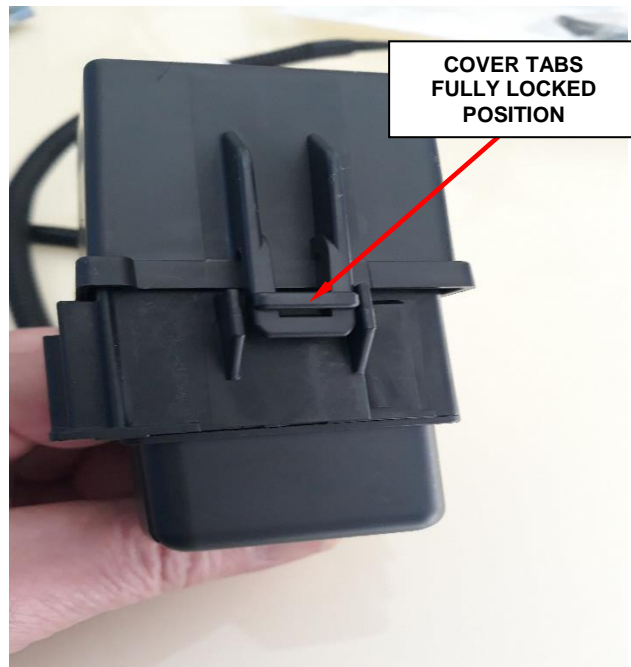
**Figure 18 – Fuel Relay Installation**

3. Align the fuel pump relay male terminals to the female terminals in the electrical housing connector and firmly insert until fully seated into the housing (Figure 18).
4. Align the cover keys to the fuel pump relay housing cover assuring the tabs are fully locked (Figure 19 and Figure 20).
