Subject: NHTSA Recall 19V826 - Brake bleeding campaign

**Campaign Code:** PP2ZZQ1904_GTS

2019 GTS/GTV 300 models
2020 GTS 300 HPE models

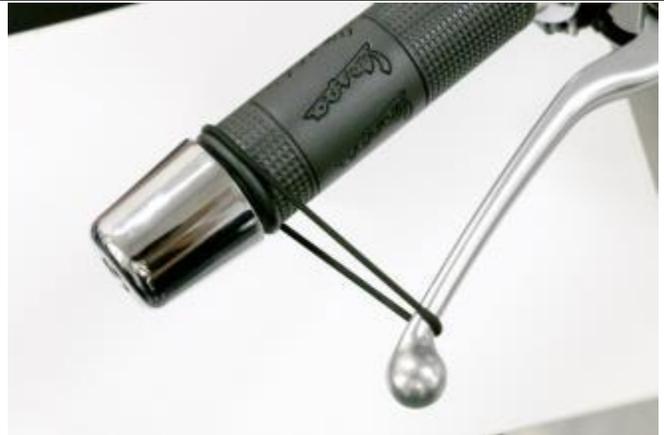
Before starting any work on the vehicle, check the travel of the two brake levers by applying the O-ring P/N **006731** as shown in the figure.

Note: O-ring found in kit 1R000467

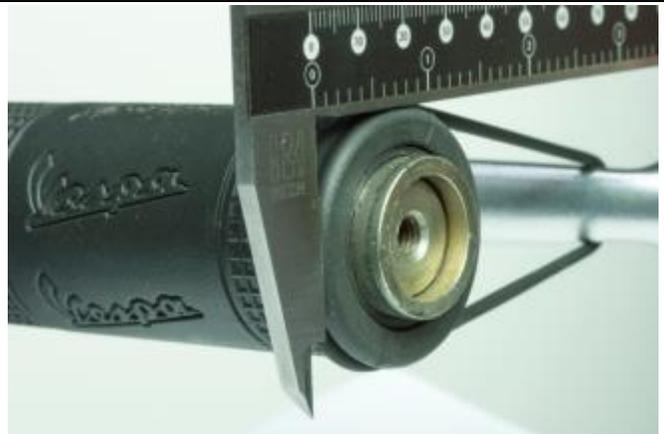
Place one end of the caliper gauge on the end of the hand grip as shown in the photo.

It is not necessary to remove the end of the handlebar, which has been removed in the photo solely to illustrate the procedure more clearly.

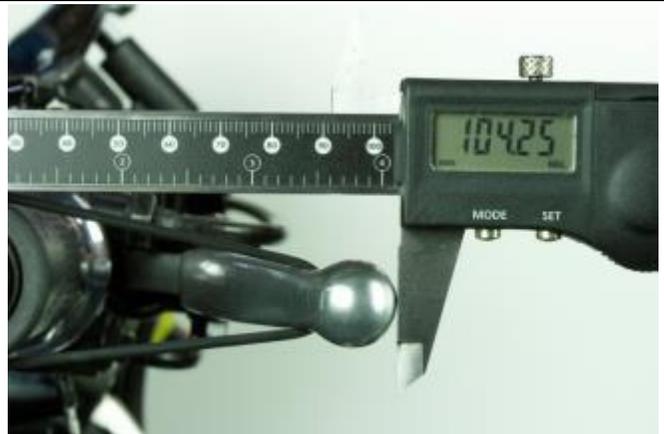
Place the other end of the caliper gauge on the brake lever as shown in the photo.

Measure the distance between the brake lever and the end of the hand grip.

Take photos of the measured values for both brake levers ensuring the readout is clearly visible. These photos must be attached to the service coupon when finalizing claim in State Management.

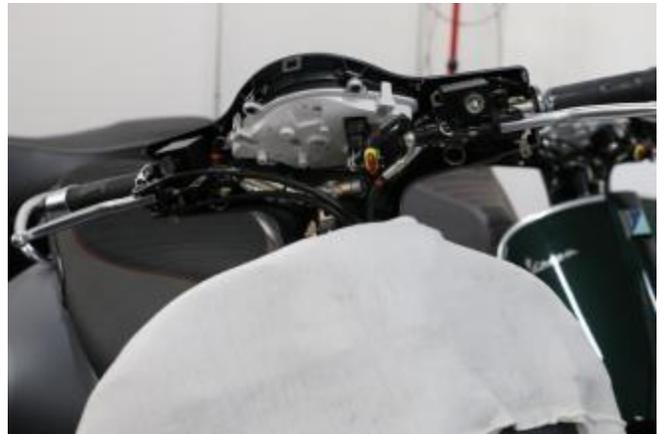
Dry the area in the vicinity of the master cylinder with absorbent paper and remove the connector with the relative copper washers.

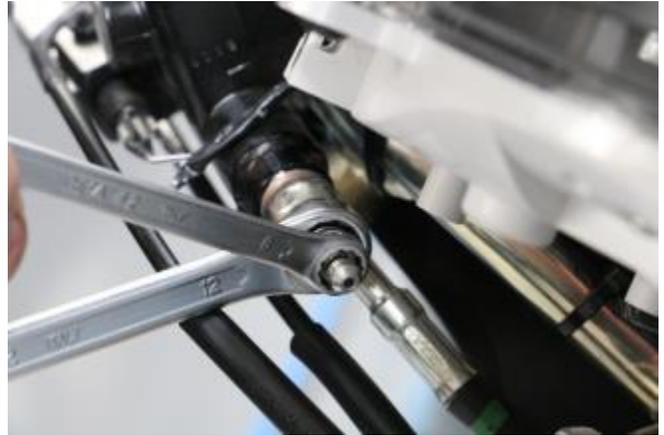
Fit the bleeding kit fitting with bleed nipple, P/N **AP8133945** with new copper washers, P/N **AP8113004**, and loosen the bleed nipple nut to open.

Note: Bleed nipples and copper washers found in kit 1R000467

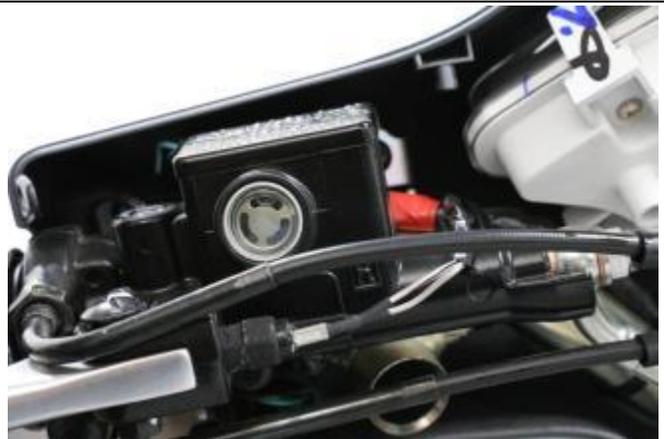
Check the brake fluid level in the reservoir.
Top up if necessary.

N.B: use DOT 4 brake fluid

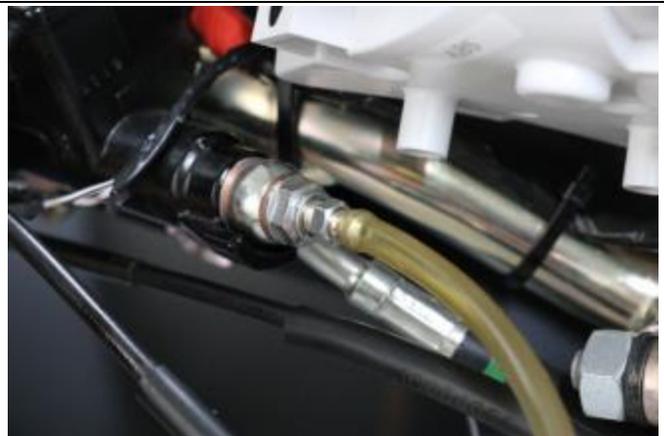
Connect one end of a transparent tube to the bleed nipple, placing the other end of the tube into a suitable container.

The tube must be kept curved, forming a bend above the level of the nipple so that the column of fluid draining from the nipple always drains upwards and never downwards.

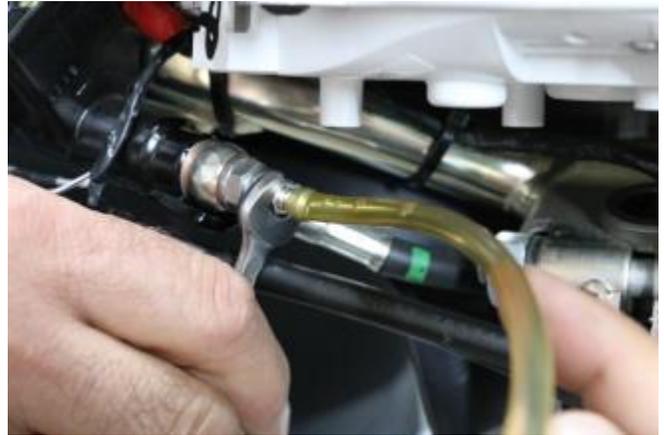
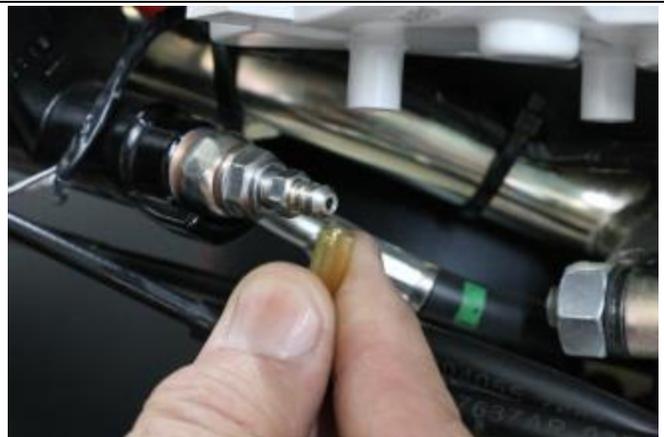
Open the lid of the master cylinder reservoir, top up with fluid to the correct level and close the lid of the master cylinder.

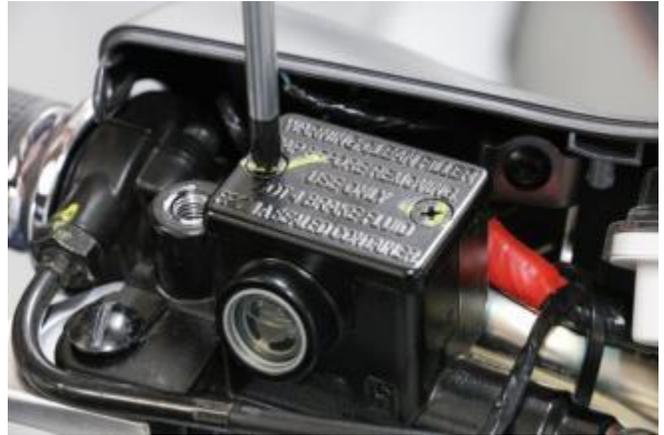
Support the vehicle adequately.
Remove the front wheel, removing the fastener screws and the relative washers.

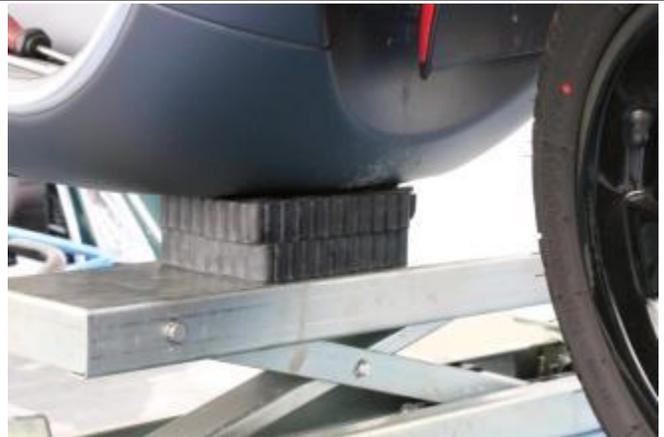
Remove the front wheel.

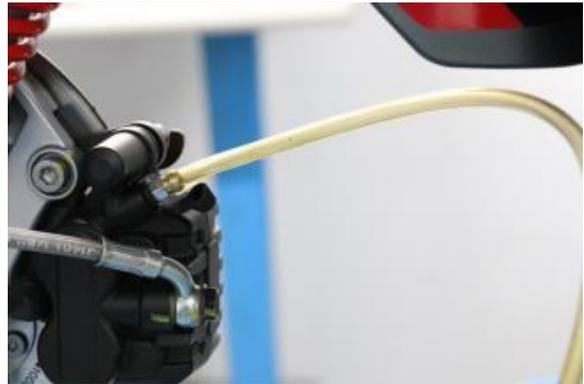
Turn the handlebar **slightly to the right** to facilitate the bleeding process.

Fit the bleed tube, curving it to form a bend above the level of the bleed nipple.

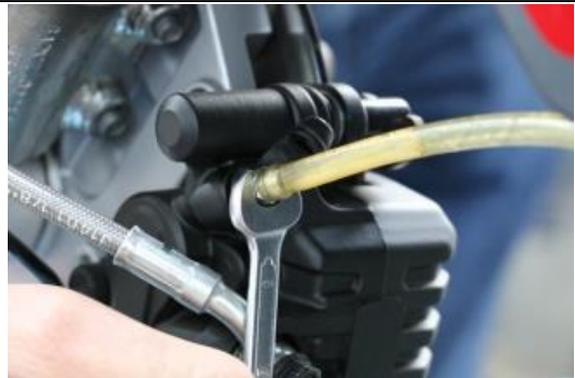
Check if the fluid contains air bubbles. Repeat the sequence described above **until only brake fluid containing no air bubbles is bled from the nipple for at least three consecutive check cycles.**

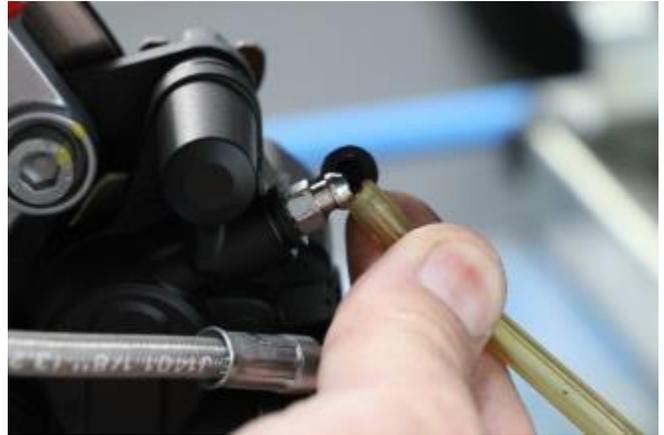
Fit the O-ring P/N **006731**, as shown in the figure. **Note: O-ring found in kit 1R000467**

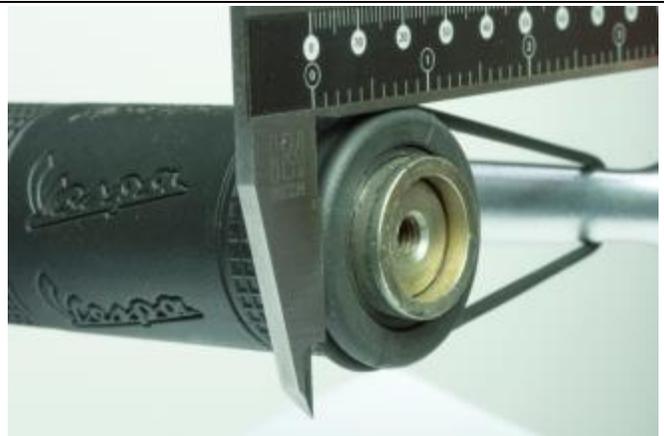
Place one end of the caliper gauge on the end of the hand grip as shown in the photo.

It is not necessary to remove the end of the handlebar, which has been removed in the photo solely to illustrate the procedure more clearly.

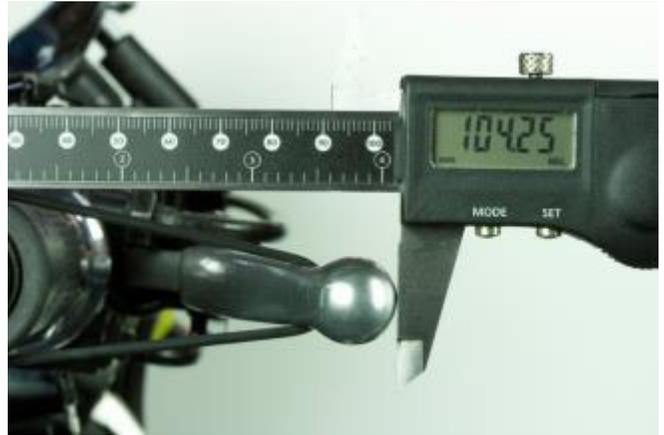
Place the other end of the caliper gauge on the brake lever as shown in the photo.

Measure the distance between the brake lever and the end of the hand grip. The distance must be at least 103 mm.

IMPORTANT: If the distance measured is not correct, repeat the entire bleeding procedure from the start.

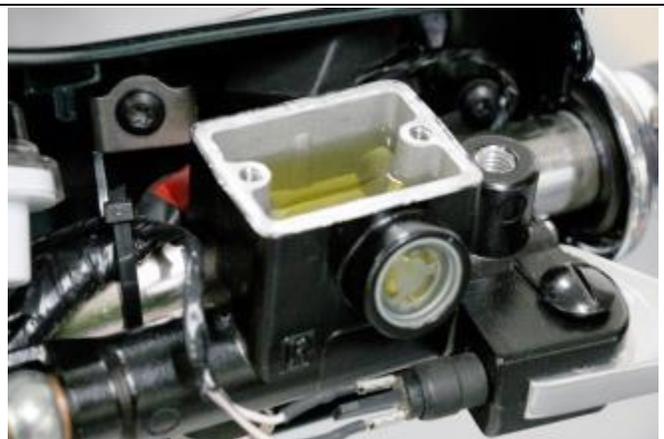
Top up the fluid in the brake master cylinder reservoir to the correct level, and then carry out the following procedure to replace the brake fluid, after forming a 180° bend in the bleed tube above the bleed nipple and immersing the other end in brake fluid (see photo):

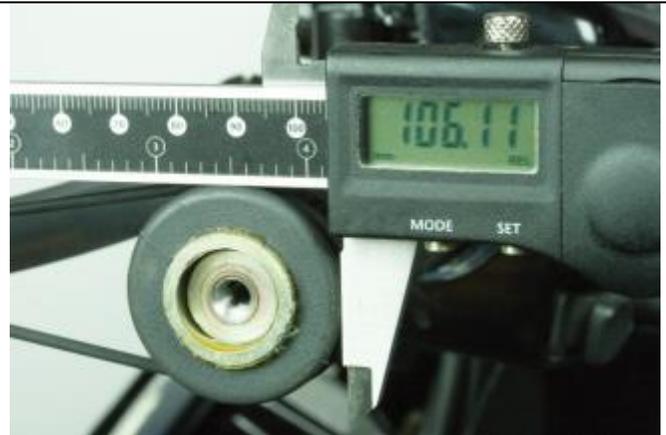
Place one end of the caliper gauge on the end of the hand grip as shown in the photo.

Measure the distance between the brake lever and the end of the hand grip. **The distance must be at least 103 mm.**

It is not necessary to remove the end of the handlebar, which has been removed in the photo solely to illustrate the procedure more clearly.

IMPORTANT: If the distance measured is not correct, repeat the entire bleeding procedure from the start.

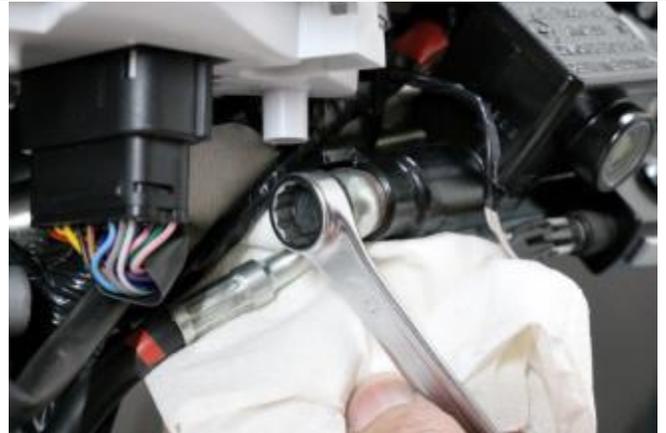
Fit the bleeding kit fitting with bleed nipple, P/N **AP8133945** with new copper washers, P/N **AP8113004**, and loosen the bleed nipple nut to open.

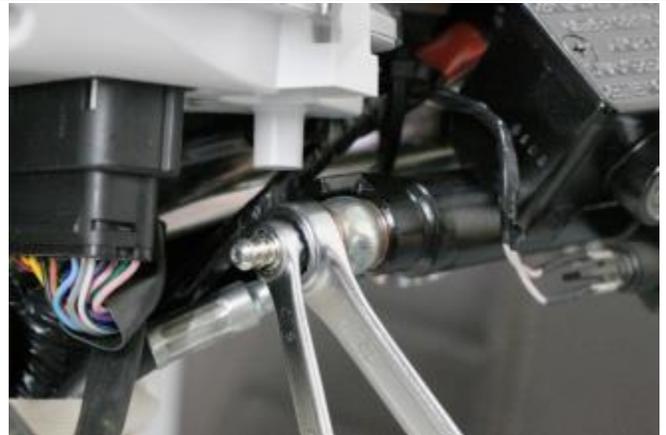
Note: Bleed nipples and copper washers found in kit 1R000467

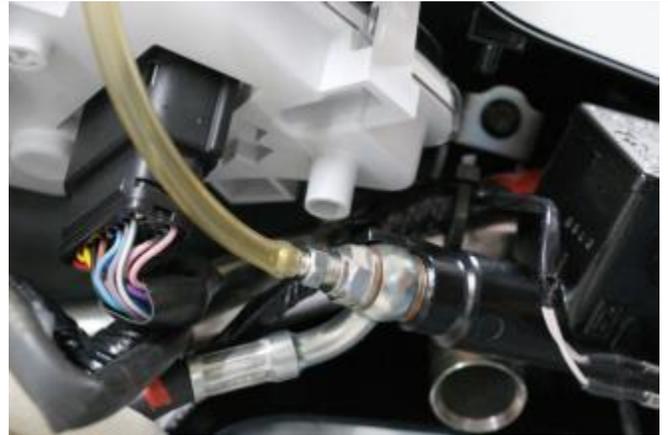
Bleed the rear brake master cylinder via the bleed nipple, **turning the handlebar fully to the left** and carrying out the procedure described below:

- Pull the brake lever to 1/3 of its total travel
- Loosen the bleed nipple and, as soon as brake fluid starts to bleed from the nipple (with or without air bubbles), pull the lever completely.
- Close the bleed nipple.
- Release the brake lever.

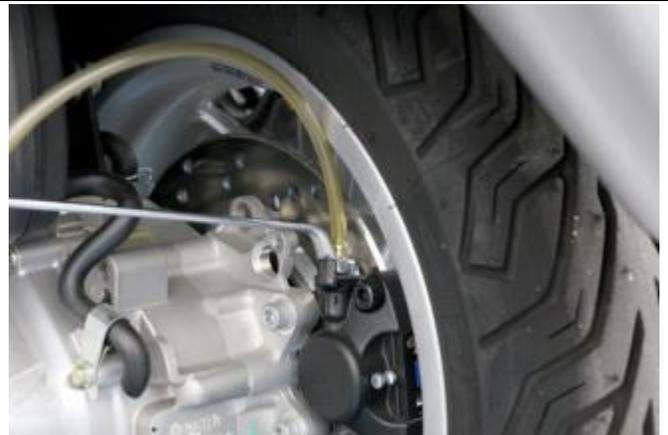
Bleed the rear caliper via the bleed nipple, **turning the handlebar fully to the left** and carrying out the procedure described below:

- Pull the brake lever to 1/3 of its total travel
- Loosen the bleed nipple and, as soon as brake fluid starts to bleed from the nipple (with or without air bubbles), pull the lever completely.
- Close the bleed nipple.
- Release the brake lever.

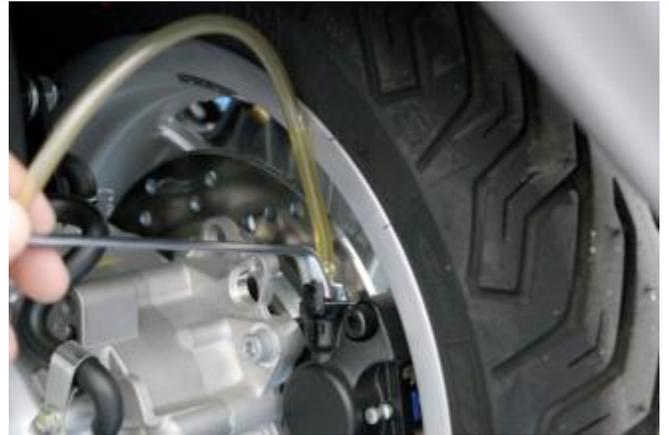
Check if the fluid contains air bubbles. Repeat the sequence described above until **only brake fluid containing no air bubbles is bled from the nipple for at least three consecutive check cycles.**

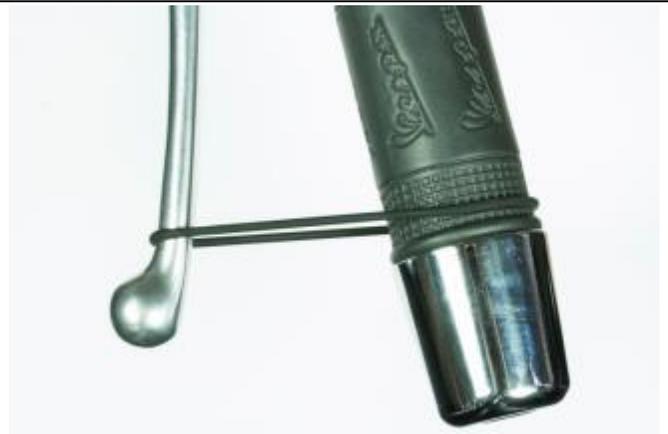
Fit the O-ring P/N **006731**, as shown in the figure.

Note: O-ring found in kit 1R000467

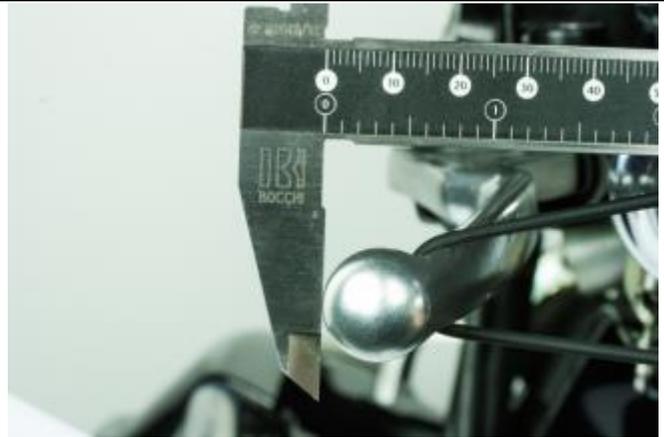
Place the other end of the caliper gauge on the brake lever as shown in the photo.

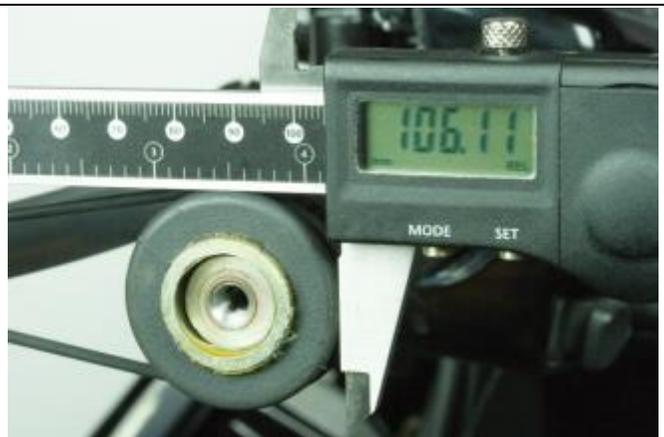
Place one end of the caliper gauge on the end of the hand grip as shown in the photo.

Measure the distance between the brake lever and the end of the hand grip. **The distance must be at least 103 mm.**

It is not necessary to remove the end of the handlebar, which has been removed in the photo solely to illustrate the procedure more clearly.

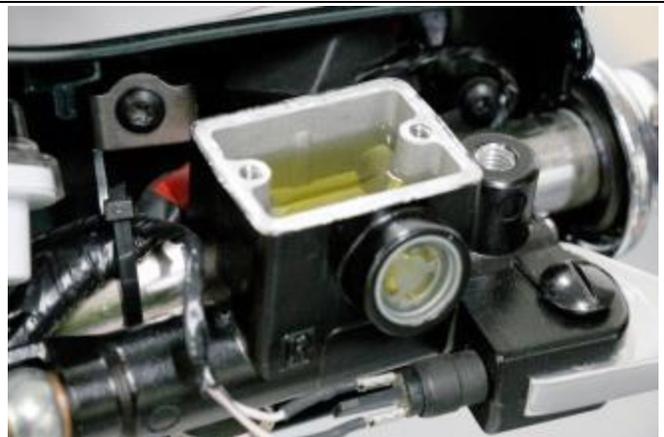
Top up the fluid in the brake master cylinder reservoir to the correct level, and then carry out the following procedure to replace the brake fluid, after forming a 180° bend in the bleed tube above the bleed nipple and immersing the other end in brake fluid (see photo on following page):

- Fill the reservoir to the max. level.
- Open the bleed screw.
- Pull the brake lever to its end of travel 6 times

Repeat the procedure until a volume of 120 cc has been pumped and collected from the caliper.

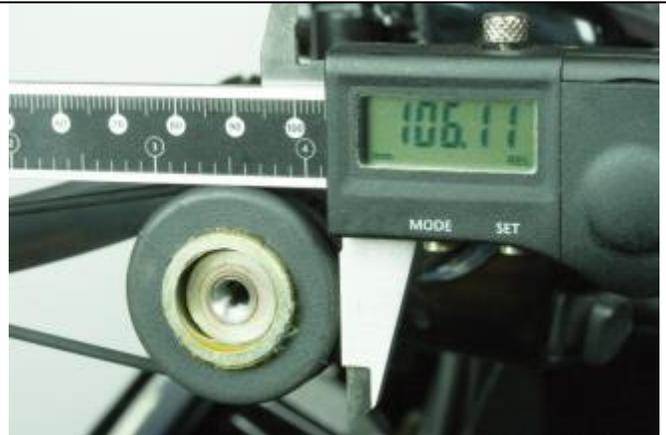
Place one end of the caliper gauge on the end of the hand grip as shown in the photo.

Measure the distance between the brake lever and the end of the hand grip. **The distance must be at least 103 mm.**

It is not necessary to remove the end of the handlebar, which has been removed in the photo solely to illustrate the procedure more clearly.

IMPORTANT: If the distance measured is not correct, repeat the entire bleeding procedure from the start.
