**SIB 65 24 19**

RECALL 19V-852: DRIVER'S FRONT AIR BAG (NADI) INFLATORThis Service Information Bulletin (Revision 8) replaces SI B65 24 19 **dated May 2020**.**What's New** (Specific text ighlighted):

E-Series	Model Description	Production Date
E46	3 Series Sedan, Coupe	March 17, 1998 – March 3, 2000

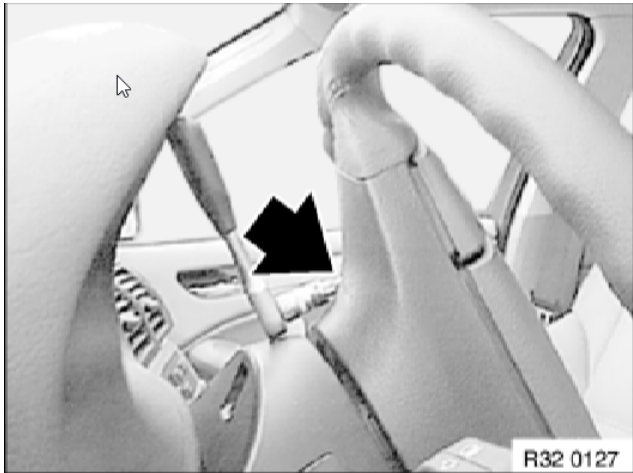
Follow all safety precautions when handling air bags.

Remove **Basic Drivers air bag** as per

REP 32 34 020 "Removing and installing/replacing airbag unit"

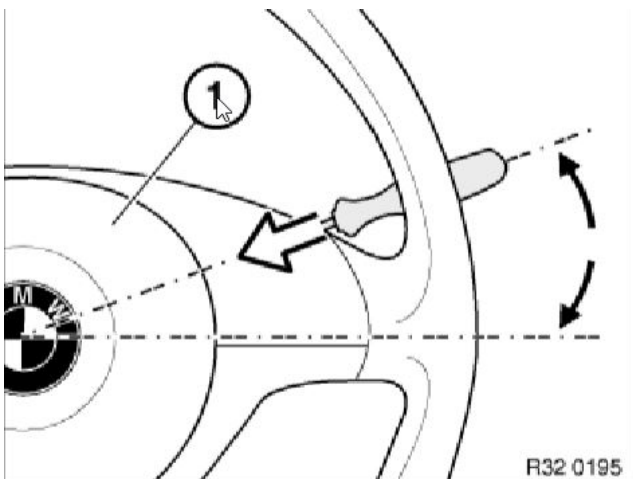
Remove **Sports Drivers air bag** as per

REP 32 34 020 "Removing and installing/replacing the airbag unit (sports steering wheel, inserted airbag unit)"

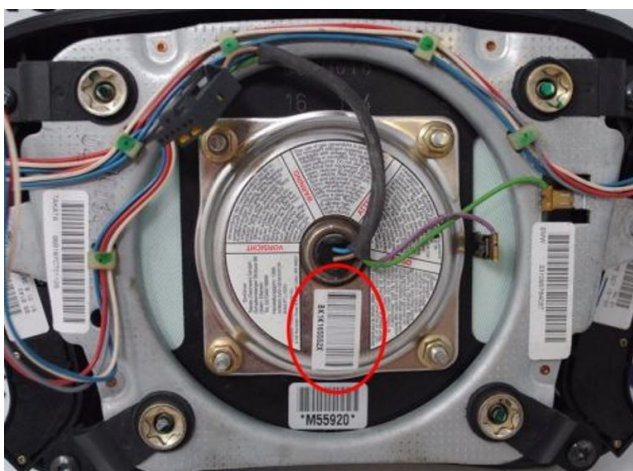
Once the air bag is removed and the wiring is disconnected, turn the air bag over to read the parts label(s) on the gas generator on the back.

Basic Driver's air bag, showing the location of the parts label.

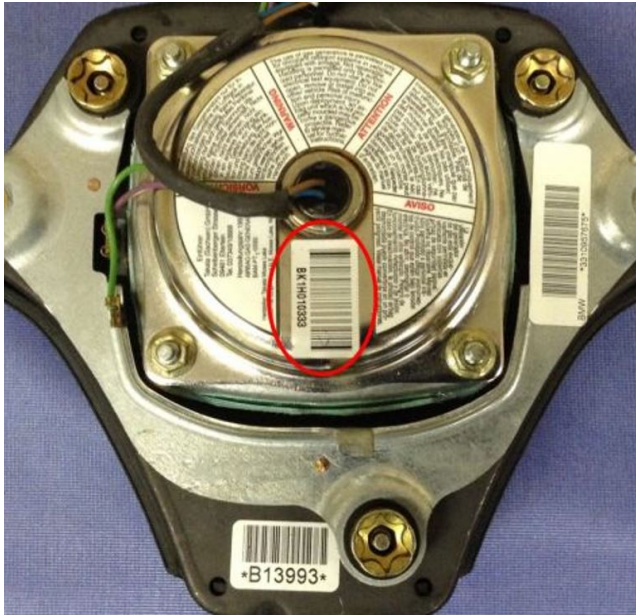
Sport Driver's air bag, showing the location of the parts label.

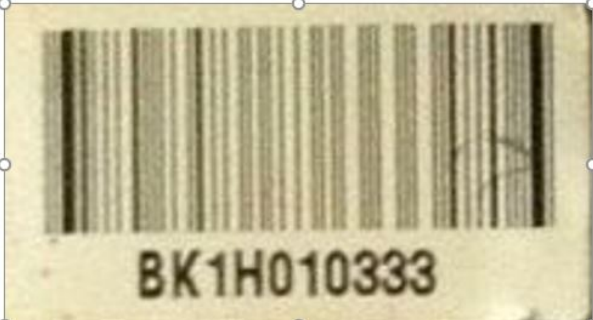
<p>Gas generator serial number decoding:</p> <p>Digits 1-2 = Type of gas generator Digit 3 = Production Line Digit 4 = Production year Digit 5-11* = Serial #</p> <p>*NOTE: The serial number can have 10 or 11 characters. Only the first 10 characters counted from the left are relevant for the check. The 11th digit can be disregarded for the repair covered by this SIB</p>

<p>EXAMPLE 1: Gas Generator Parts Label</p> <p>All BK1H are Category 2</p>

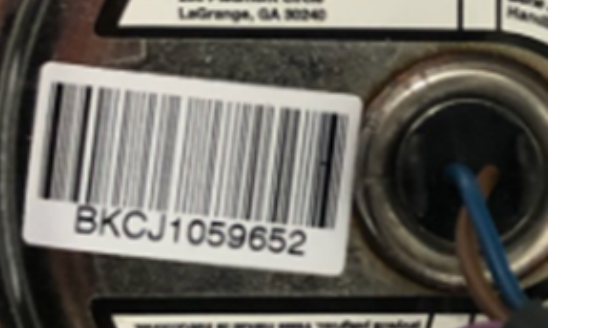
<p>EXAMPLE 2: Gas Generator Parts Label</p> <p>BKCJ may fall under two categories:</p> <table border="1" data-bbox="737 1648 1380 1774"> <tr> <td>Up to 059642</td> <td>Category 1 – Drivers air bag gas generator must be replaced; the vehicle cannot be driven until repaired.</td> </tr> <tr> <td>From 059659</td> <td>Category 2 – Drivers air bag gas generator must be replaced</td> </tr> </table> <p>This example is 1059652 which is a higher serial number than 059659 so this is Category 2</p> <p>*NOTE: The serial number can have 10 or 11 characters. Only the first 10 characters</p>	Up to 059642	Category 1 – Drivers air bag gas generator must be replaced; the vehicle cannot be driven until repaired.	From 059659	Category 2 – Drivers air bag gas generator must be replaced
Up to 059642	Category 1 – Drivers air bag gas generator must be replaced; the vehicle cannot be driven until repaired.				
From 059659	Category 2 – Drivers air bag gas generator must be replaced

<p>counted from the left are relevant for the check. The 11th digit can be disregarded for the repair covered by this SIB, so ignore the last digit 2</p>

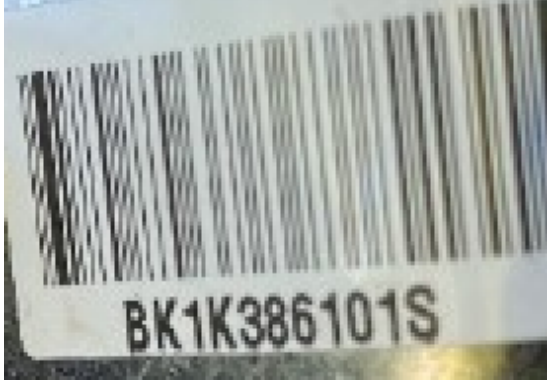
<p>EXAMPLE 3: Gas Generator Parts Label</p> <p>BK1K may fall under two categories:</p> <table border="1" data-bbox="737 380 1385 480"> <tr> <td>Up to 088984</td> <td>Category 2 – Drivers air bag gas generator must be replaced</td> </tr> <tr> <td>From 088992</td> <td>Category 3 – Drivers air bag gas generator is OK</td> </tr> </table> <p>This example is 11 digits and 386101S is above 088992 so this is Category 3</p> <p>*NOTE: The serial number can have 10 or 11 characters. Only the first 10 characters counted from the left are relevant for the check. The 11th digit can be disregarded for the repair covered by this SIB, so ignore the letter S</p>	Up to 088984	Category 2 – Drivers air bag gas generator must be replaced	From 088992	Category 3 – Drivers air bag gas generator is OK
Up to 088984	Category 2 – Drivers air bag gas generator must be replaced				
From 088992	Category 3 – Drivers air bag gas generator is OK

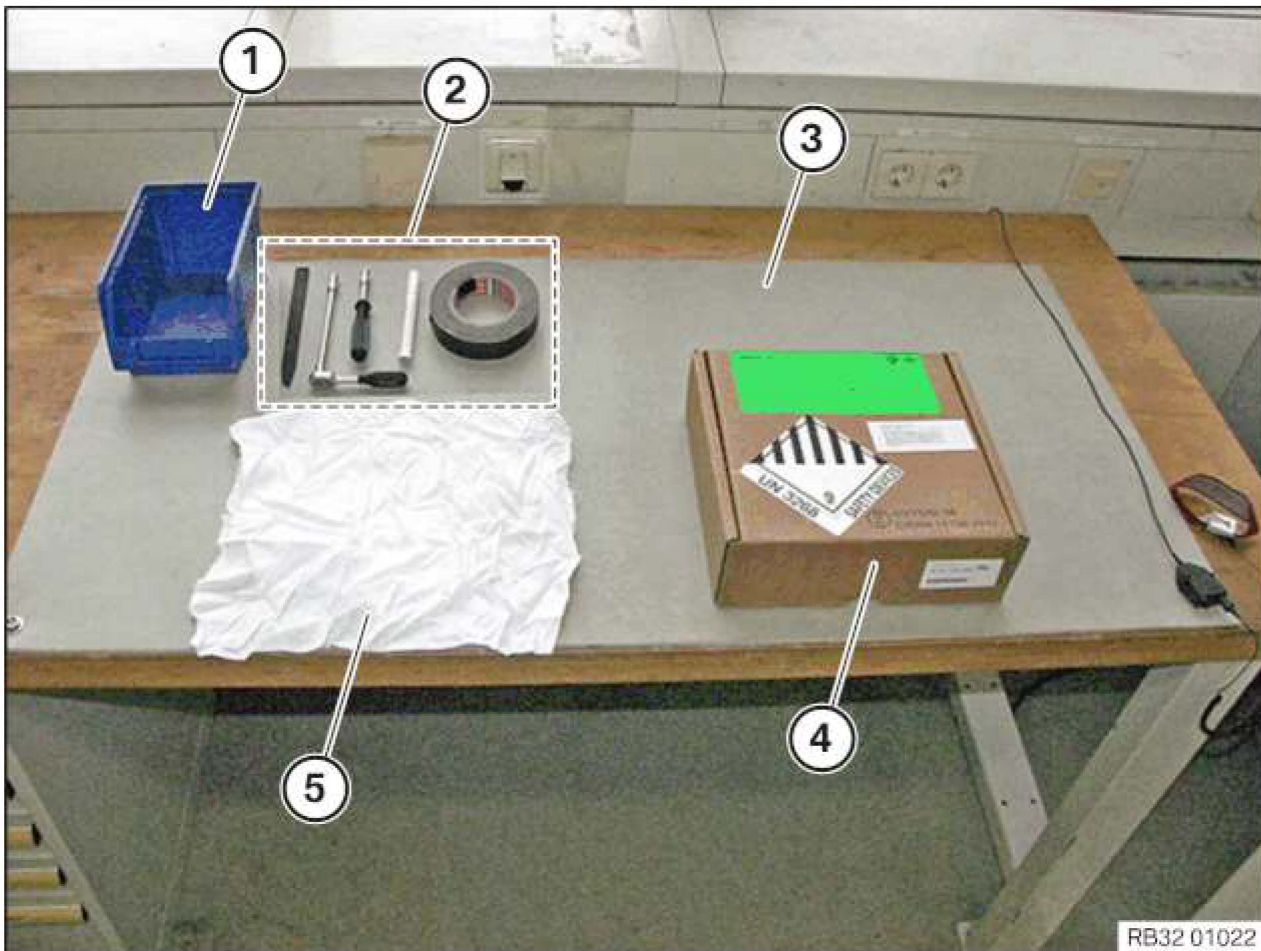
Workplace for replacement of the gas generator (E46)

- 1 Collection container for disposal of the nuts
- 2 Tools required for the exchange
- 3 Antistatic mat
- 4 New, packaged gas generator
- 5 Scratch-resistant cotton underlay

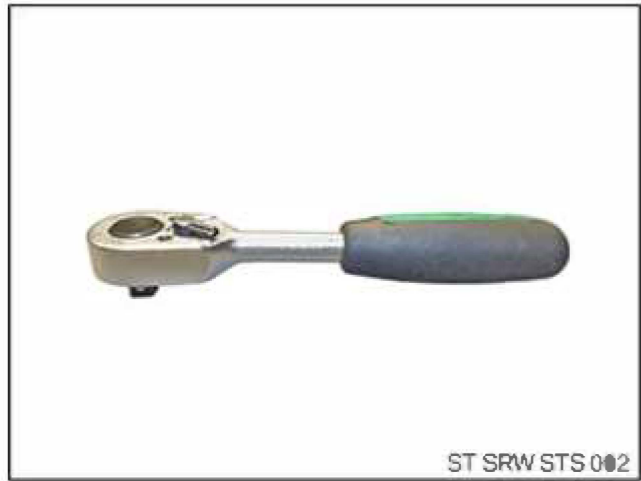
- Prepare the antistatic mat and cotton pad:
- Have the following tools ready:
 - Felt pen
 - Adhesive tape (width min. 25 mm)
 - Wedge 0 490 539 (00 9 322)
 - 1/4" reversible ratchet
 - 1/4" reversible ratchet

1/4" reversible ratchet
with Extension 1/4 inch
Extension 1/4 inch

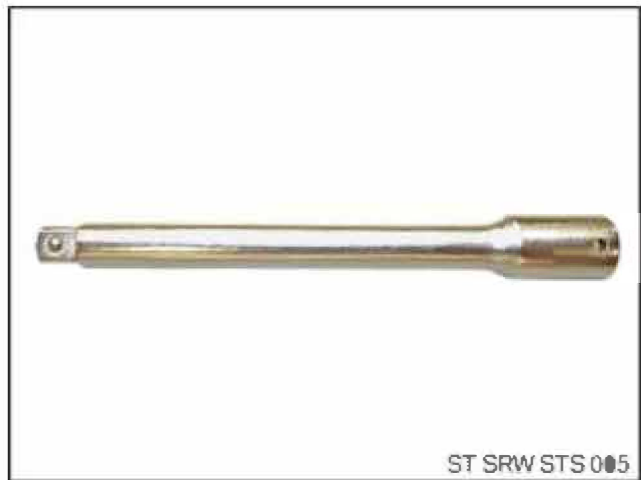
Extension 1/4 inch
and Socket wrench for hexagon
Socket wrench for hexagon

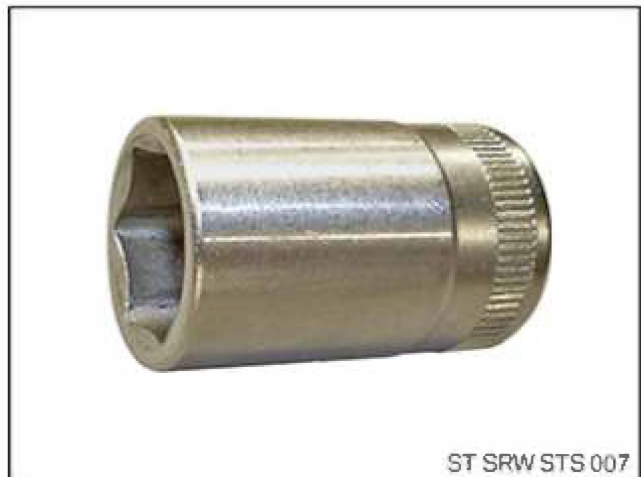
Socket wrench for hexagon
8 mm

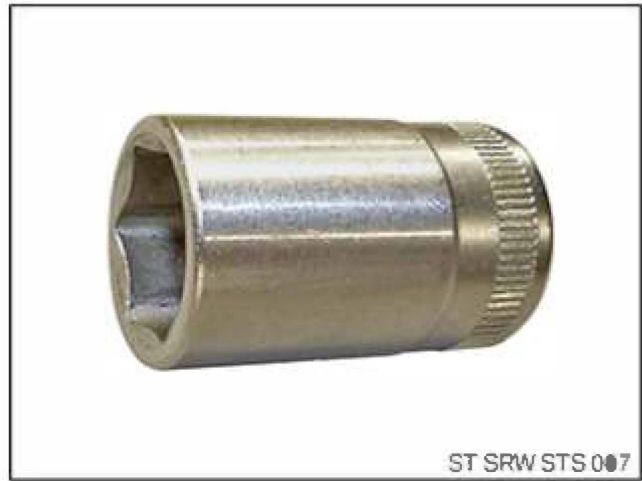
Torque wrench with Socket wrench for hexagon
Socket wrench for hexagon

Socket wrench for hexagon
8 mm

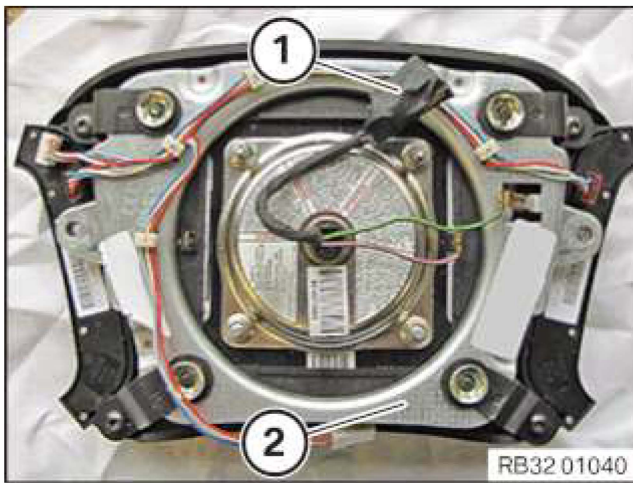
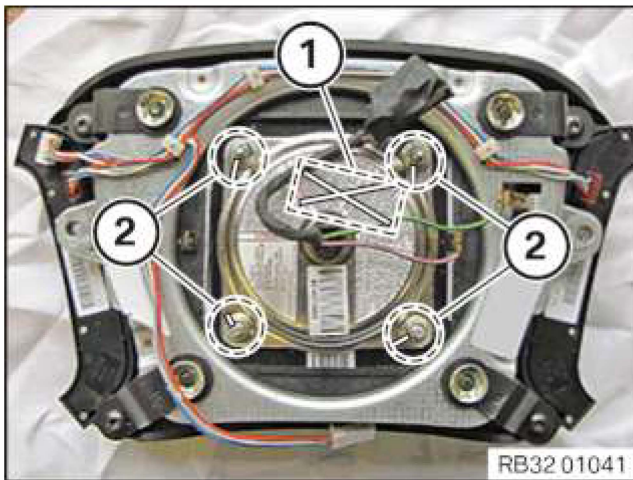
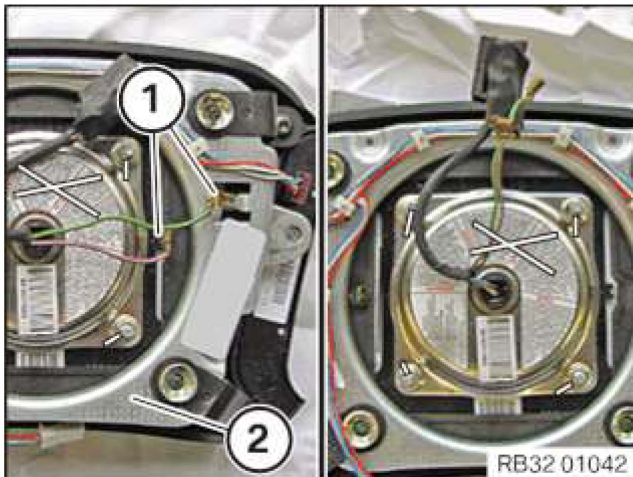
- Glue the connector (1) from the previous gas generator of the airbag unit (2) with the adhesive tape so that the contacts cannot be touched.

- Mark a cross (1) with the felt pen to avoid a mix-up with the new gas generator.
 - Mark all the four nuts (2) with the felt pen to avoid a mix-up with the new nuts.
-
- Release both the connectors (1) on the airbag unit (2).
-
- **Auxiliary person:** Hold the airbag unit (1).
 - Unscrew all the nuts (2) in any order and dispose of immediately in the collection container provided (3).
 - Do not reuse the nuts (2).

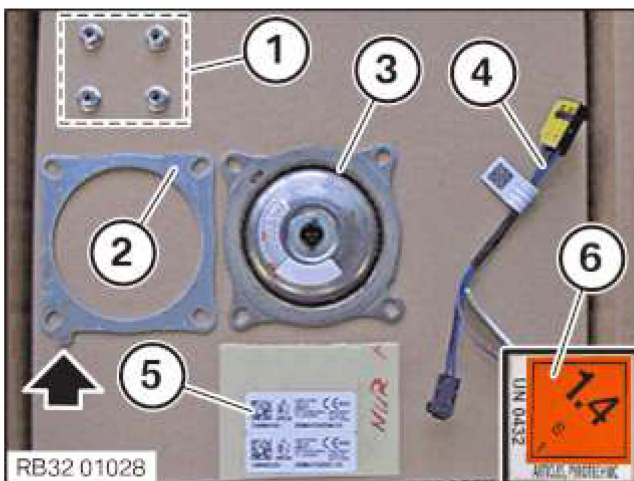
- Unpack the new nuts (1), reinforcement plate (2), new gas generator (3), cable (4) and sticker (5) and place it as shown.
- Make sure that the groove (arrow) of the reinforcement plate (2) is positioned correctly.
- USA only:
Dispose of the hazard sticker (6).

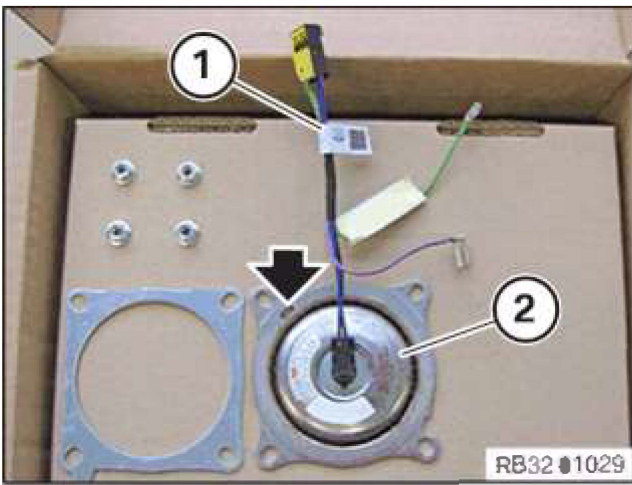
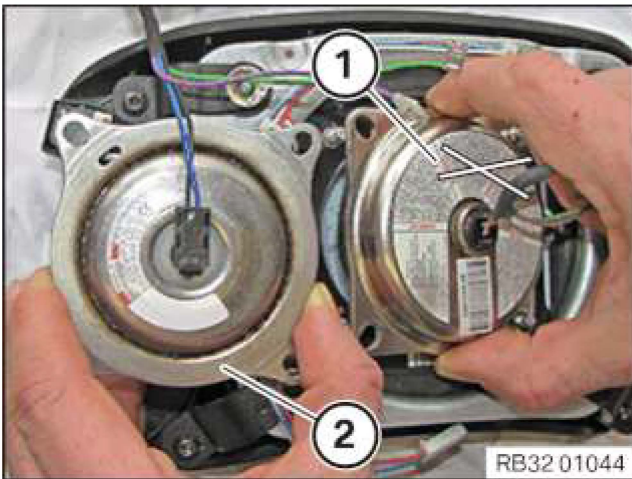
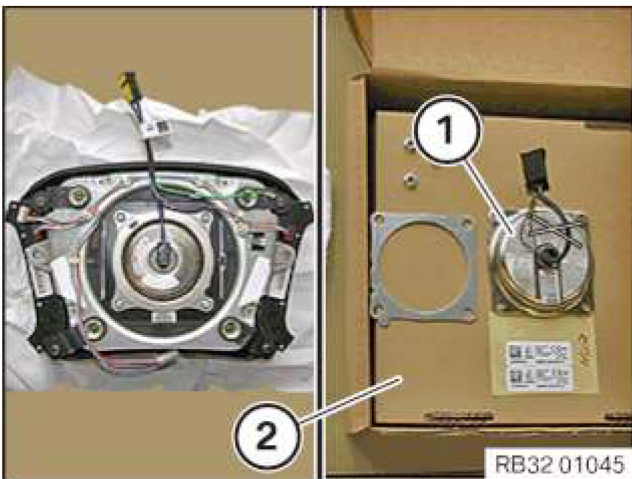
- Clip in the cable (1) as shown in the new gas generator (2).

The cable (1) and the groove (arrow) of the new gas generator (2) point upwards.

The connector is encoded against incorrect assembly.

- Remove the previous gas generator (1) and subsequently directly place the new gas generator (2).

The cable and the groove of the new gas generator (2) point upwards.

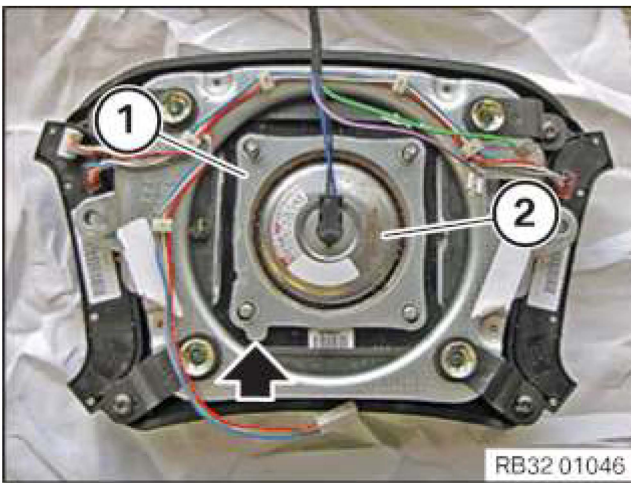
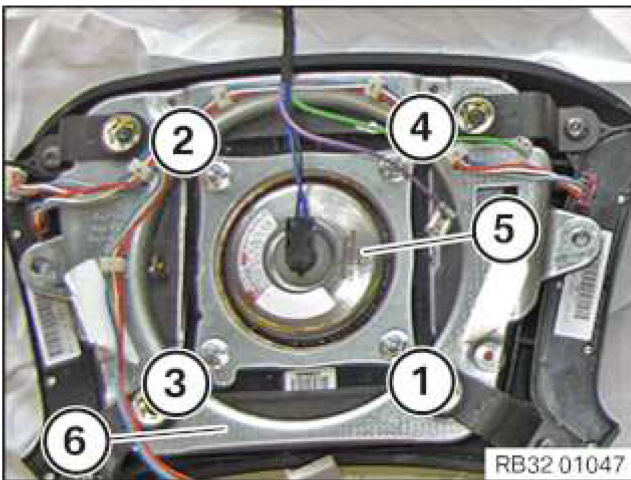
- Position the reinforcement plate (1) over the new gas generator (2).
- Make sure that the groove (arrow) of the reinforcement plate (1) is positioned correctly.

The groove (arrow) points downwards to the left.

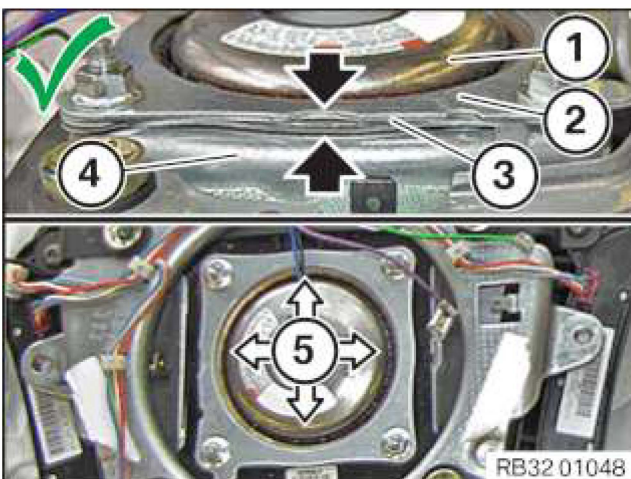
Nut
Renew nut.

Tightening torque
5Nm

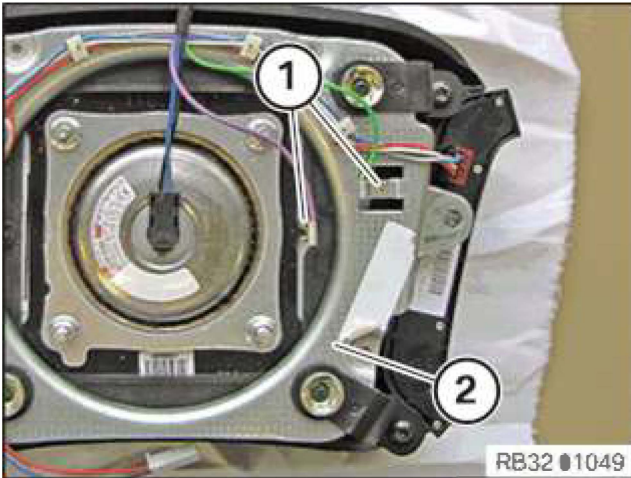
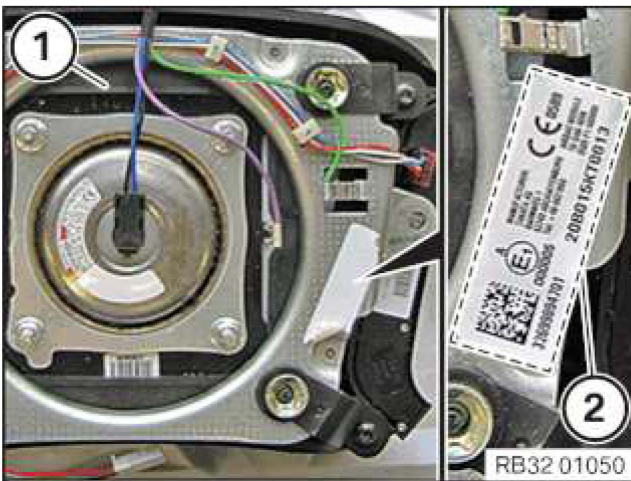
Visually inspect the gap (3) between the new gas generator (1), reinforcement plate (2) and airbag unit (4) on all four sides (5).

Release the screw connection and tighten again as described in the previous step. If the gap is still not OK, then cancel the repair. Install the new airbag unit in this case.

- Connect both the connectors (1) with the airbag unit (2).

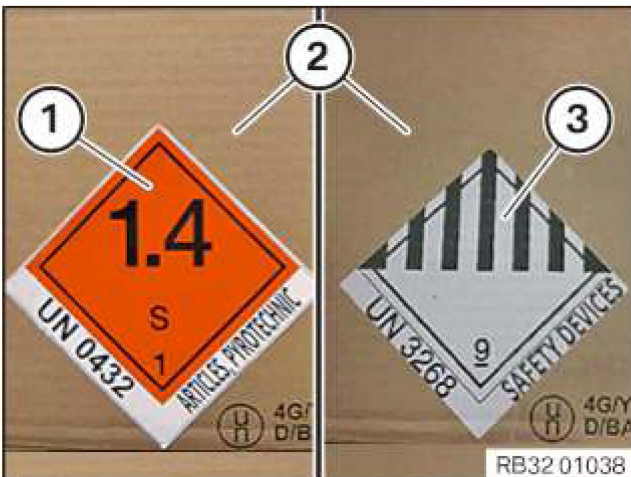
Affix the hazard sticker (1) externally on the packaging (2).

Do not affix any hazard sticker (3) externally on the packaging (2).

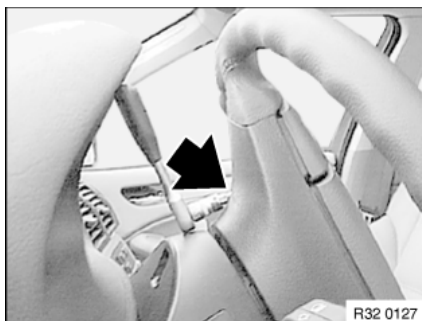
Release screws (Torx T30) on both sides.

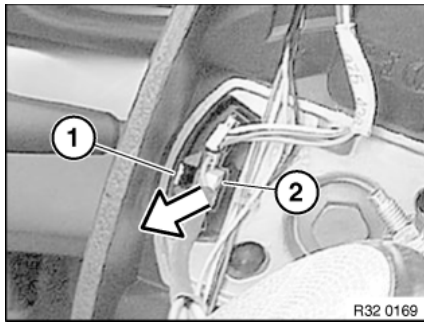
Press down lock (1) and disconnect plug (2).

Remove airbag unit.
