## SIB 65 24 19

## RECALL 19V-852: DRIVER'S FRONT AIR BAG (NADI) INFLATOR

2020-07-27

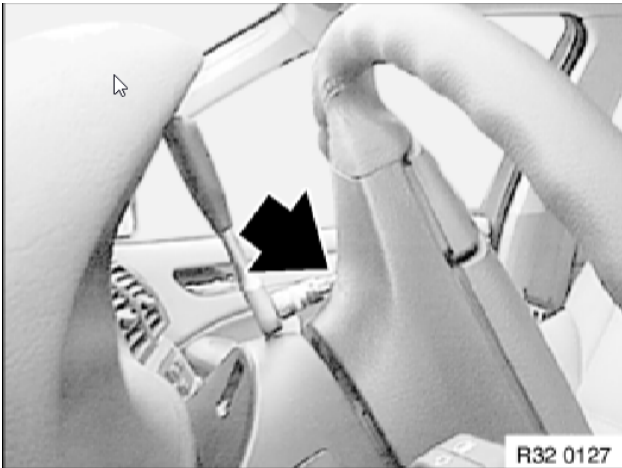
Remove **Basic Drivers air bag** as per

**REP 32 34 020** "Removing and installing/replacing airbag unit"

Follow all safety precautions when handling air bags.

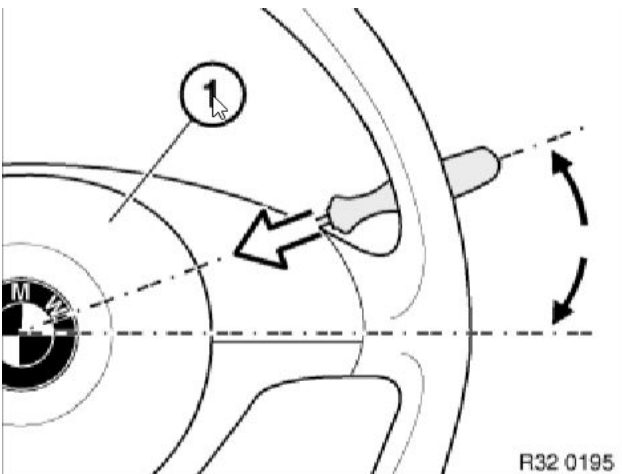
Remove **Sports Drivers air bag** as per

**REP 32 34 020** "Removing and installing/replacing the airbag unit (sports steering wheel, inserted airbag unit)"

Once the air bag is removed and the wiring is disconnected, turn the air bag over to read the parts label(s) on the gas generator on the back.

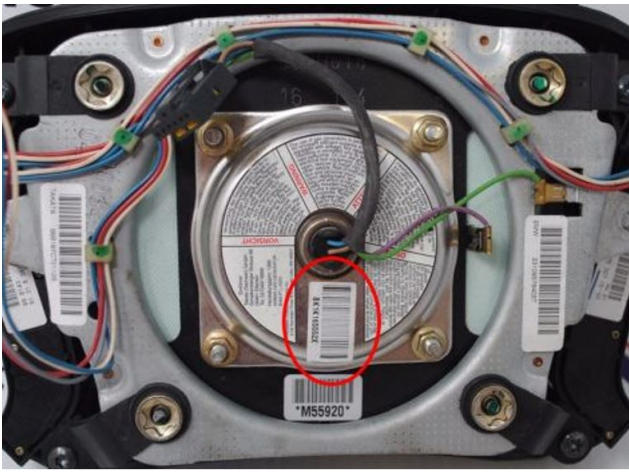
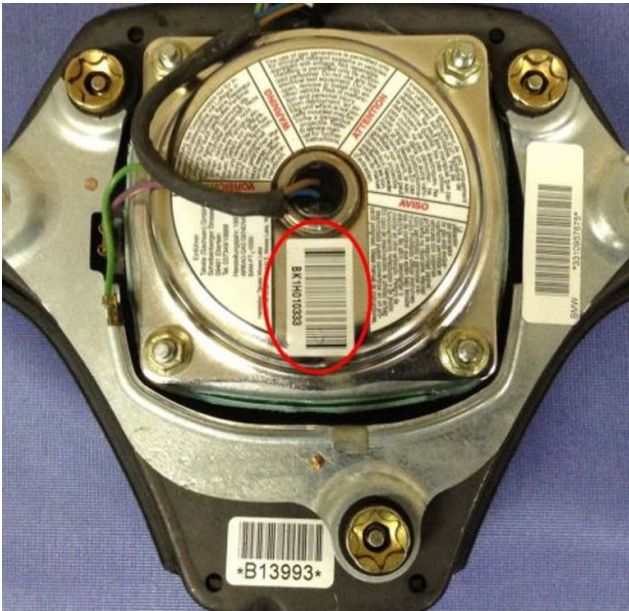
**Basic Driver's air bag**, showing the location of the parts label.

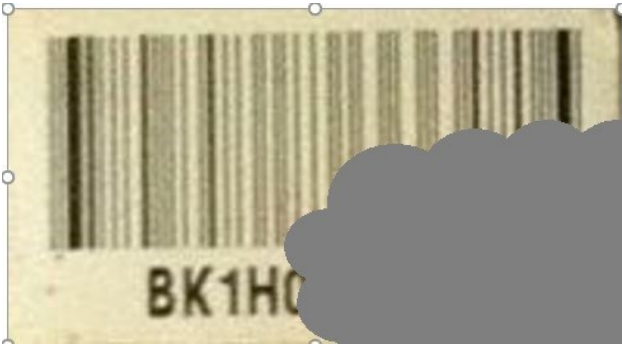
Parts label (sample):

- Digits 1-2 = Type of gas generator
- Digit 3 = Production Line
- Digit 4 = Production year
- Digit 5-11 = Serial #

**NOTE: The serial number can have 10 or 11 characters. Only the first 10 characters counted from the left are relevant for the check.**

Refer to the table below to see which category this air bag gas generator falls into. Descriptions of each category are shown below the table.
