## SIB 65 25 19

### RECALL 19V-853: DRIVER'S FRONT AIR BAG (NADI) INFLATOR

This Service Information Bulletin (Revision 4) replaces SI B65 25 19 **dated March, 2020**.

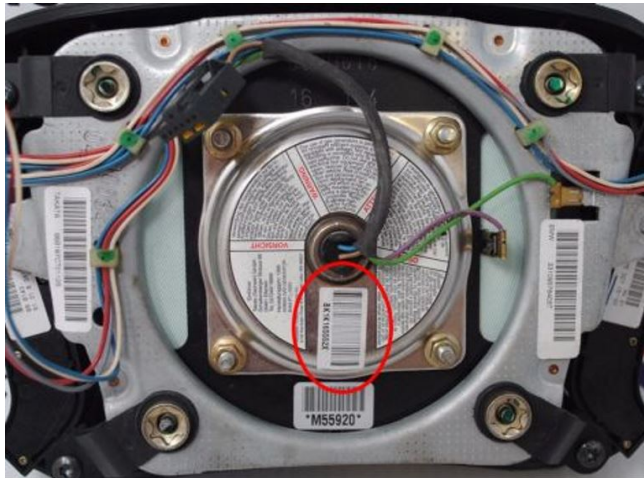
Once the air bag is removed and the wiring is disconnected, turn air bag over to read the parts label(s) on the back.

**Basic Driver's air bag**, showing the location of the parts label.

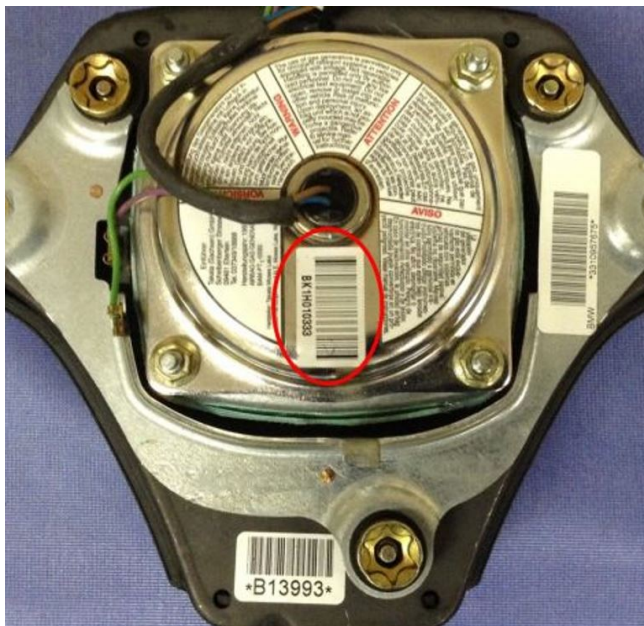
**Sport Driver's air bag**, showing the location of the parts label.

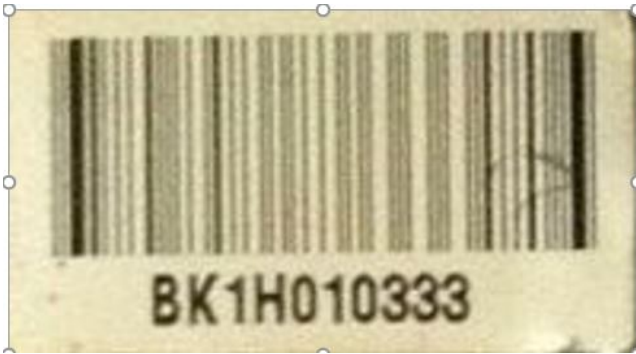
Parts label (sample):

- Digits 1-2 = Type of gas generator
- Digit 3 = Production Line
- Digit 4 = Production year
- Digit 5-11 = Serial #

**NOTE: The serial number can have 10 or 11 characters. Only the first 10 characters counted from the left are relevant for the check.**

Refer to the table below to see which category this air bag falls into. Descriptions of each category are shown below the table.

Digits 1-3	Digit 4	Digit 5-10	Repair Category
BKC	H	ALL	<b>Category 1</b> – Drivers air bag must be replaced; the vehicle cannot be driven until repaired.
BKC	J	Up to 059642	<b>Category 1</b> – Drivers air bag must be replaced; the vehicle cannot be driven until repaired.
BK1	H	ALL	<b>Category 2</b> – Drivers air bag must be replaced once parts become available
BK1	J	ALL	<b>Category 2</b> – Drivers air bag must be replaced once parts become available
BK1	K	Up to 088984	<b>Category 2</b> – Drivers air bag must be replaced once parts become available
BKC	J	From 059659	<b>Category 2</b> – Drivers air bag must be replaced once parts become available
BK1	K	From 088992	<b>Category 3</b> - Air bag is OK
BK1	L M N P Q R U V	ALL	<b>Category 3</b> – Air bag is OK
BK5	-	ALL	<b>Category 3</b> – Air bag is OK
BKV	-	ALL	<b>Category 3</b> – Air bag is OK

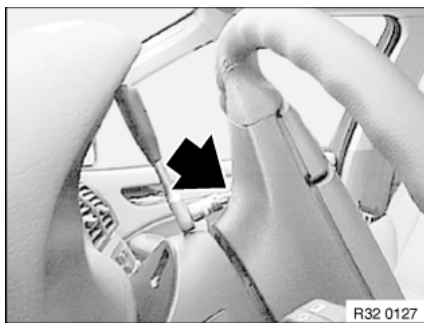
Release screws (Torx T30) on both sides.

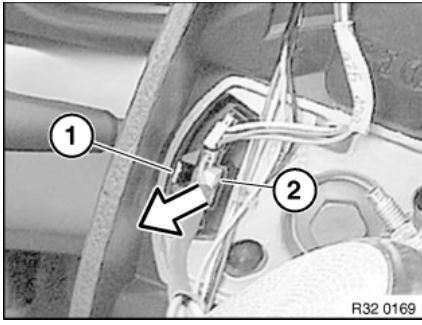
Press down lock (1) and disconnect plug (2).

Remove airbag unit.

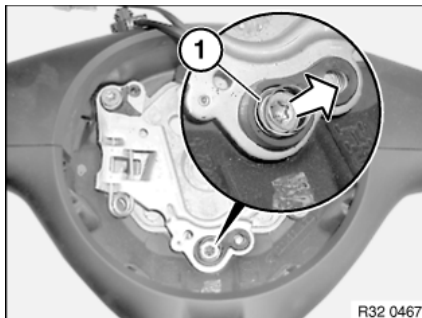
When installing a new airbag unit (see table below), the available ground spring (1) must be removed from the base plate of the steering wheel.

Omitting the ground spring (1) on new airbag units is not a safety hazard.

Introduction dates of new airbag units:

E46:	01/2002
E53:	02/2003
E39:	03/2002

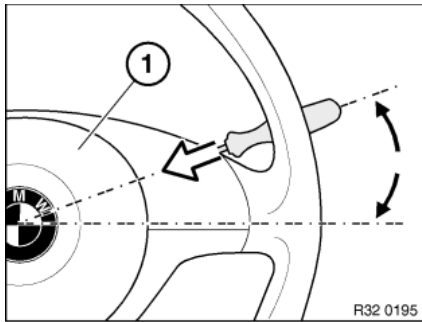
Insert a screwdriver through the opening on the rear side of the steering wheel and press on the lock. In the event of a spring resistance, press the lock up to the limit position and simultaneously pull away the airbag unit (1) from the steering wheel.

Repeat the process on the opposite side.

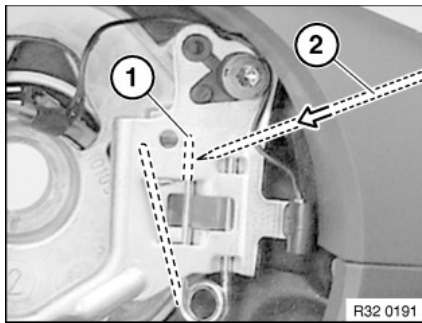
Use the screwdriver (2) to press on the lock (1).

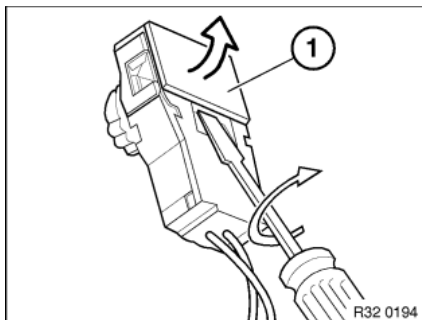
Unlocking the airbag plug connection:

Lever out the lock (1) with a screwdriver.

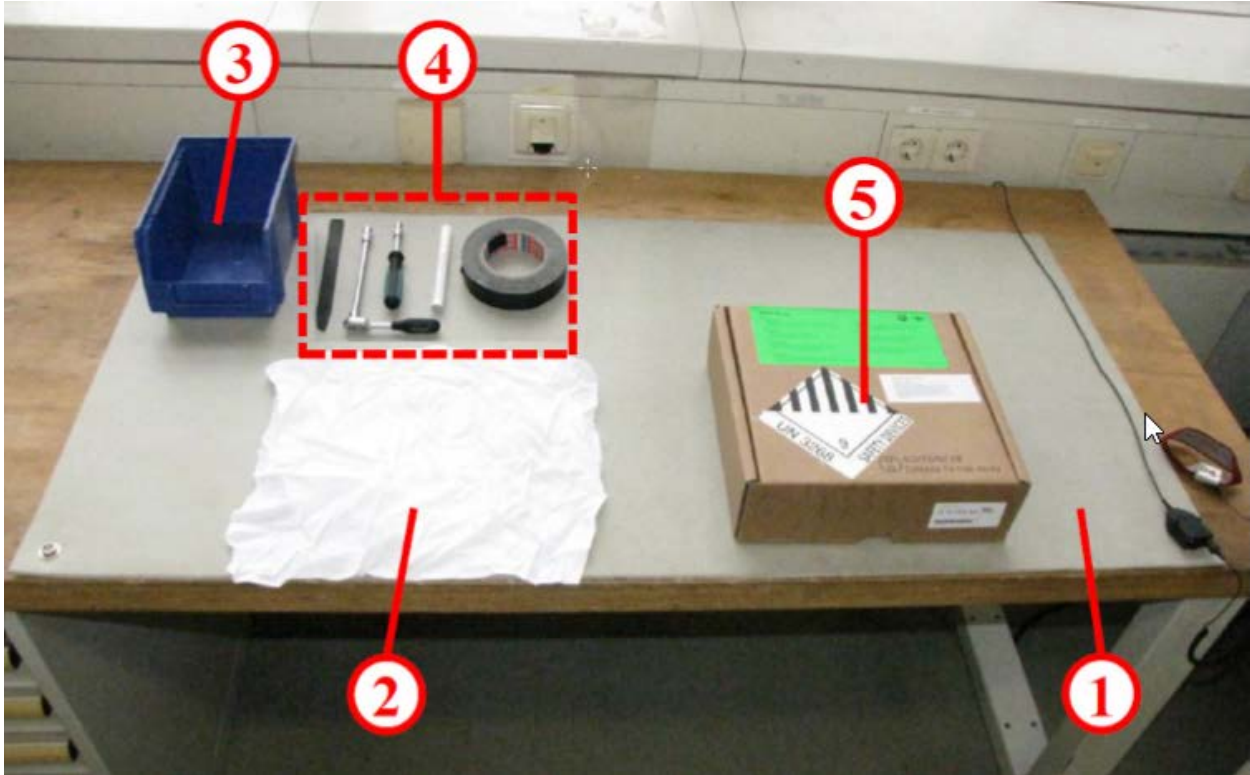
The workbench should be prepared with the following items:

- Anti-Static mat (1) which must be grounded (See SWS 2 06 04 (128))
- A soft blanket or material (2) to prevent damaging the air bag cover
- A container (3) for disposal of the original Generator nuts
- A packaged new part (5)

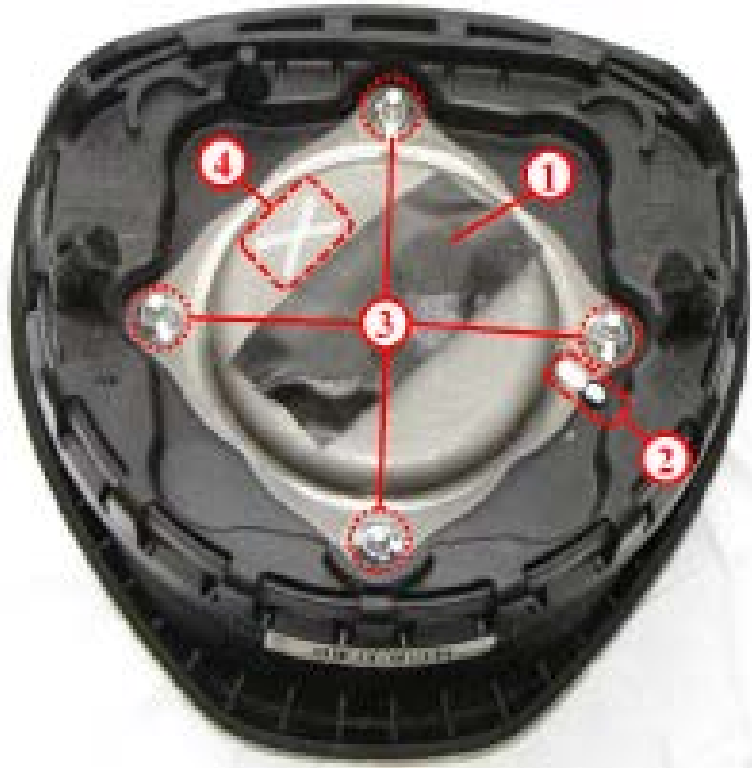
*NOTE: – Picture above is an example and may not exactly match your Generator / air bag.*

- Cover the connections on the old Generator with duct tape (1) so the contacts cannot be touched
- Mark orientation (2) of the Generator in the Air Bag with the felt tip marker

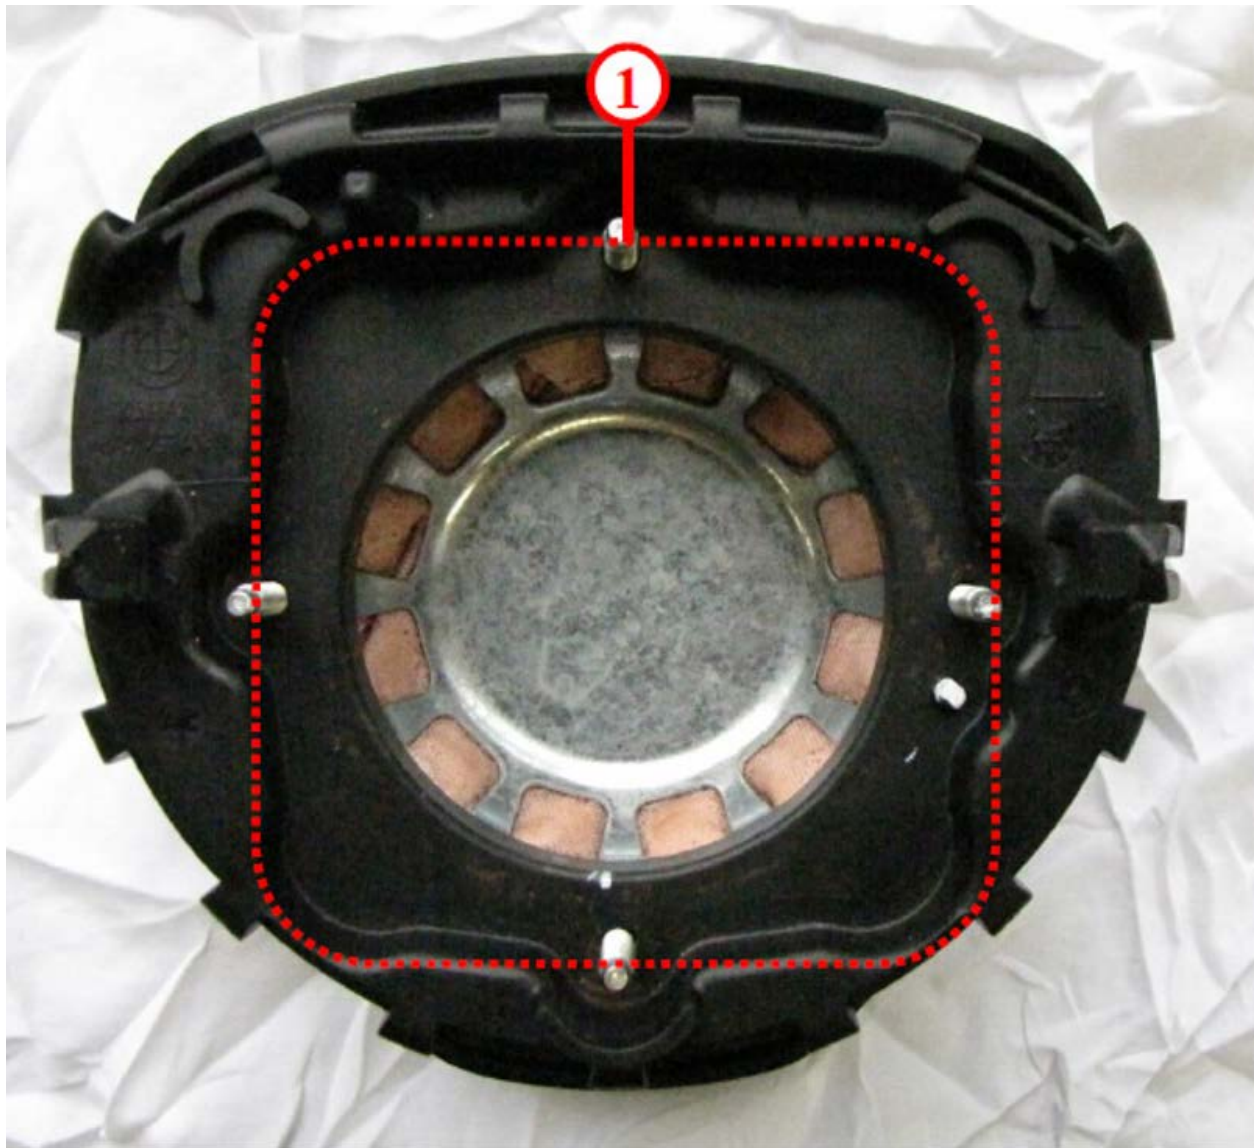
*NOTE: – Picture above is an example and may not exactly match your air bag*

**ATTENTION: In the area (1) above there must be no foreign objects!**

There may be a small amount of surface rust on the metal within the air bag. This is normal.

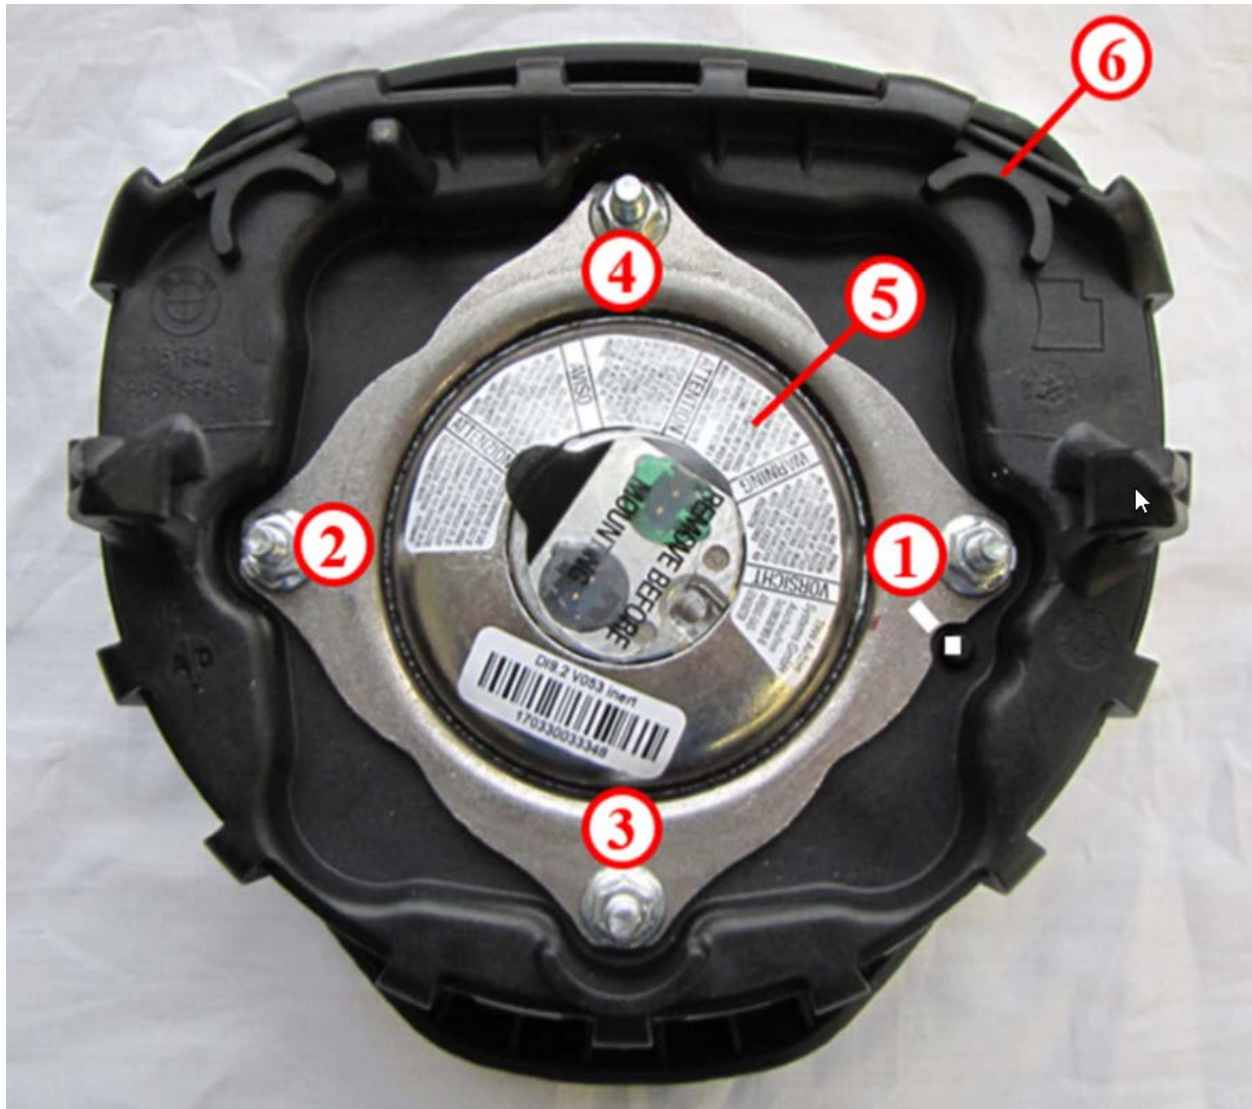
*NOTE: – Picture above is an example and may not exactly match your Generator / air bag.*

2<sup>nd</sup> Technician should hold air bag steady for 1st Technician.

Install the four new nuts (1,2,3,4) onto the studs and lightly tighten the nuts in the sequence shown (1,2,3,4).

**Torque nuts in sequence (1,2,3,4,) to 5 Nm**

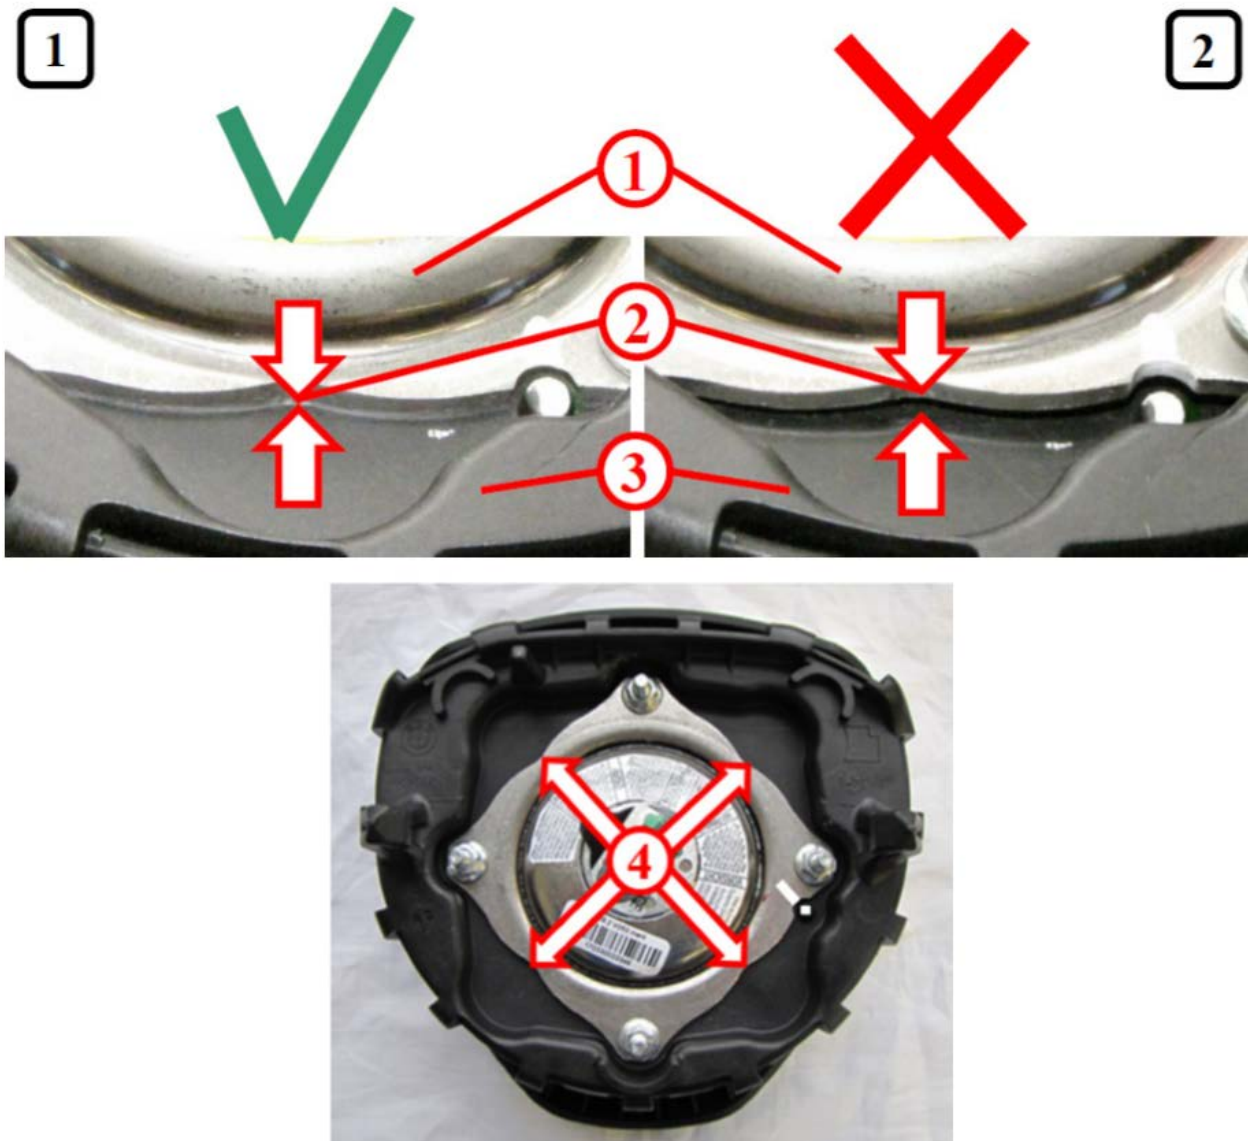
Perform a visual inspection of the gap (2) between the Generator (1) and the Air Bag (3) on all four sides of the Generator (4).

Picture (1) shows a correctly installed Generator

Picture (2) shows an improperly installed Generator with an excessive gap (2).

**ATTENTION:** If the gap cannot be closed up, cancel this procedure and replace the entire Air Bag assembly.

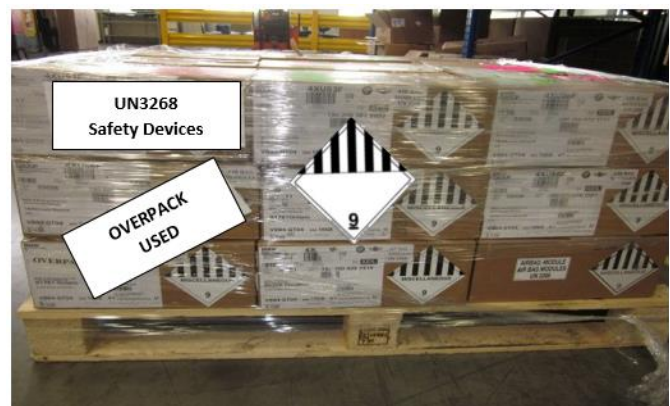
Securely attach the following labels on each side of the shrink-wrapped pallet.

- o Class 9 Label
- o UN3268 Safety Device \*
- o OVERPACK USED \*
