SIB 65 06 20

RECALL CAMPAIGNS 19V-852 AND 19V-853: INSPECTION PERFORMED AND DRIVER'S FRONT

BMW AG is conducting a Voluntary Safety Recall (effective December 4, 2019) on certain Model Year – 1999-2001 BMW vehicles that were produced between February 17, 1998 – July 14, 2000. These vehicles require a new air bag inflator to be installed.

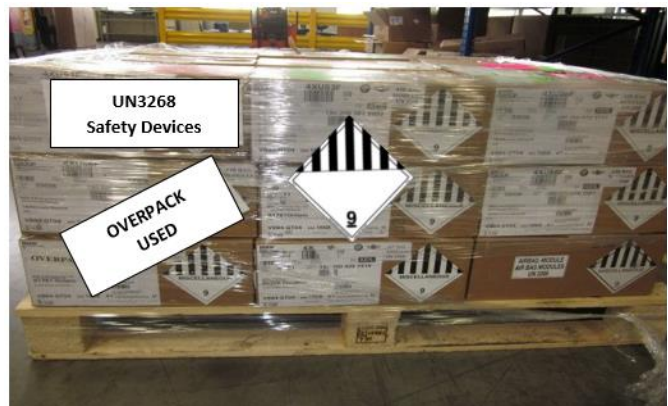
Securely attach the following labels on each side of the shrink-wrapped pallet.

- o Class 9 Label
- o UN3268 Safety Device *
- o OVERPACK USED *
