T680, T800, T880, W990 DANA Axle Output Shaft

Title	19KWE ^(OBJ) T680, T800, T880, W990 DANA Axle Output Shaft
Search Words	
Bulletin No.	19KWE
What's New Abstract	Safety Recall – Certain Dana forward rear axle output shafts may have been improperly heat treated, which can cause the shaft to fracture. Fracture of the shaft could result in a portion of the shaft and the driveline yoke retaining nut to detach from the vehicle and fall onto the roadway. Additionally, if the detachment of the nut were to go unnoticed, the interaxle driveline may become detached from the forward rear axle during suspension/axle articulation.
Supplier	Dana
Description	Recall 19KWA T680, T800, T880, W990 DANA Axle Output Shaft
Release Date	
Introduction	Kenworth Truck Company has determined that a defect, which relates to motor vehicle safety, exists in certain model chassis manufactured between November 22, 2019 and December 05, 2019.
Situation	96 chassis (84 U.S. and 12 Canada), T680, T800, T880, and W990 Model Year 2020 vehicles built from 11/22/2019 through 12/05/2019 with Dana axles. See the attached chassis list for specific chassis.

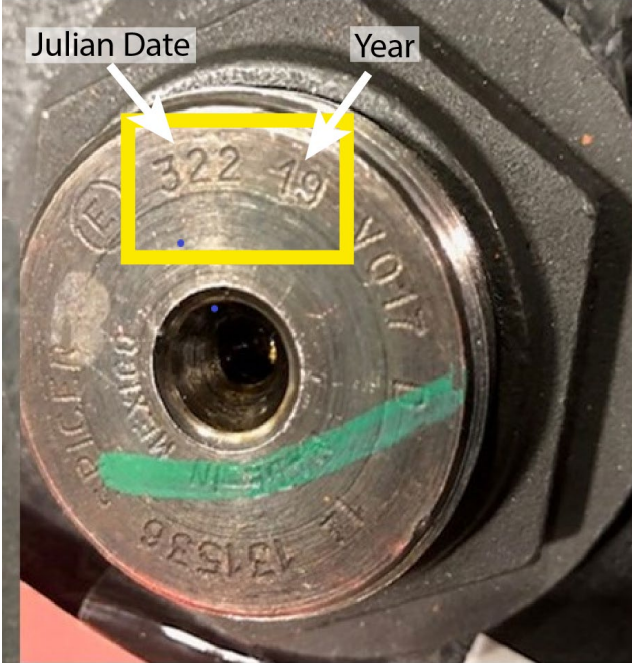
<p>Procedure</p>	<p>Vehicles with tridems (number of axles in chassis list is 3) will require inspections of the forward rear and middle rear axle output shafts.</p> <ol style="list-style-type: none"> 1. Disconnect the interaxle driveline from the suspect output shaft. 2. Inspect and record the Julian date code on the output shaft. <ul style="list-style-type: none"> • If the Julian date code is 312 or from 318 through 328, then continue with this procedure. • If the Julian date code is outside of the dates above, then no further action is required. Reinstall the driveline.

<ol style="list-style-type: none"> 3. Replace the output shaft using procedures in manual ASXM-0057. Please note the following exceptions to those procedures: <ul style="list-style-type: none"> • the axle shafts do not need to be removed • the inner bearing cup DOES NOT need to be replaced • the repair can be performed without removing the carrier cover
