Federal Recall Information

19PBG

Dana Axles

DANA Axle Output Shaft

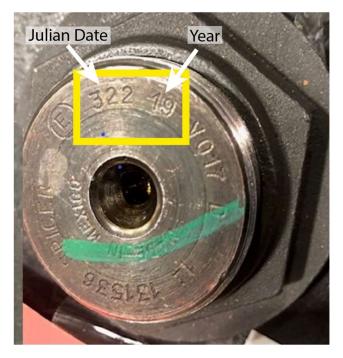
- 1. Disconnect the interaxle driveline from the suspect output shaft.
- 2. Inspect the date code on the output shaft.
 - If the date code is 312 or from 318 through 328, then continue with this procedure.
 - If the date code is outside of the dates above, then no further action is required. Reinstall the driveline.

- 3. Replace the output shaft using procedures in manual <u>ASXM-0057</u> with the following exceptions:
 - the axle shafts do not need to be removed
 - the inner bearing cup DOES NOT need to be replaced
