SIB 72 03 19

## RECALL 19V-XXX: REAR SEAT SAFETY BELT

E-Series	Model Description	Production Date
G20	3 Series Sedan	April 11, 2019 – December 5, 2019

RE: Recall 19V-912: Rear Seat Safety Belt Retractor – B72 03 19

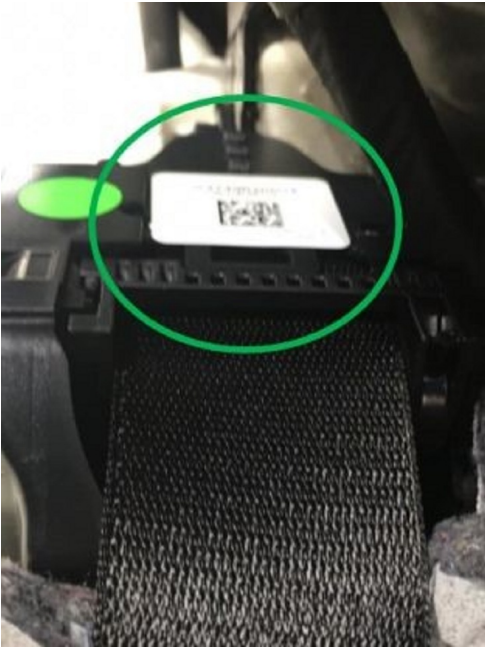
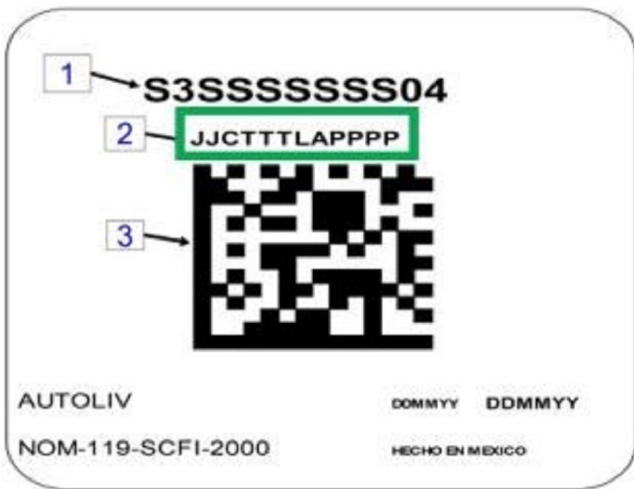
Parts label location (circled).

The serial number (2) is found in the green box.

Compare the serial number on the safety belt to the attached list.

If the serial number is on the list, the safety belt must be replaced.

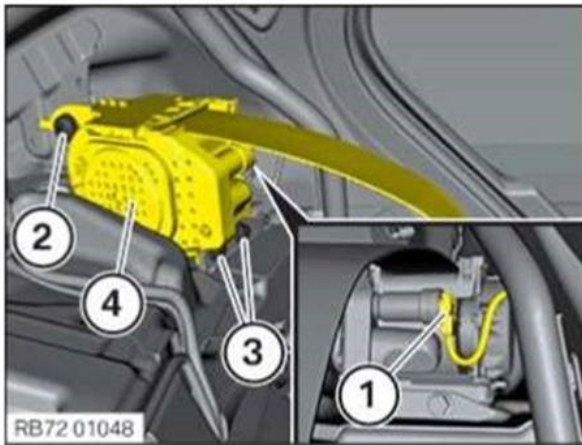
## Remove rear upper seat belt

- Unlock plug connection (1) and disconnect.
- Loosen screw (2).
- Loosen screws (3).
- Feed out seat belt retractor (4) towards the front.

The safety belts mounting screw must be replaced once removed. This is the large M10 bolt on the rear of the reel (2). The two small M6 bolts at the front of the reel can be reused (3).

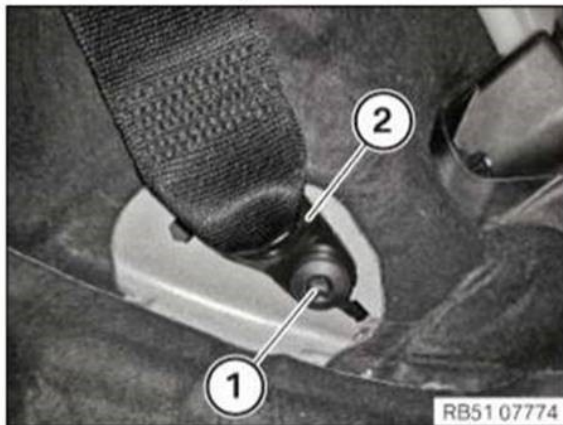
## Remove the trim panel for the storage shelf

- Release the screws (1) on the rear strap fitting (2) at left and right.
- Feed out the rear strap fitting (2) at left and right from the body.

The safety belt reel anchor for the outer safety belt must be removed in order to remove the safety belt reel. The anchor bolt must be replaced once removed (1).

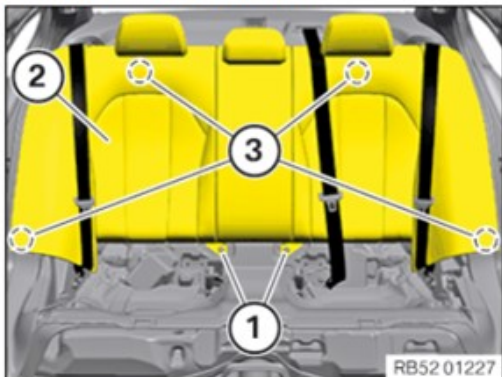
## Remove rear seat backrest

- Guide the rear seat backrest (2) into the seat belts and position it.
  - Attach the rear seat backrest (2) in the guides (3) from the top.
  - Renew screws (1).
- Parts: Bolts
- Tighten the screws (1).

Screw	Tightening torque
Renew screw.	42Nm

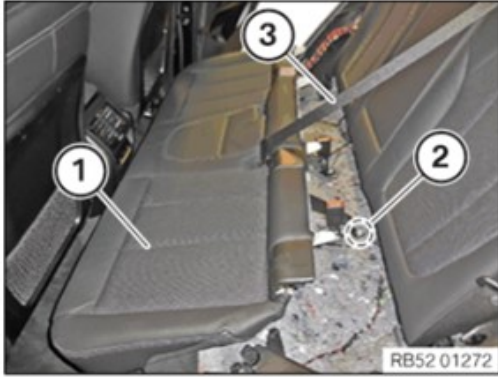
### Installing rear seat bench

- Lift the seat bench (1) into the vehicle.
  - Insert the seat belt (3).
  - Renew the screw (2).
- Parts: Screw
- Tighten down screw (2).

Screw	Tightening torque	42Nm
Renew screw.

The safety belt reel anchor for the rear seat center safety belt must be removed in order to remove the rear seat bottom cushion. The anchor bolt must be replaced once removed (2). The seat bottom can be moved enough to gain clearance without removing this bolt as shown.

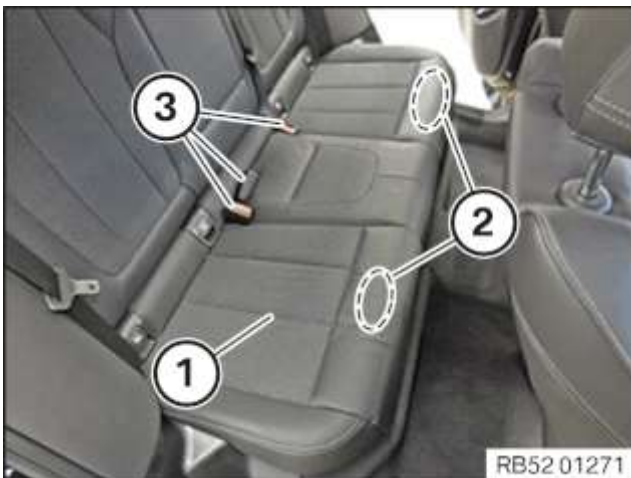
### Remove rear seat bench

- Disengage the rear seat bench (1) in area (2) in an upward direction.
- Feed out the seat belt buckle (3) from the seat bench.

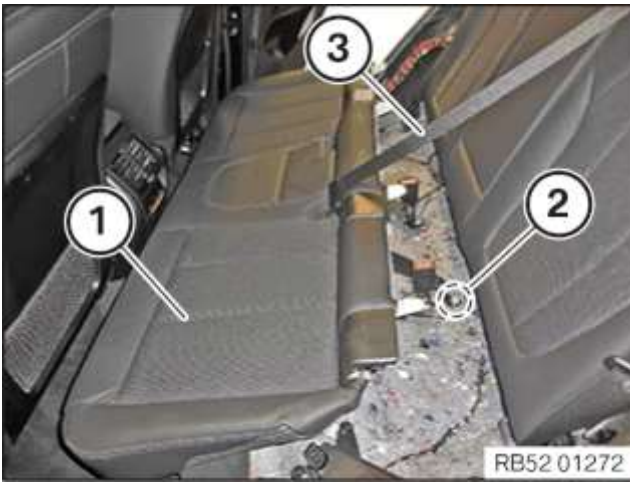
- Pull the rear seat bench (1) further forward.
- Unscrew the screw (2) on the strap fitting and feed out the safety belt (3).

If a belt lock is available on the safety belt, the screw on the strap fitting does not have to be loosened.

- If necessary, disconnect the present plug connections.
- Lift the rear seat bench (1) out of the vehicle.

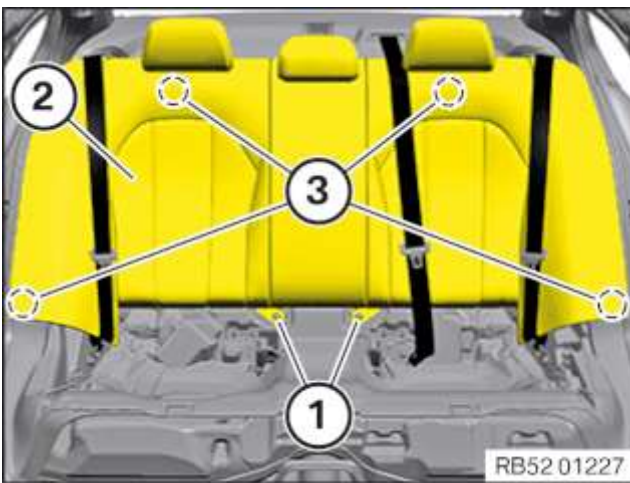
### Remove rear seat backrest

- Loosen screws (1).
- Detach the rear seat backrest (2) upwards out of the guides (3).
- Feed out and remove the rear seat backrest (2) from the safety belts.

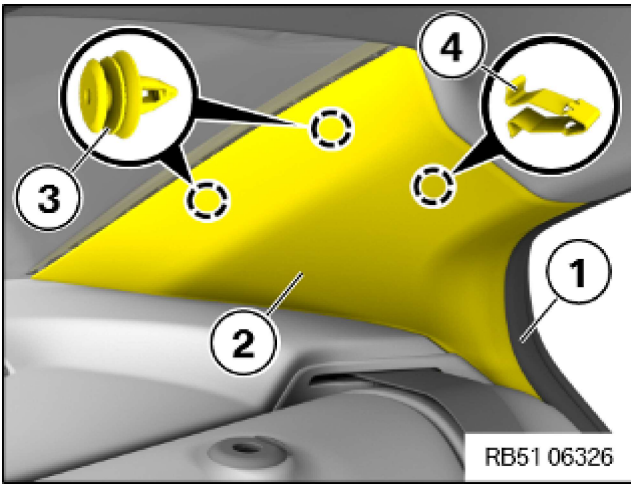
- Unclip the clamp (4).
- Unclip clips (3).
- Guide out the C-pillar trim panel (2) from the guides to the front.

- Feed the C-pillar trim panel (2) out of the lip of edge protection (1).

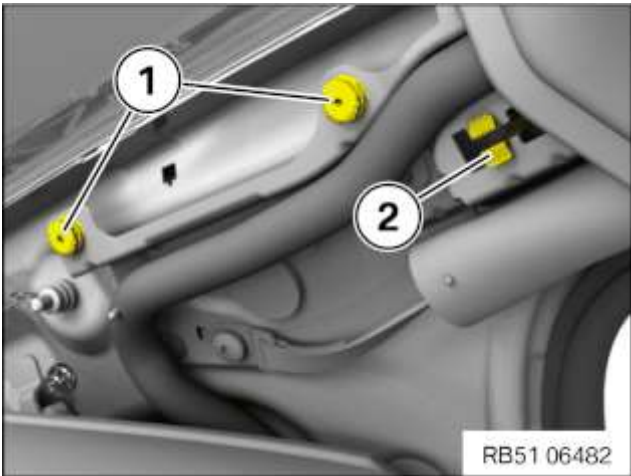
- If applicable, remove the clips (1) and the clamp (2) and insert on the trim panel.

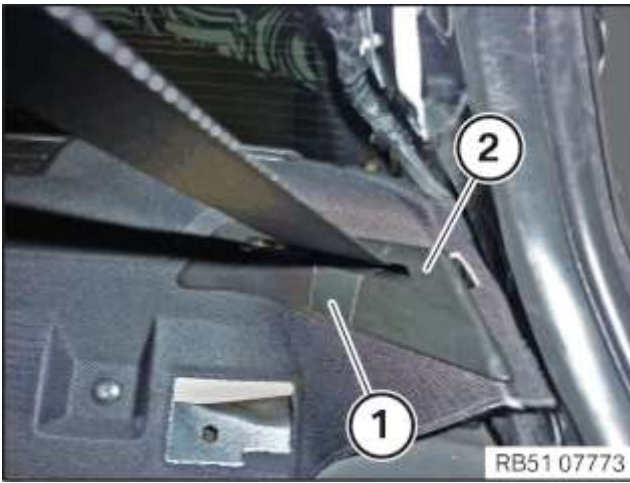
- Unclip the cover (1) towards the front.
- Unclip the seat belt finisher strip (2) forwards starting from the outer and feed out.

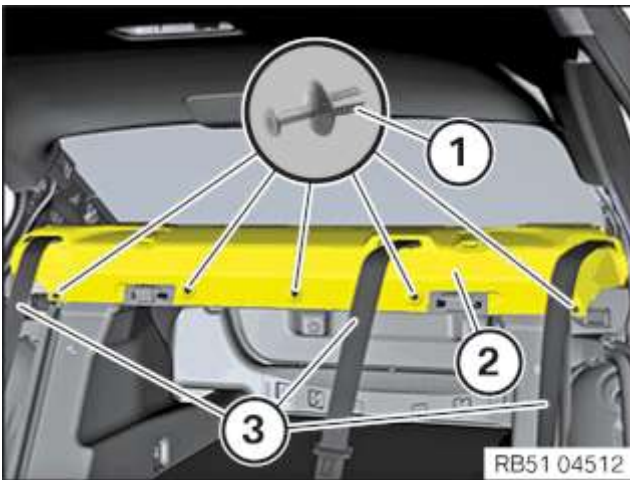
- Loosen the expanding rivet (1).
- Lift the trim panel for the storage shelf (2) a little and disconnect the underlying plug connections.
- Remove the trim panel for the storage shelf (2) to the front and feed out the safety belt (3).

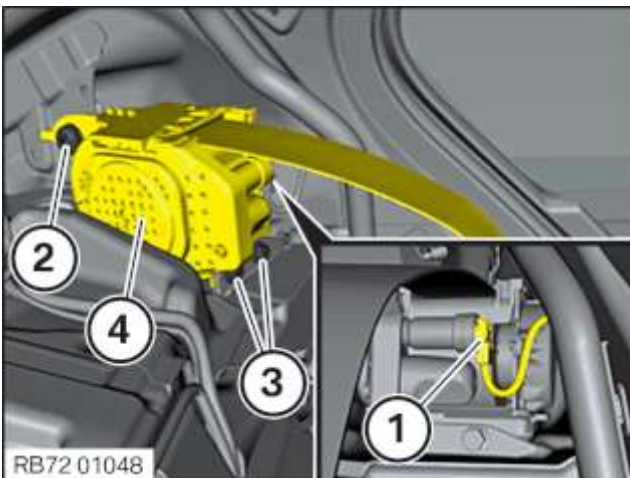
### Remove rear upper seat belt

- Unlock plug connection (1) and disconnect.
- Loosen screw (2).
- Loosen screws (3).
- Feed out seat belt retractor (4) towards the front.

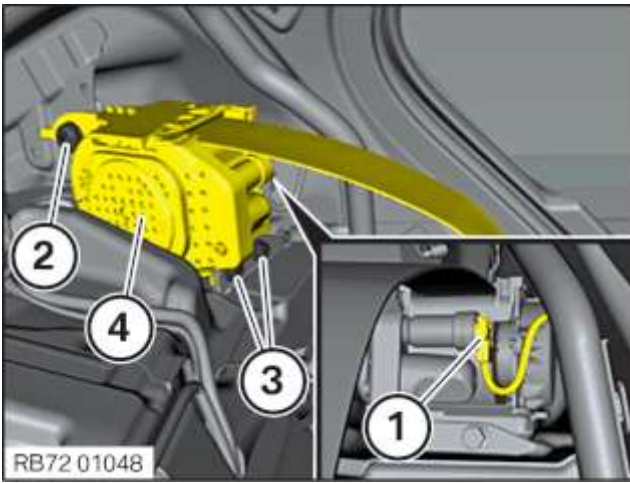
### Install rear upper seat belt

Component is encoded against incorrect assembly.

- Feed in and position the seat belt retractor (4).
- Renew the screw (2).

M10  
Renew screw.

42Nm

- Tighten down screws (3).

M6

8Nm

- Connect plug connection (1) and lock.

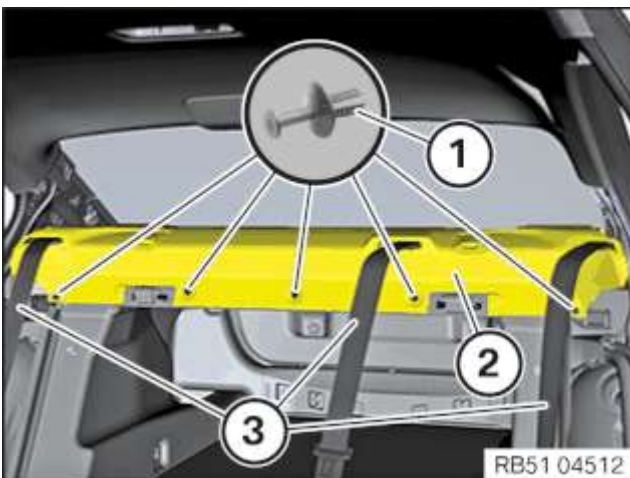
### Install the trim panel for the storage shelf

- Install the trim panel for the storage shelf (2) and feed in the safety belts (3).
- Lift the trim panel for the storage shelf (2) a little and connect the underlying connectors.
- Feed in the trim panel for the storage shelf (2) at the rear guide and position it correctly.
- Mount the expanding rivets (1).

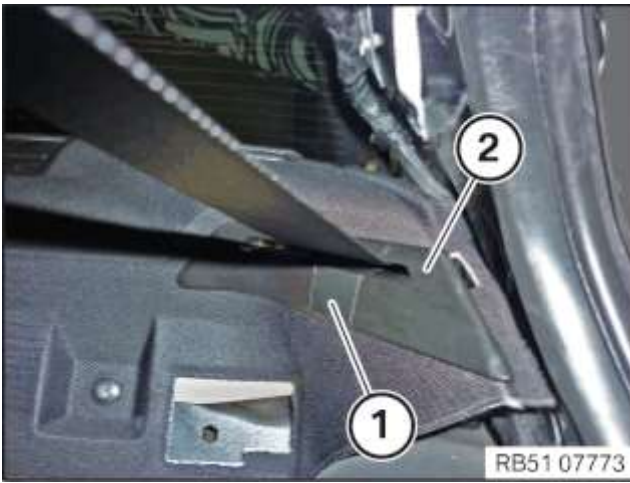
- Insert the seat belt finisher strip (2).
- Clip in the cover (1).

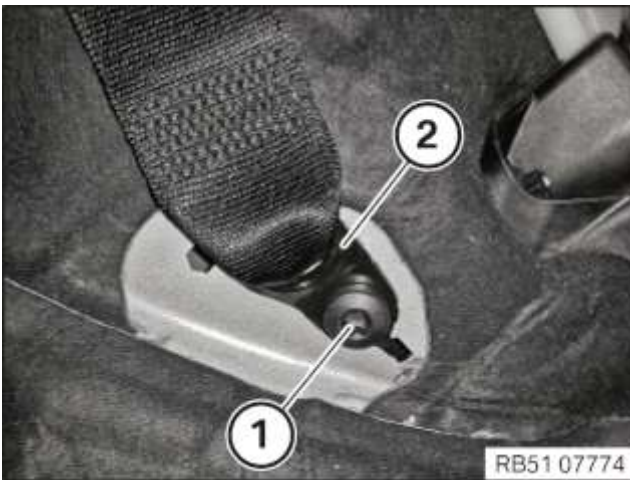
- Feed the strap fitting (2) at left and right into the body.
  - Renew screws (1).
- Parts: screw
- Tighten screws (1) on the left and right.

M10  
Renew screw.

42Nm

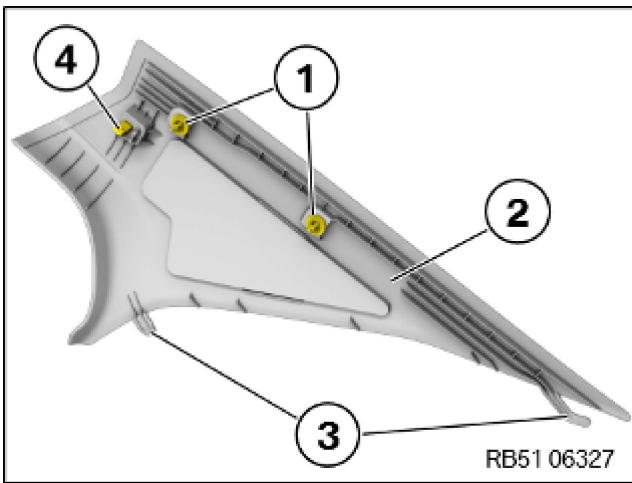
- Check the clips (1) and the clamp (4) for damage and renew if necessary.
- Check guides (3) for damage.

- » The guide is damaged.

- Renew the C-pillar trim panel .

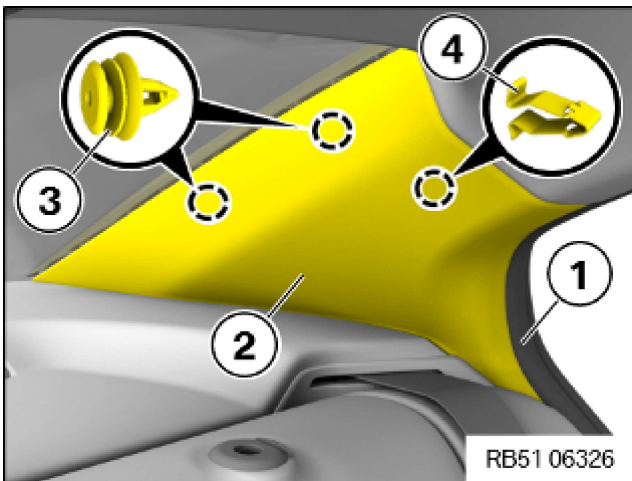
- Thread in C-pillar trim panel (2) in the guides to the rear.
- Clip in clips (3).
- Clip in clamp (4).
- Feed in the C-pillar trim panel (2) under the lip of edge protection (1).

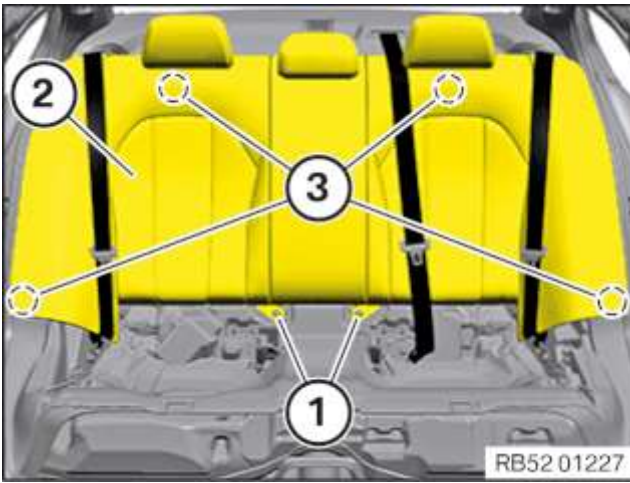
- Guide the rear seat backrest (2) into the safety belt and position it.
- Attach the rear seat backrest (2) in the guides (3) from the top.
- Renew screws (1).

Tightening torque  
42Nm

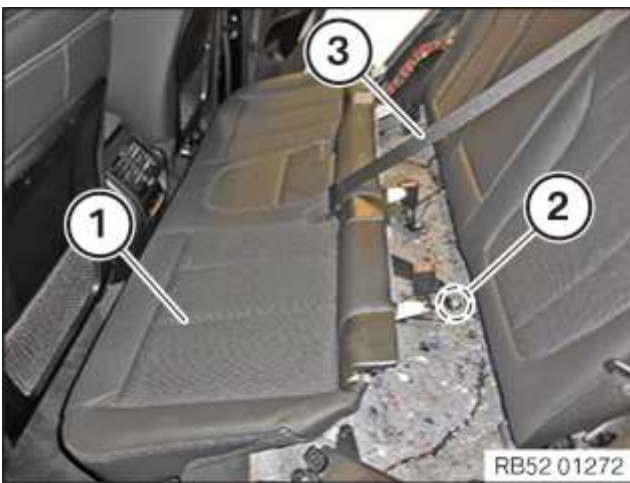
### Install rear seat bench

- Lift the seat bench (1) into the vehicle.
- Insert the safety belt (3).
- Renew the screw (2).

tightening torque  
42Nm

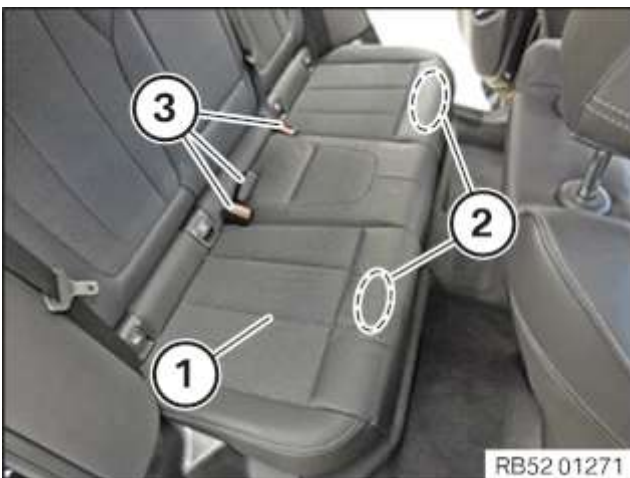
- Connect available connectors.
- Insert the rear seat bench (1).
- Insert the seat belt buckles (3) into the rear seat bench.
- Engage the seat bench (1) in the area (2).
