Mercedes-Benz

Campaign No. 2020040011, June 2020

SUBJECT: **Models C-Class, CLK-Class, E-Class, and CLS-Class (203, 209, 211, and 219 platform)**  
**Model Years 2001-2011**  
**Sliding Roof Bonding - Phase 2**

Order No. P-RC-2020040011

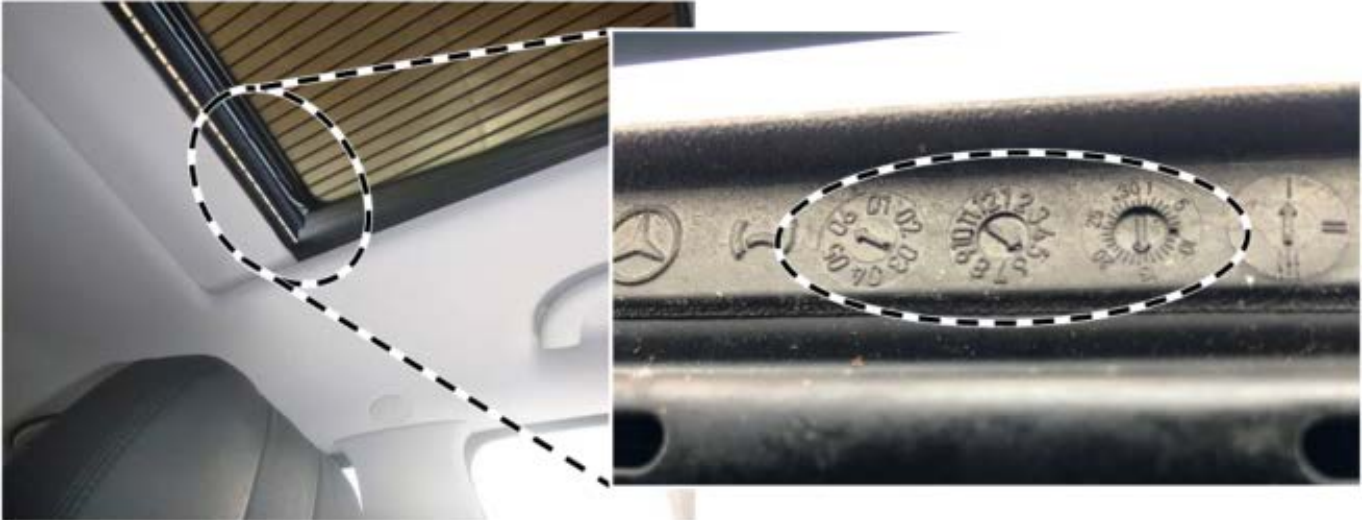
**Figure 1** (The production date in the sample picture is **06 year / 5 month / 15 day**)(5-15-2006)

1. Move sliding sunroof to tilt position and check production date (**figure 1**).

**i** The production date **must** be on or **after 01-16-2006** or on or **before 07-09-2006**.

**i** If the production date is **not** at the shown location (**figure 1**), this vehicle is **not** affected.

**A.** Production date between 01-16-2006 and 07-09-2006: Carry out **check/test procedure B**.

**B.** Production date **not** between 01-16-2006 and 07-09-2006: **End measure**.

**C.** **No production date present at shown location (figure 1): End measure.**

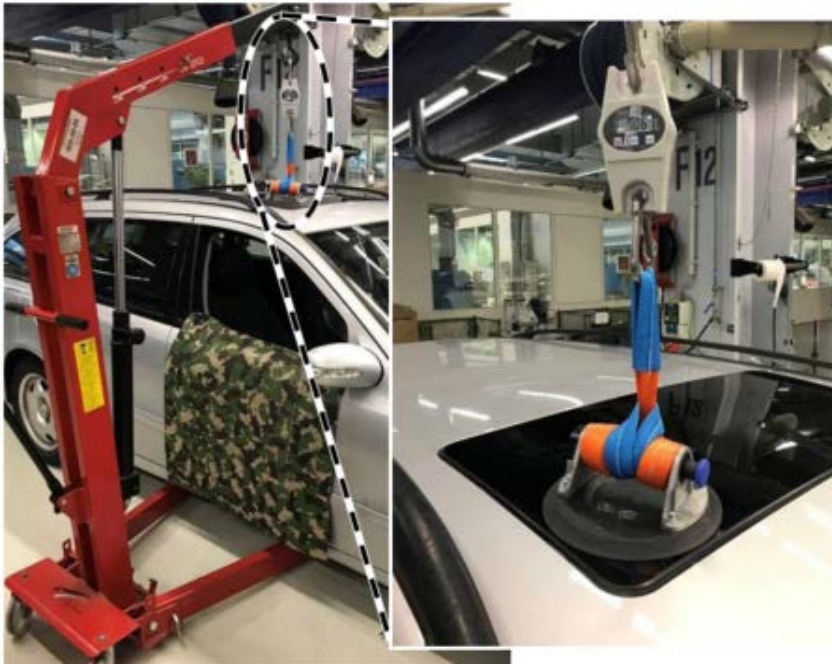
Figure 2

- i** The sliding sunroof must be closed.
  - i** Special caution must be exercised during the check. The cup suction tool may be used for this check.
3. Position cup suction tool (**figure 2**) and pull as **vertically** as possible (tolerance of  $\pm 10$  degrees) using lifting tool (hoist/crane).

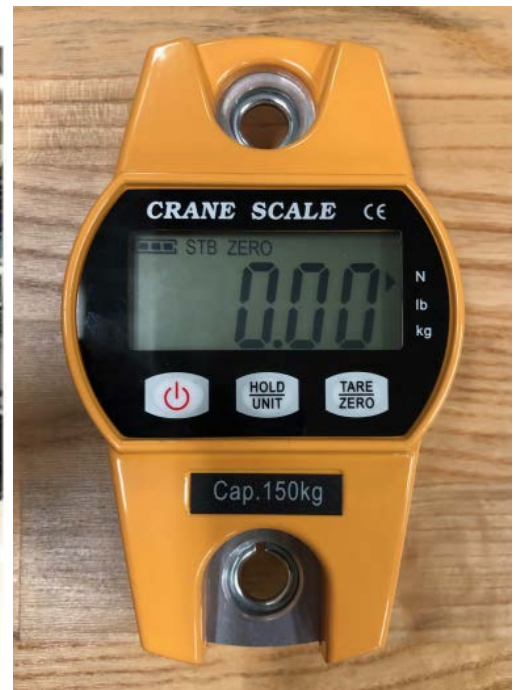
Figure 3 (Correct scale display)

- i** Before the start of the measurement, the "(auto) hold function" of the hanging scale **must** be deactivated and the measurement scale is set to N (see operator's manual). **(See figure 3) for correct scale display.**

**No** "hold function" may be activated so that the current pulling force is always displayed.
  - i** Position cup suction tool at 5 positions in the sequence **1, 2, 3, 4, 5: (Figure 4)**.
