TO: Mercedes-Benz Dealer Principals, General Managers, Sales Managers, Service Managers, Parts Managers	FROM: Gregory Gunther, Department Manager, Vehicle Compliance and Analysis, Engineering Services
RE: <b>Recall Campaign 2017120018</b> <b>Launch Notification</b> <b>Seatbelt Guide Loop Retrofit (2 of 2)</b> <b>MY 18 190</b> <b>(AMG GT-Class Roadster)</b>	DATE: March 23, 2018

Campaign No. 2017120018, March 2018

SUBJECT: **Model 190 Model year 2018**  
**Retrofit seat belt guide on driver's seat and front passenger seat (roadster)**

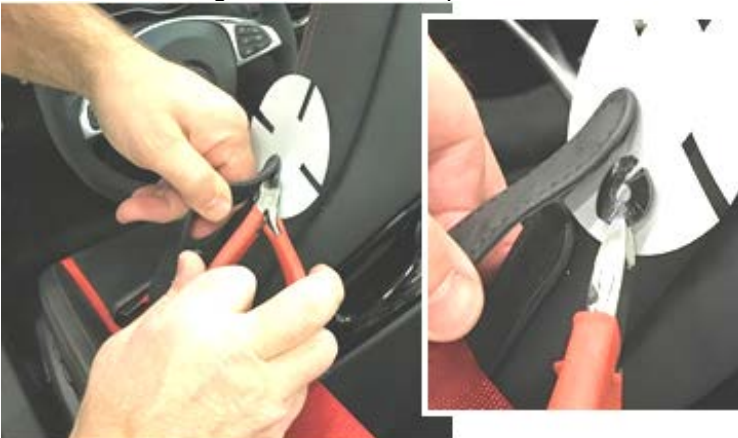
Figure 2

2. Measure the outside diameter of the shim between the seat backrest and the seat belt strap.

**i** If the outside diameter is **17 mm**, continue with operation step 3.

**i** If the outside diameter is **12 mm** or if no shim is installed, continue with operation step 4.

3. Sever the shim (**C, figure 1**) with pliers and remove.

**i** The shim will not be installed anymore.

**i** Do not damage the seat belt strap or seat cover.

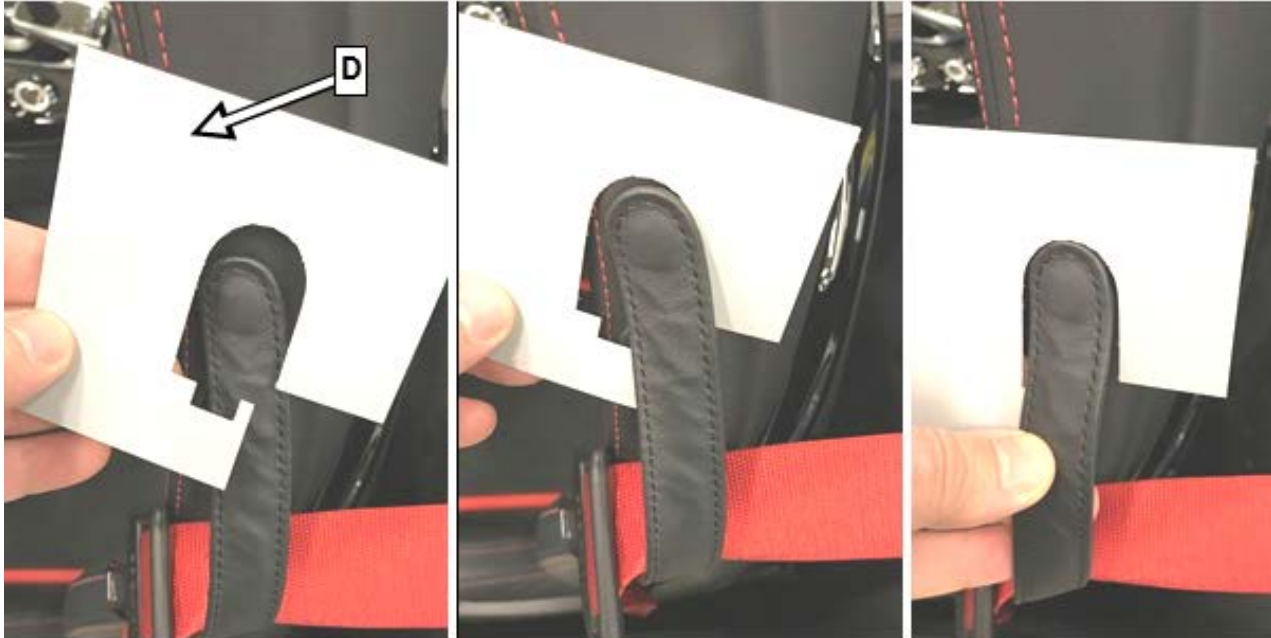
Figure 3

4. Place cutting template (**D**, figure 3) for marking the cutting edge on the seat belt strap.

Place the rounding of the cutting template flush with the radius of the seat belt strap at the top.

Mark cutting edge on the inner side of the seat belt strap.

After positioning, hold the template on the cutting edge.

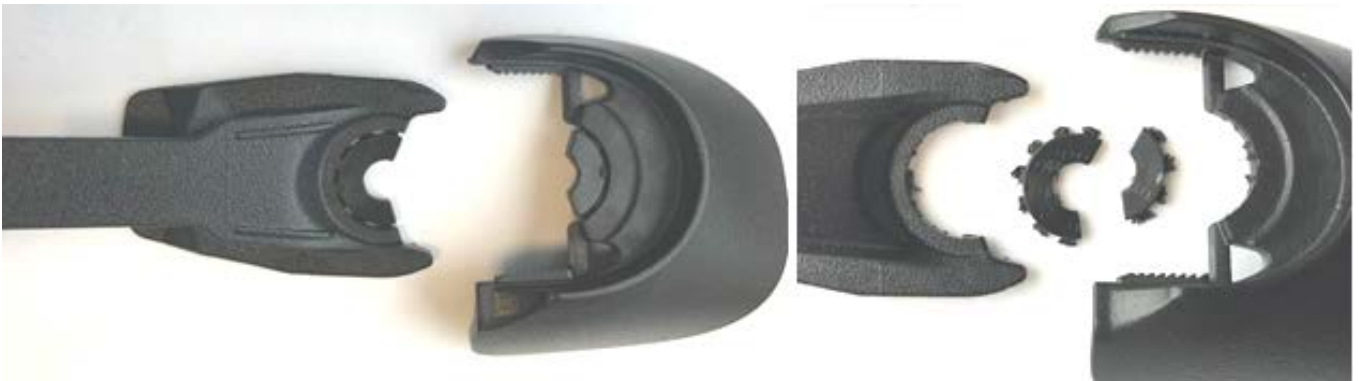
Figure 6

7. Only for seat belt straps with **12 mm shims** that are still installed: Break seat belt guide at the perforation and deburr the broken edge.

**i** For seats without a shim, continue with **operation step 8**.

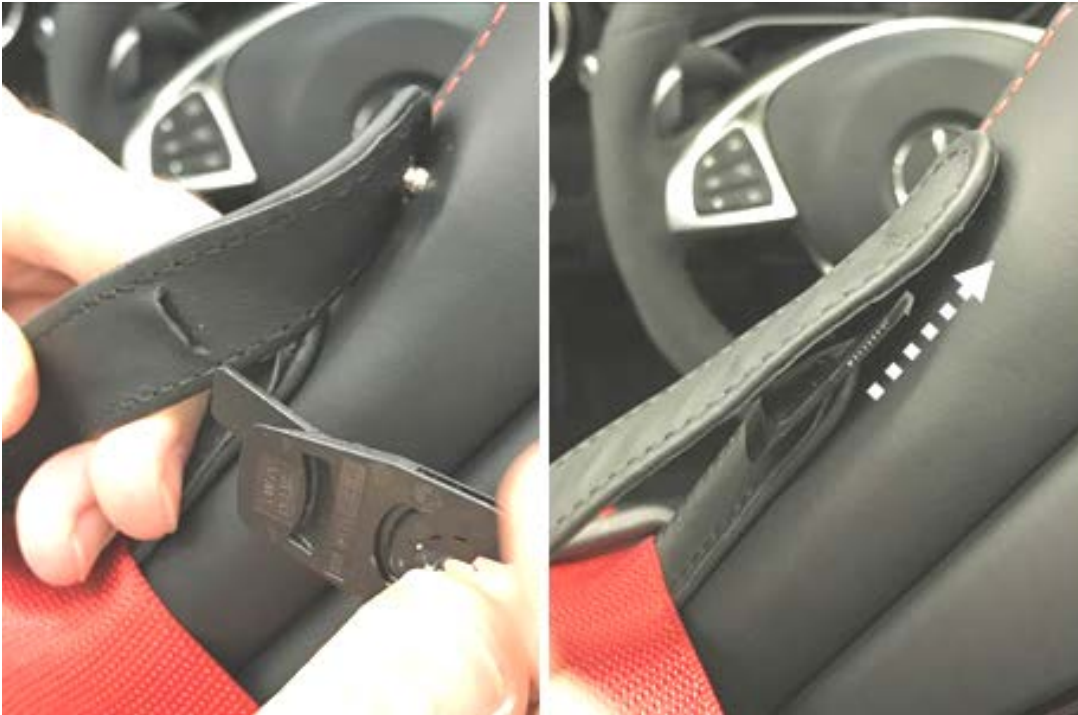
Figure 7

8. Insert the seat belt guide completely into the notched seat belt strap and then push upwards towards the seat belt strap rivet.

**i** If a previous version is installed, remove it and replace it with the current version.

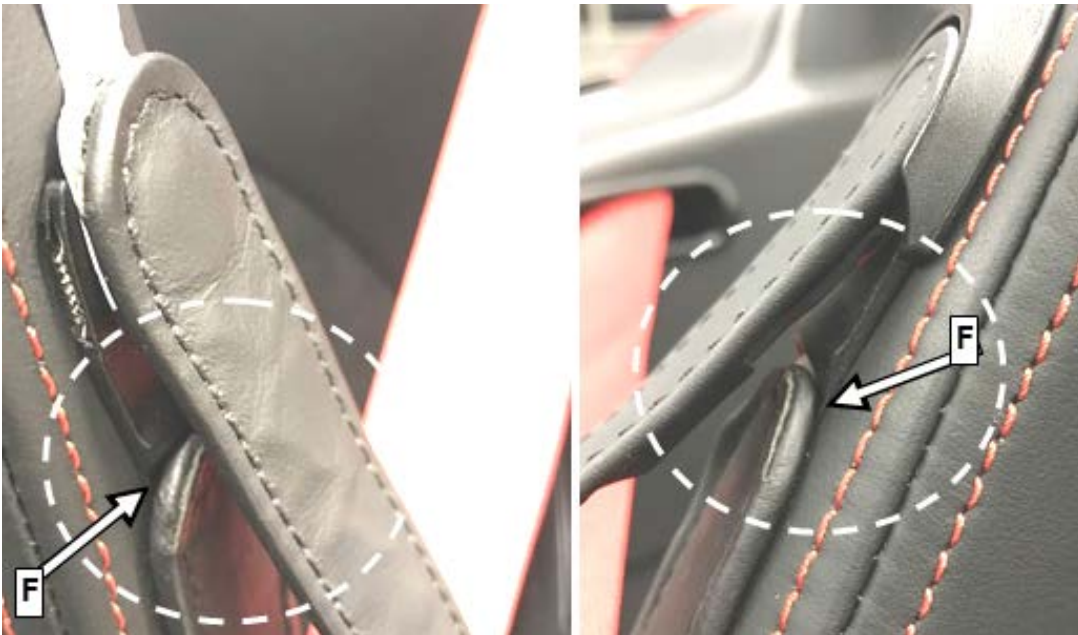
Figure 8

9. Thread in the lower edge (F, figure 8) of the seat belt guide under the seat belt strap.

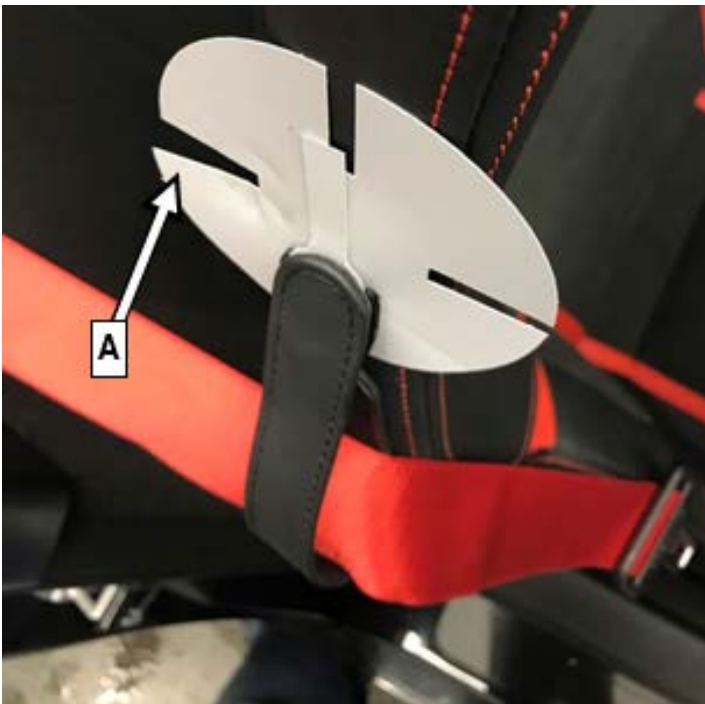
Figure 10

11. Slide the protective foil (**A**, figure 10) over the attachment rivet between the seat belt guide and the seat cover.

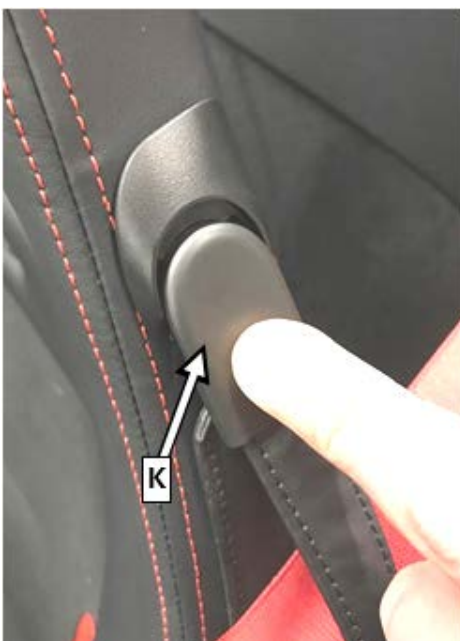
**Figure 12**

13. Take out the protective foil (**G, figure 9**) and place the protective cap (**K, figure 12**) on the seat belt strap end and hold it.

**i** The protective cap is used later when the upper and lower part of the seat belt guide are bonded to protect the seat belt strap.

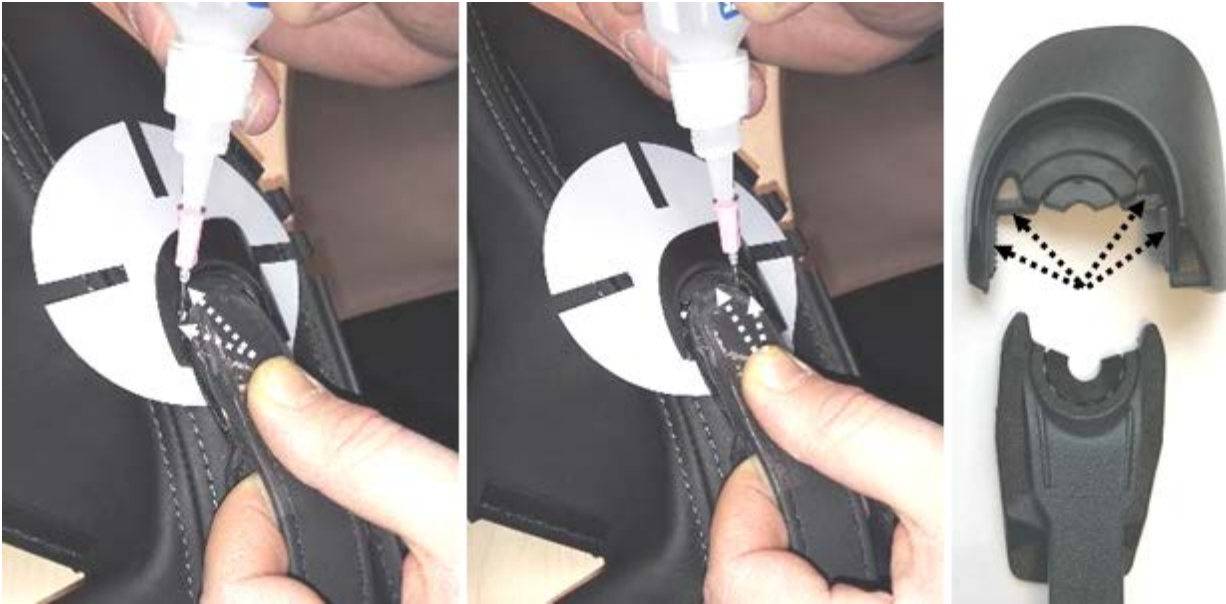
Figure 13

14. Install the supplied needle on the adhesive and apply adhesive to the engaging parts on the left, right and top on the retaining bridges for the catch tabs of the upper part.

**i** After applying adhesive, remove the protective cap.

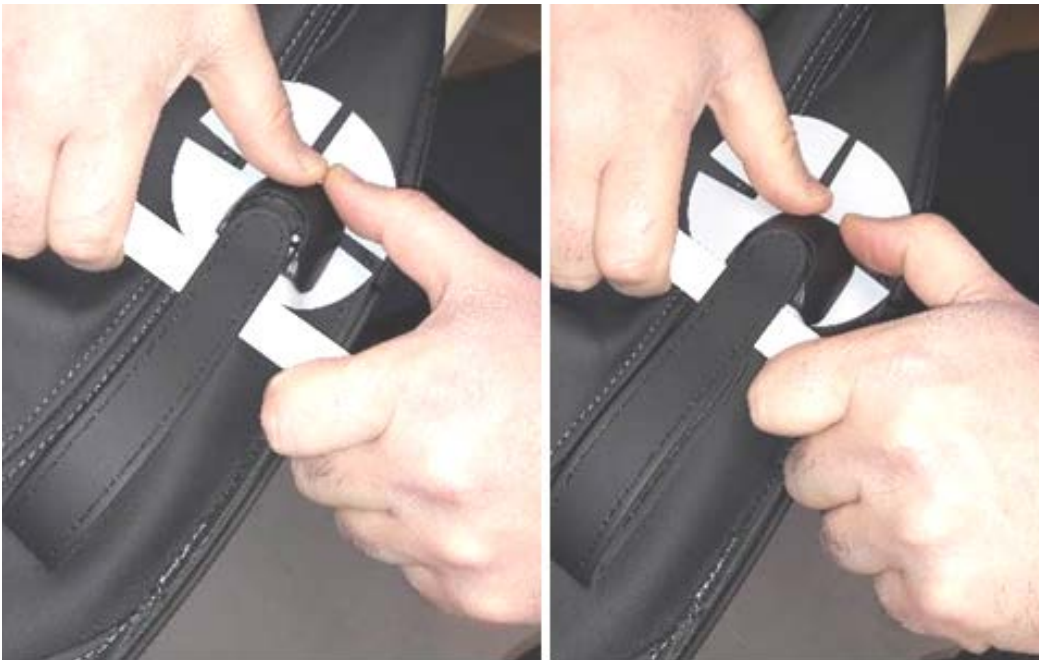
Figure 14

15. Insert plastic strip into the lower part of the seat belt guide and completely engage the upper part with the lower part.

**i** Then remove the protective foil.

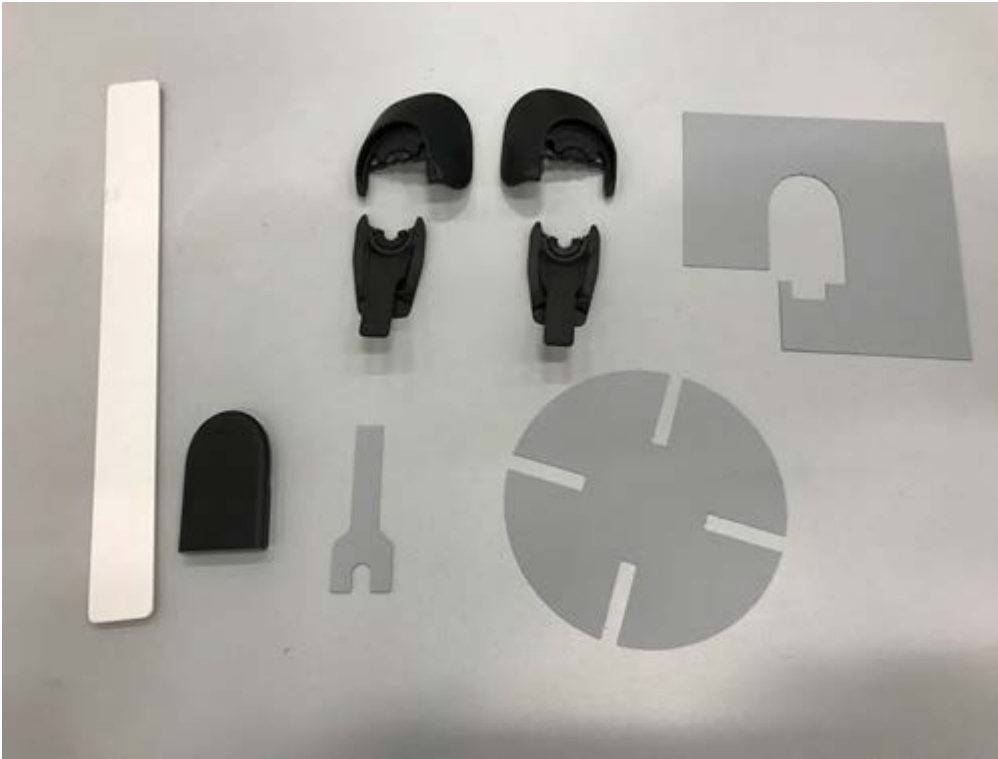
Figure 15

**i** Content of the parts kit (figure 15)
