Safety Recall Code: 20AR

Fuel Line

U.S.A. & CANADA: Certain 2012-2014 MY Audi A6 & A7

The fuel line was designed with a compression point to assist in installation. This area of the fuel line may weaken and leak over time. Leaking fuel, in the presence of an ignition source, can lead to a fire.

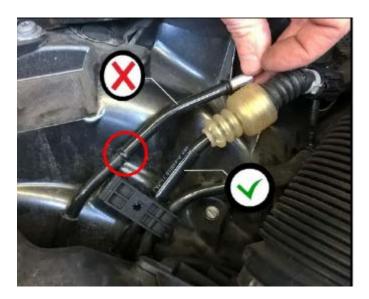
- Open hood and inspect fuel line.
- If fuel line is flared <circle> Continue with fuel line replacement.
- If fuel line is not flared, no further work is required - Proceed to Section C.

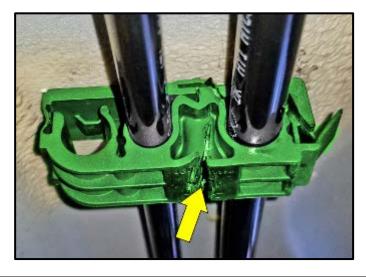
Remove the fuel line clips <1> using Pry lever -80-200- (or equivalent).

Using a gasket scraper, small size chisel, or equivalent, to carefully split each fuel line mounting clip will aid in removal.

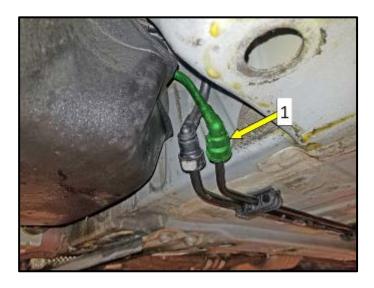
Remove the protective cap from the new fuel line and connect fuel line coupling <1> until it audibly engages.

Install new fuel line clips <1 through 6>.

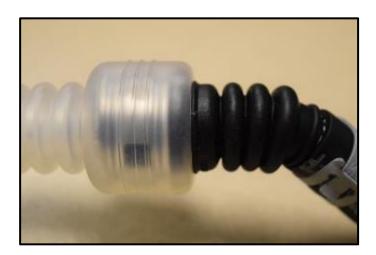
• When correctly seated, the fuel line coupling cover should appear as shown.
