SIB 65 03 20

2020-01-16

RECALL CAMPAIGN 20V-017: REPLACE DRIVER'S FRONT AIR BAG MODULE

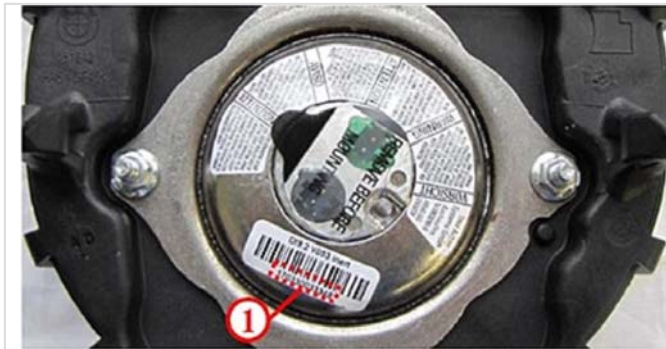
It is necessary to document which gas generator goes into which vehicle. Therefore, the technician is required to note on the repair order the serial number of the new gas generator. The serial number should also be entered into the warranty claims comment section. The serial number can be found on the gas generator below the barcode.

Serial Number location (1).

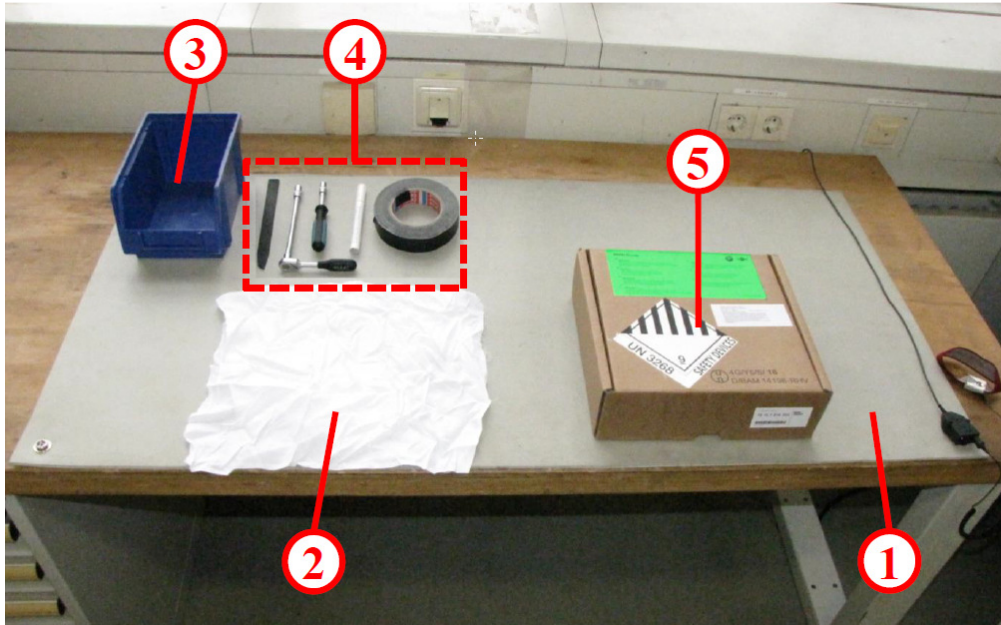
[1] The workbench should be prepared with the following items:

- Anti-Static mat (1) which must be grounded (See SWS 2 06 04 (128))
- A soft blanket or material (2) to prevent damaging the airbag cover
- A container (3) for disposal of the original Generator nuts
- A packaged new part (5)

Tools required (4) for the Generator exchange:

- Plastic bone tool (SWZ 0 490 539)
- Ratchet with extension and 8 mm socket
- Small torque wrench with 8 mm socket (5 NM)
- Felt tip marker (sharpie)
- Duct tape (.25 mm wide)

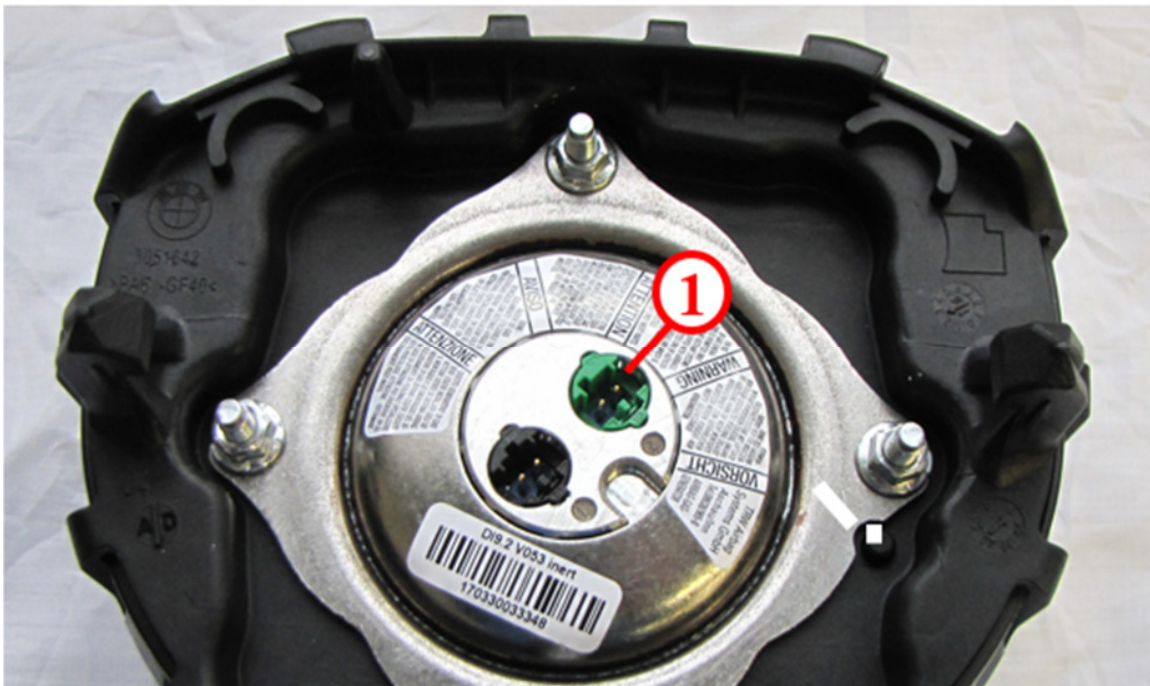
[20] 1st and 2nd Technician must ensure green connector is orientated as shown (1)

[21] Turn the Air Bag assembly over and perform a visual inspection of the Air Bag cover to ensure its condition matches what was noted on the Repair Order prior to this repair.

[22] Remove the wiring harness (5) from the steering wheel:

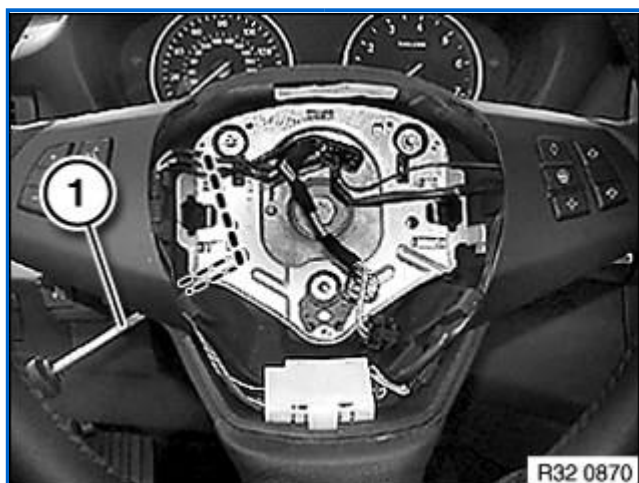
Insert Torx screwdriver T30 (1) at an angle into concealed opening on reverse side of steering wheel until a spring resistance is felt (approx. 2 cm).

Increase pressure with Torx screwdriver T30 (1) on spring leg until airbag unit is unlocked.

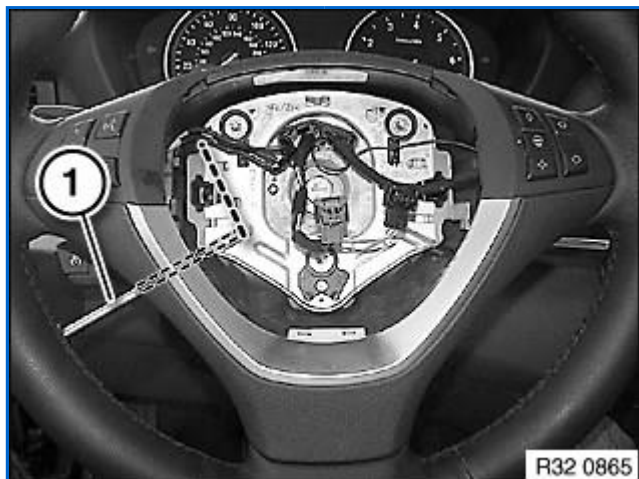
Insert Torx screwdriver T30 (1) at an angle into concealed opening on reverse side of steering wheel until a spring resistance is felt (approx. 2 cm).

Increase pressure with Torx screwdriver T30 (1) on spring leg until airbag unit is unlocked.
