## 1. VEHICLE INSPECTION PROCEDURE

2016 Model Year Mazda CX-5 vehicles, equipped with LED Daytime Running Light (DRL)

## 2. REPAIR PROCEDURE

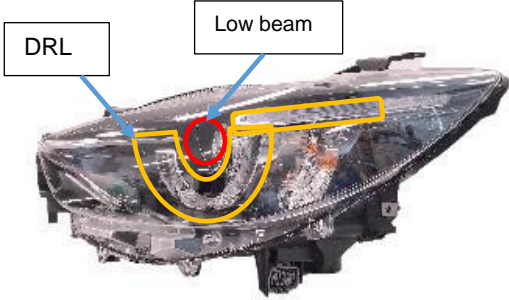
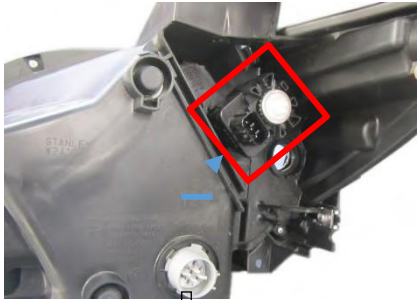
AFS	Front image	Back image
Yes (Equipped)

AFS: Adaptive Front Lighting system, which enhances the range of visibility when the headlights are turned on by pointing the optical axis of the headlights in the direction in which the vehicle is advancing according to the steering operation. The swivel actuator constantly detects the headlight swivel angle from the hall sensor built into the actuator, and inputs the swivel angle to the AFS control module via LIN communication.

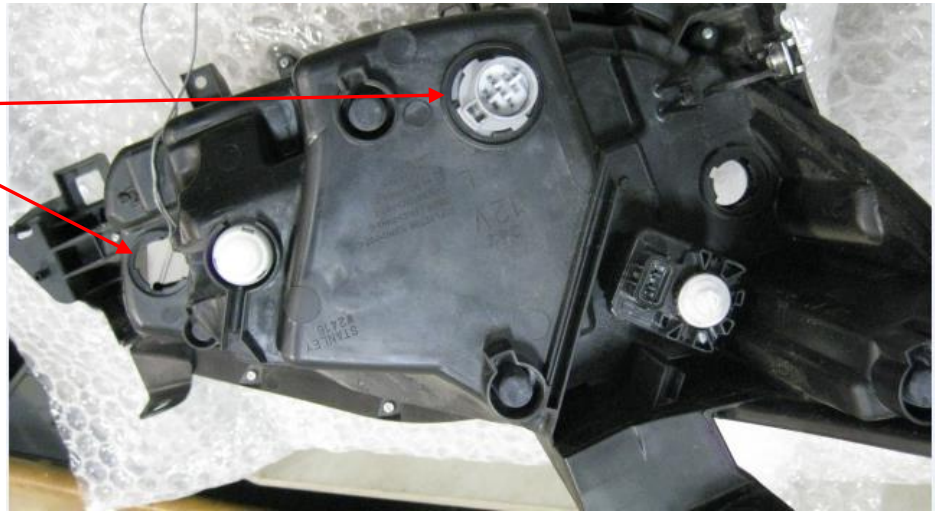
Replacement of gaskets for Connector A and B

Connector of headlight

A: Connector A

B: Connector B

**Caution:** Be careful not to damage the headlight lens (scratch etc...) or deform the terminal.

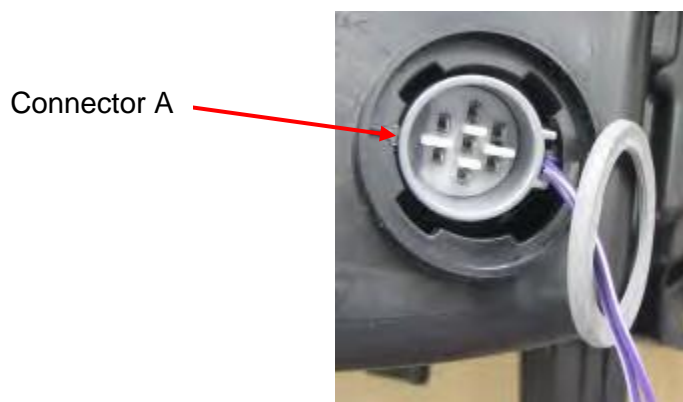
- 2) Unlock the connector from the headlamp and make room between housing and connector to allow for the removal of the gasket.
- 3) Using a pick tool, hook and pull the gasket off of the connector and out of the headlamp.

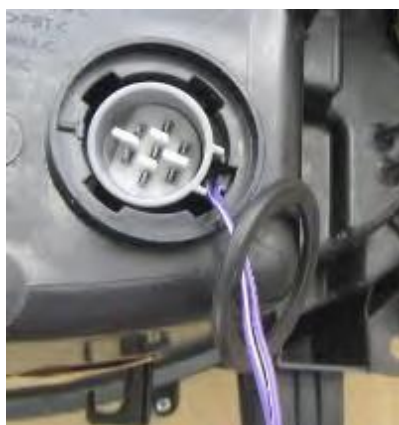
- 4) Install the gasket with new one (black one).
  - Thread the new gasket onto the spare wire/string.

- Push the gasket into the four hooks at the bottom of the connector.

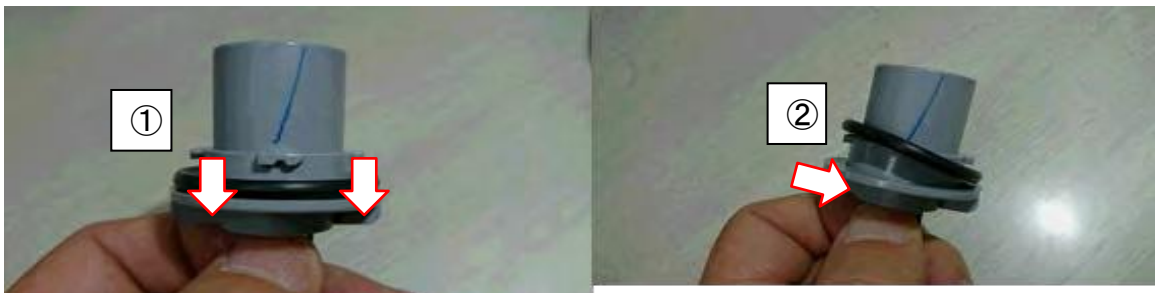
①	OK: Gasket has seated.
②	NG: Gasket is not seated on the hook.

**Note: Connector A will not drop down far enough to turn 90 degrees. This gasket has limited room and visibility. Watch Video A**

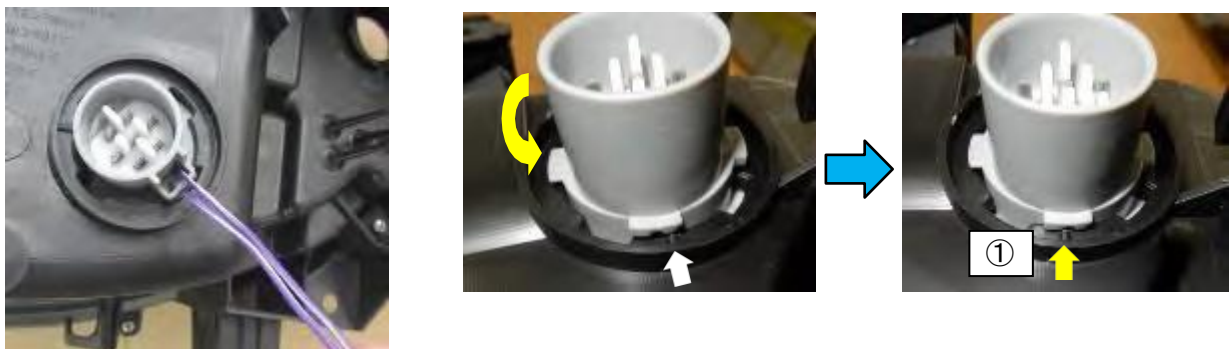
- Lock the connector shown the image below.
- Pull the spare wire/string and remove from connector.

①	OK: Fits on rib protrusion.
---	-----------------------------

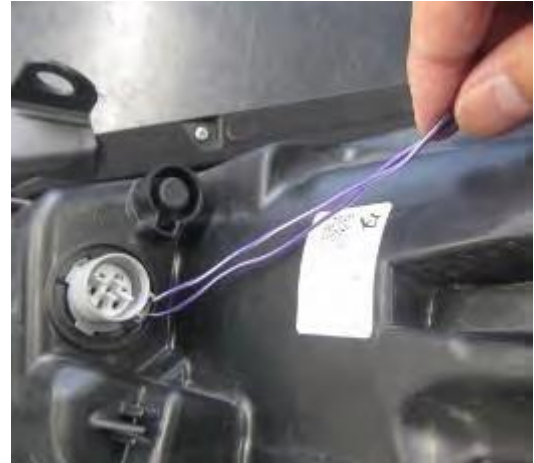
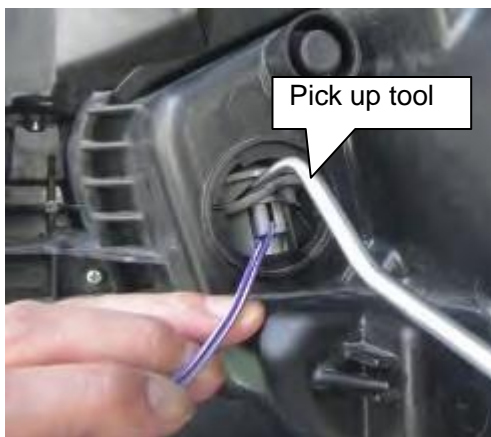
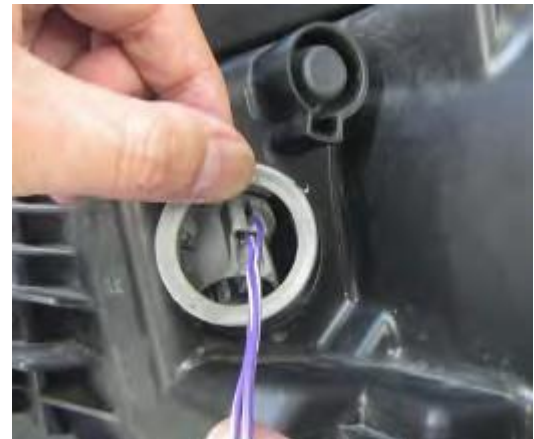
- 1) Unlock and make a gap between housing and connector.
- 2) Use a pick tool, pull the gasket toward the outside.

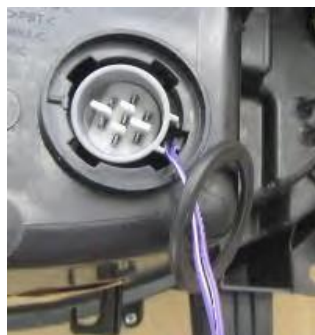
- 3) Install the gasket with new one (black one).
  - Thread the new gasket onto the spare wire or string.

- Push the gasket into the four hooks at the bottom of the connector.

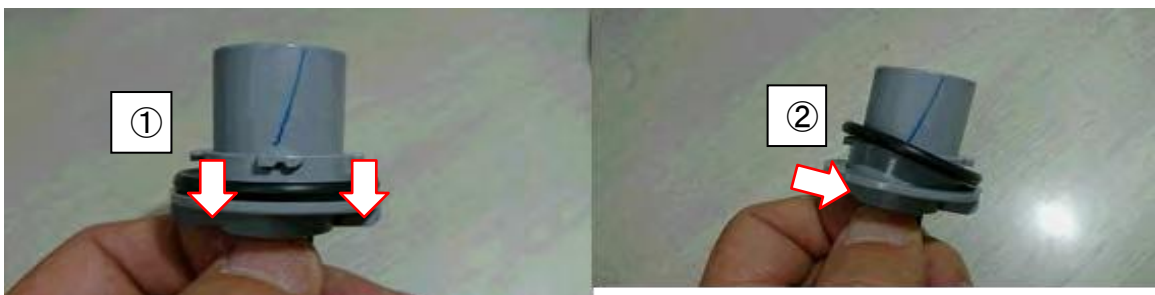
①	OK: Gasket has seated.
②	NG: Gasket comes out from the hook.

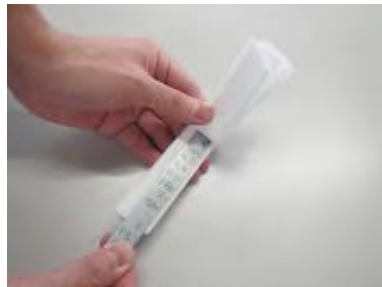
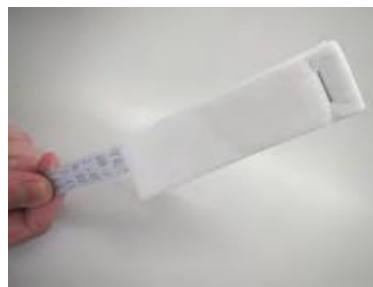
1. Prepare a gas absorption sheet and use your finger, or tweezer, short ruler to install.
2. **Peel off the adhesive tape back of gas absorption sheet.**  
**Caution:** Do not break the ply formation of the gas absorption sheet.

3. Install gas absorption sheets **(2 pieces per one side)** inside the connector hole.

Connector B:  
Necessary to install gas  
absorption sheets through  
the connector B hole after  
the gaskets replacement.

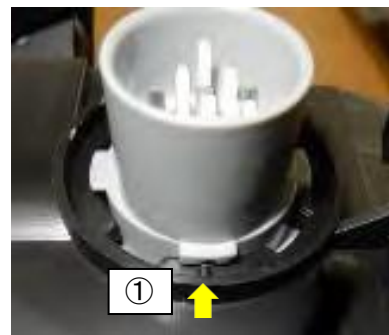
4. Lock the connector B.
5. Remove the spare wire/string from connector.
6. Make sure the connectors A & B are locked. (Confirm with the mark (in yellow circle) at fully locked position.)

① OK: Fits on rib protrusion.
