Safety Recall: 2020 Passport and Pilot Certification Label

BACKGROUND

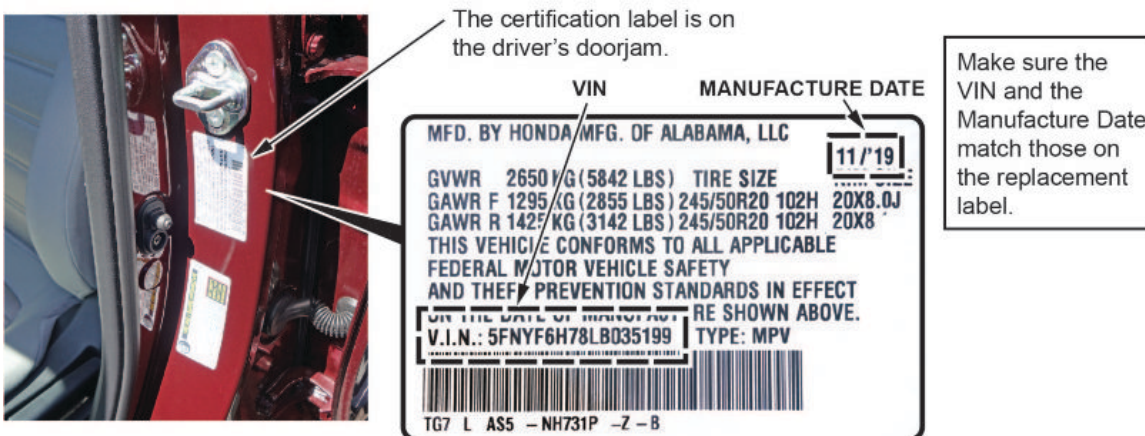
2. Make sure the VIN on the dashboard matches the one on the new certification label. Also, make sure the VIN and manufacture date on the new label matches the old label.

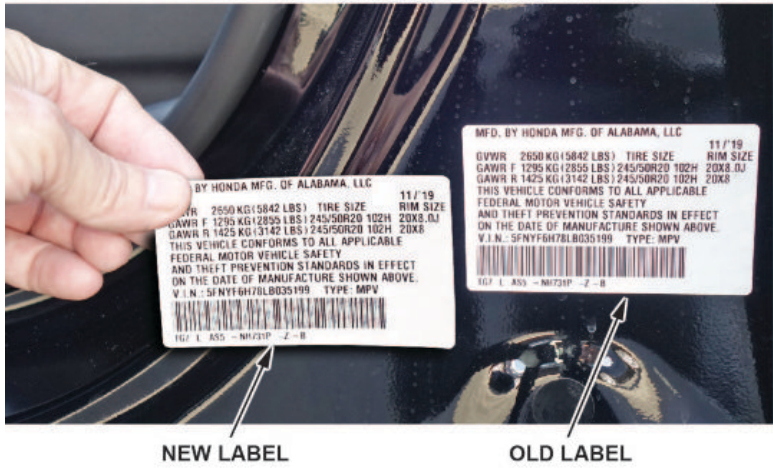
- Before removing the old certification label, take a photo of the old and new label next to each other. Attach the photo to the warranty claim.

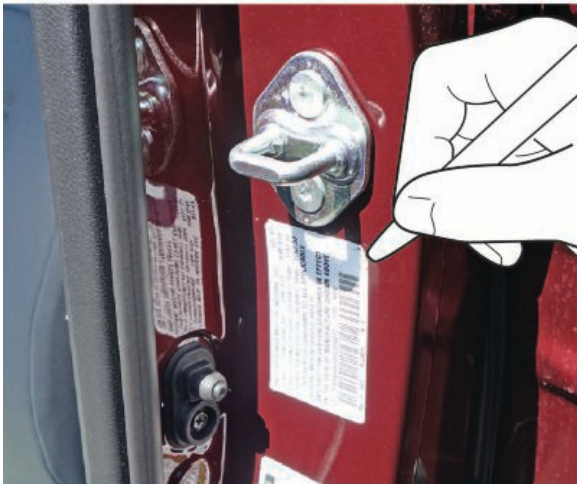
- Use a plastic tool to remove the label. Be careful not to scratch or damage the paint.

Applying heat with a heat gun may make the label easier to remove.

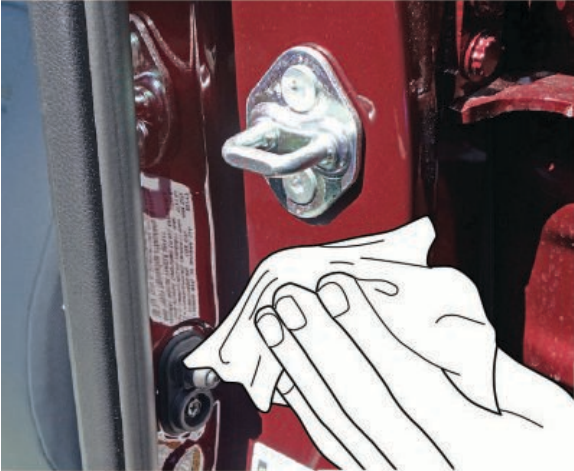
5. After the label is removed, using isopropyl alcohol on a lint-free cloth, thoroughly clean the area where the new label will be attached. Make sure there is no residue from the old label, and allow the alcohol to dry.

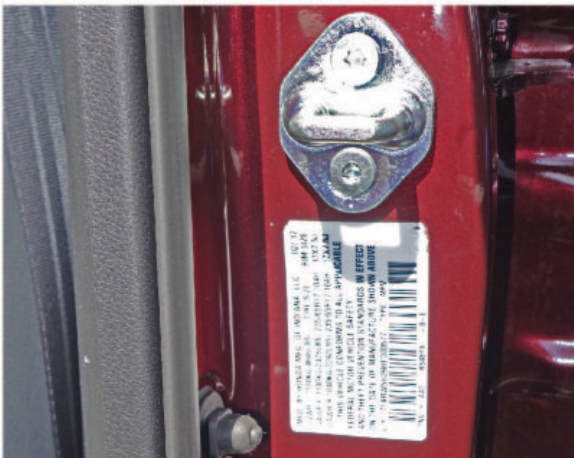
6. Apply the new certification label in the same location as the old label. Make sure the label is applied in the same orientation as the removed label.

Make sure the label is properly applied to the body, and make sure there are no wrinkles, tears, or bubbles.
