Dealer Service Instructions for:

Safety Recall W06 / NHTSA 20V-080

Transfer Case

2019 (DT) Ram 1500 Pickup

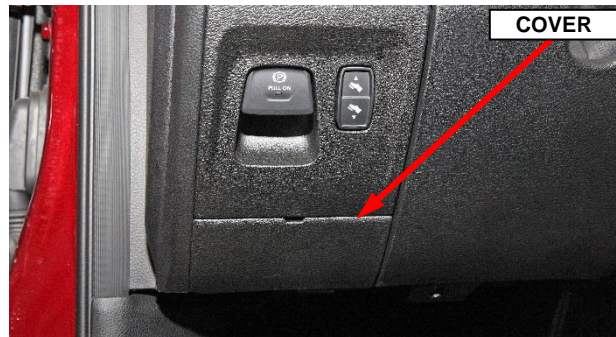
Figure 1 – Park Release Access Cover

2. Using a trim stick or similar tool, remove the manual park release cover, which is located to the lower left of the steering column (Figure 1).

33. Stow the tether strap behind the retaining clip (Figure 2).
34. Verify the transmission is in PARK.
35. Install the manual park release access cover (Figure 1).

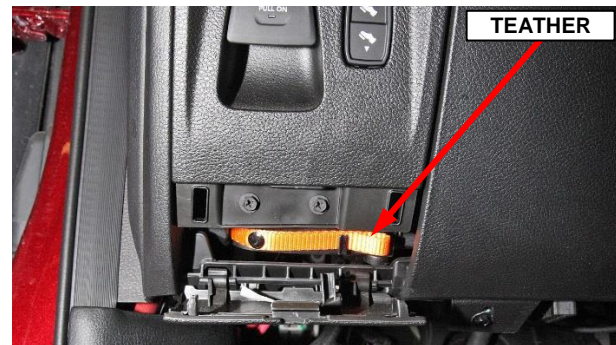
Figure 2 – Park Release Tether

3. Behind the manual park release access cover is the orange tether strap (Figure 2).

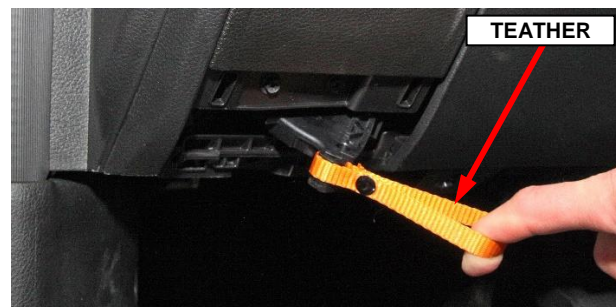
Figure 3 – Pull Park Release Tether

4. Pull the tether strap out as far as it will go, then release it. The tether and lever will remain outside of the trim panel and the transmission will now be in **NEUTRAL** (Figure 3).

30. Apply firm pressure to the brake pedal while seated in the driver's seat.
31. Pull the tether strap outward then release it (Figure 3).
32. Allow the tether to retract with the lever back to its original position. Confirm that the lever is fully retracted.

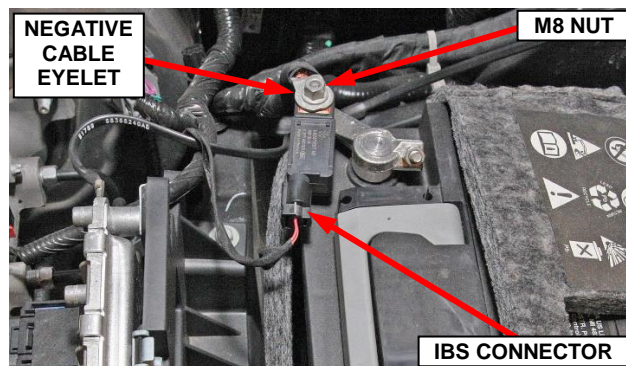
Figure 4 – Battery Negative Post

- Disconnect the Intelligent Battery Sensor (IBS) wire harness connector (Figure 4).

- Remove and **SAVE** the M8 nut from the IBS (Figure 4).

- Remove the battery negative cable eyelet from the IBS stud and isolate the negative battery cable away from the IBS negative cable terminal (Figure 4).

28. Install the negative battery cable eyelet to the IBS M8 stud and secure using the M8 nut (Figure 4). Tighten the M8 nut to 7 N·m (62 in. lbs.).

29. Connect the IBS wire harness connector (Figure 4).

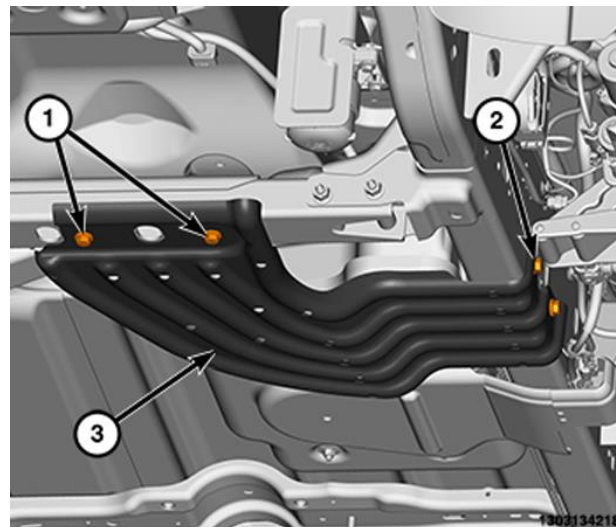
Figure 5 – Transfer Case Skid Plate

- If equipped with a transfer case skid plate. Remove and **SAVE** the bolts (1) and (2) then remove and **SAVE** the skid plate (3) (Figure 5).

26. **If equipped with a transfer case skid plate.** Install the skid plate (3) then install the bolts (1) and (2) (Figure 5). Tighten the bolts to 55 N·m (41 ft. lbs.).

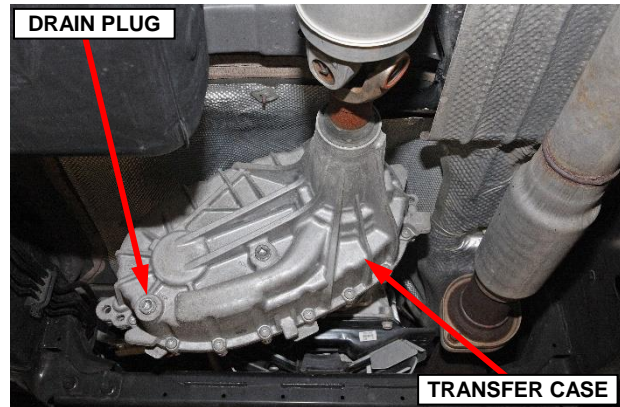
Figure 6 – Transfer Case Drain Plug

11. Place a drain pan under the transfer case then remove and **SAVE** the drain plug. Allow the transfer case to drain while removing drive shafts. Once the transfer case has finished draining, install and tighten the drain plug to 19 N·m (15 ft. lbs.). Transfer case must be drained for core return (Figure 6).

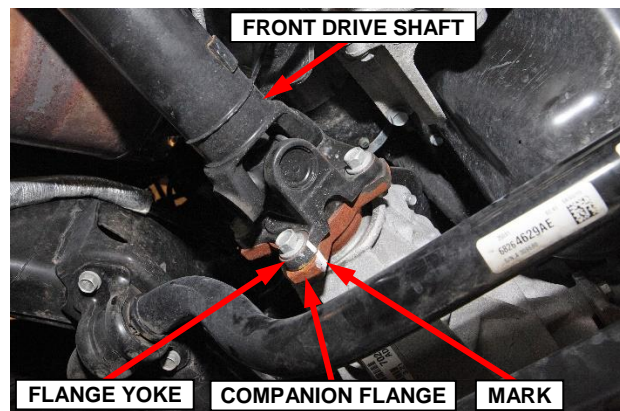
Figure 7 – Mark Front Drive Shaft

12. Mark a line across the front axle companion flange and front drive shaft flange yoke for drive shaft installation reference (Figure 7).

18. Use the mark made earlier to align the front drive shaft flange yoke to the front axle companion flange (Figure 10).

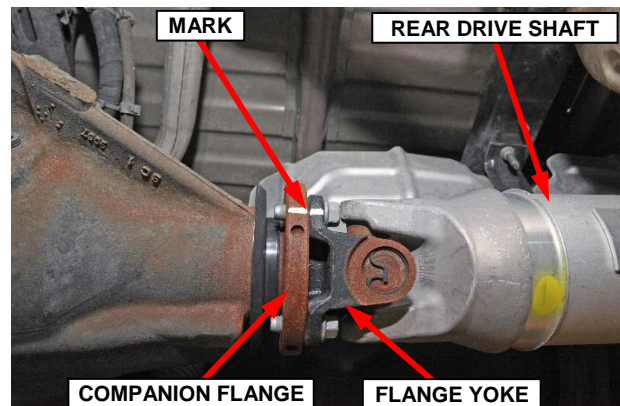
Figure 8 – Mark Rear Drive Shaft

13. Mark a line across the rear axle companion flange and rear drive shaft flange yoke for drive shaft installation reference (Figure 8).

15. Use the mark made earlier to align the rear drive shaft flange yoke to the rear axle companion flange (Figure 12).

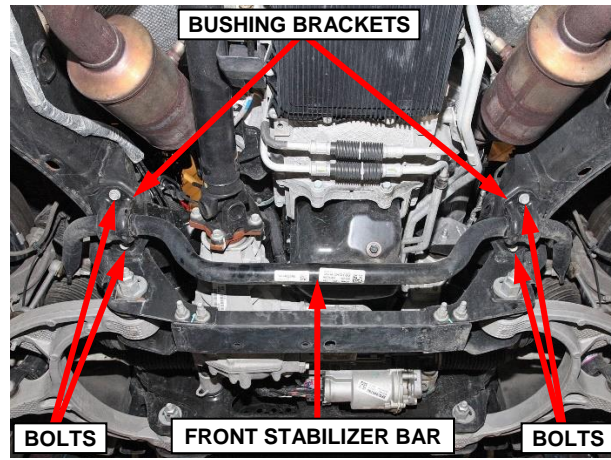
Figure 9 – Front Stabilizer Bar

- Remove the four bolts (two per side) securing the front stabilizer bar bushing brackets. Lower the stabilizer bar with bushings and brackets allowing it to be supported by the stabilizer links (Figure 9).

NOTE: The front stabilizer bar must be lowered for front drive shaft removal and installation clearance.

20. Raise the stabilizer bar into position then install the four bolts (two per side) securing the front stabilizer bar bushing brackets (Figure 9). Tighten the bolts to 45 N·m (33 ft. lbs.).

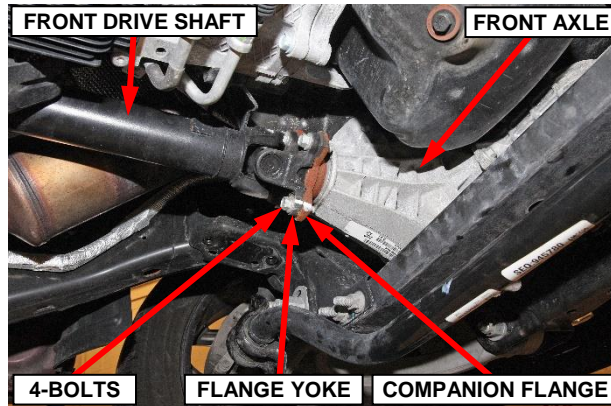
Figure 10 – Front Drive Shaft

- Remove and **DISCARD** the four bolts attaching the front drive shaft flange yoke to the front axle companion flange (Figure 10).

19. Install the four **NEW** bolts attaching the front drive shaft flange yoke to the front axle companion flange (Figure 10). Tighten the bolts to 115 N·m (85 ft. lbs.).

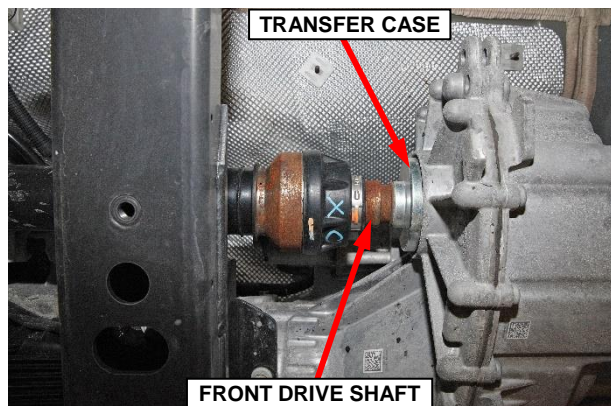
Figure 11 – Front Drive Shaft

- Slide the front drive shaft off the transfer case output shaft spline then remove and **SAVE** the front drive shaft (Figure 11).

17. Slide the front drive shaft onto the transfer case output shaft spline (Figure 11).

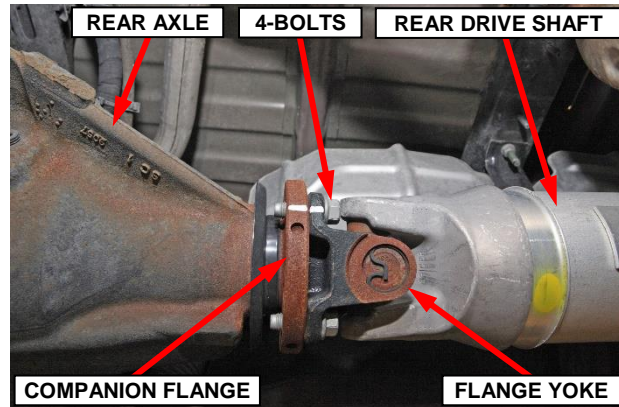
Figure 12 – Rear Drive Shaft

17. Remove and **DISCARD** the four bolts attaching the rear drive shaft flange yoke to the rear axle companion flange (Figure 12).

16. Install the four **NEW** bolts attaching the rear drive shaft flange yoke to the rear axle companion flange (Figure 12). Tighten the bolts to 115 N·m (85 ft. lbs.).

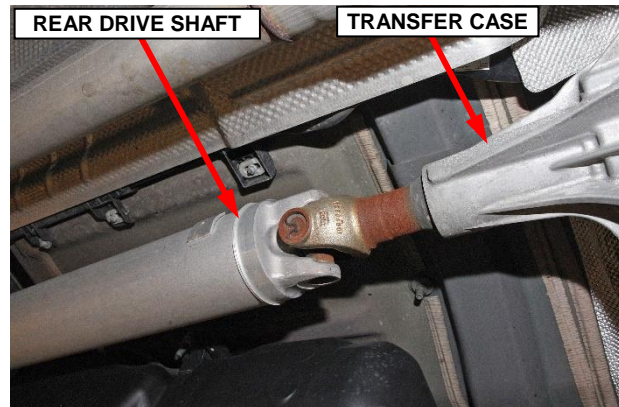
Figure 13 – Rear Drive Shaft

18. Slide the rear drive shaft off the transfer case output shaft spline then remove and **SAVE** the rear drive shaft (Figure 13).

14. Slide the rear drive shaft onto the transfer case output shaft spline (Figure 13).

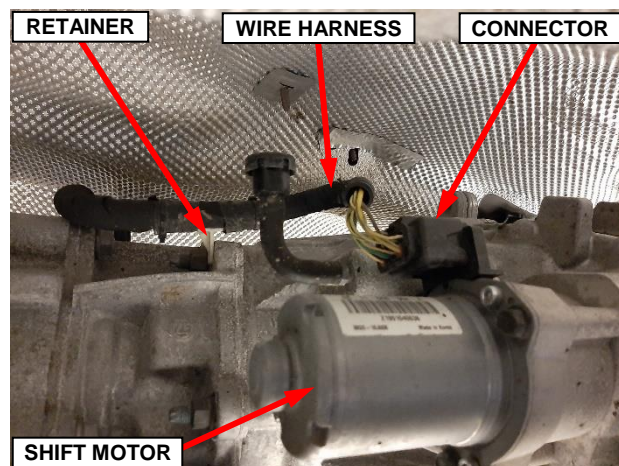
Figure 14 – Transfer Case Shift Motor Wire Harness Connector

19. Disconnect the wire harness connector from the transfer case shift motor and release the wire harness retainer from the transfer case adapter (Figure 14).

12. Connect the wire harness connector to the transfer case shift motor and attach the wire harness retainer to the transfer case adapter (Figure 14).

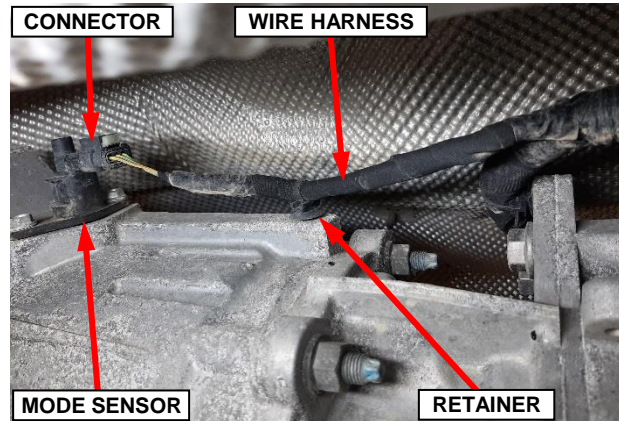
Figure 15 – Transfer Case Shift Mode Sensor Wire Harness Connector

20. Disconnect the wire harness connector from the transfer case mode sensor and release the wire harness retainer from the transfer case (Figure 15).

10. Install the three nuts securing the transmission mount to the crossmember (Figure 16). Tighten the nuts to 25 N·m (18 ft. lbs.).
11. Connect the wire harness connector to the transfer case mode sensor and attach the wire harness retainer to the transfer case (Figure 15).

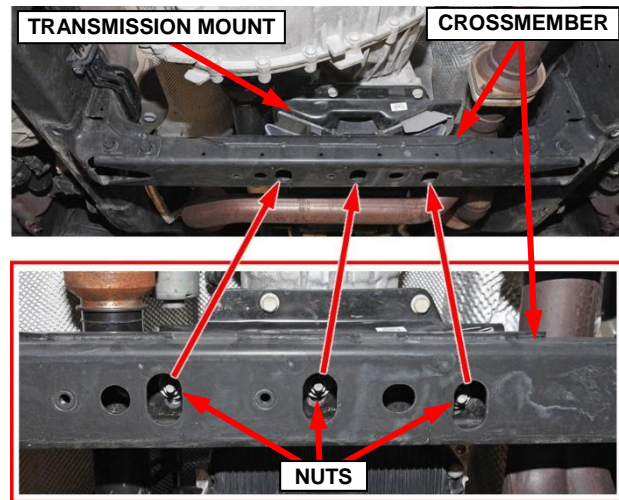
Figure 16 – Transmission Mount Nuts

21. Remove and **SAVE** the three nuts securing the transmission mount to the crossmember (Figure 16).

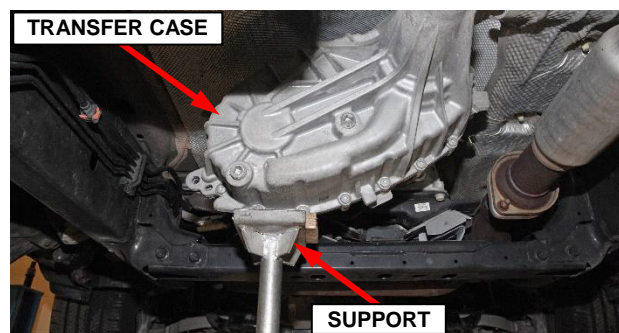
Figure 17 – Support Transfer Case

22. Support the transfer case with a suitable transmission jack or lifting device during crossmember and transmission mount removal (Figure 17).

8. Install the transmission crossmember and the four bolts and nuts (Figure 18). Tighten the bolts to 115 N·m (85 ft. lbs.).
9. Lower the transfer case until fully supported by the transmission crossmember then remove the transmission jack or lifting device (Figure 17).

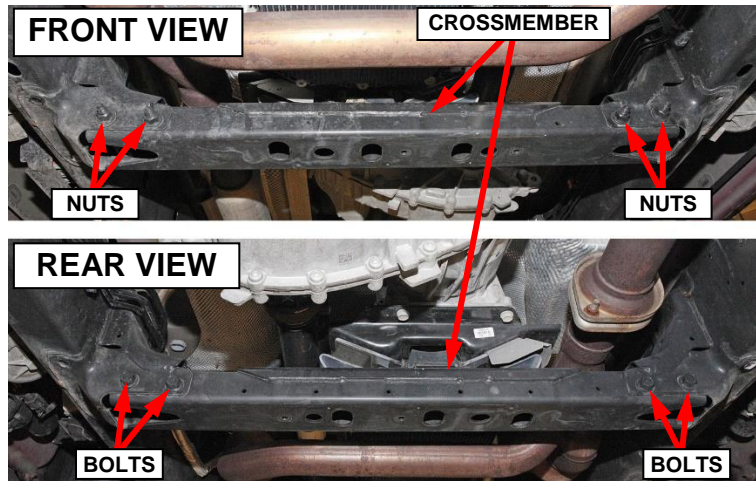
Figure 18 – Transmission Crossmember

23. Remove and **SAVE** the four nuts and bolts then remove and **SAVE** the crossmember (Figure 18).

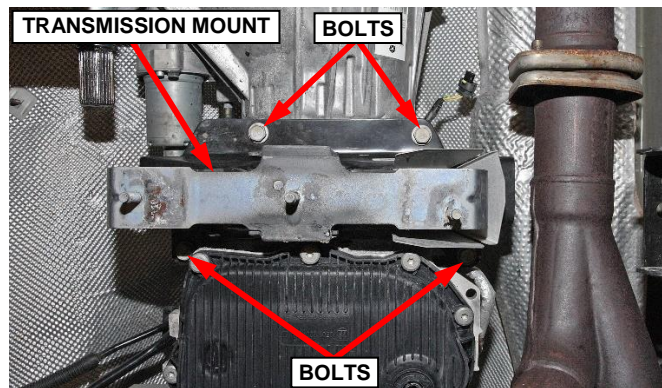
Figure 19 – Transmission Mount

24. Remove and **SAVE** the four bolts then remove and **SAVE** the transmission mount (Figure 19).

6. Install the transmission mount bracket and the two bolts then tighten the bolts to 64 N·m (47 ft. lbs.) (Figure 20).
7. Install the transmission mount and the four bolts then tighten the bolts to 64 N·m (47 ft. lbs.) (Figure 19).

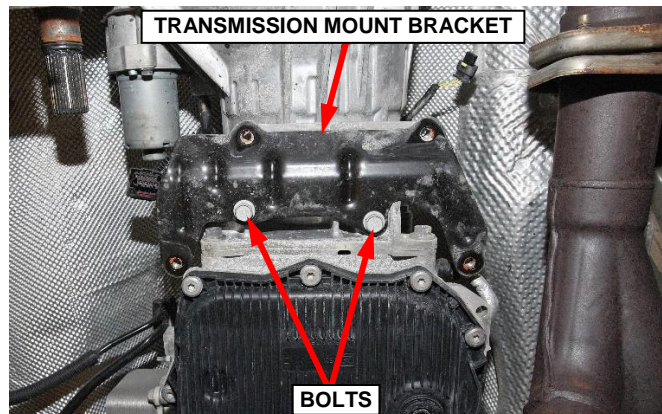
Figure 20 – Transmission Mount Bracket

25. Remove and **SAVE** the two bolts then remove and **SAVE** the transmission mount bracket (Figure 20).

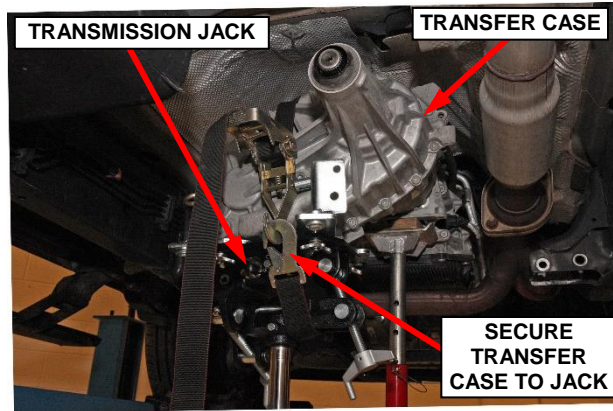
Figure 21 – Support and Secure Transfer Case

- 26. Support the transfer case with a suitable transmission jack (Figure 21).
- 27. Secure the transfer case to the jack with chains or straps (Figure 21).
- 28. Remove and **SAVE** the six nuts securing the transfer case to the transmission (Figure 22).

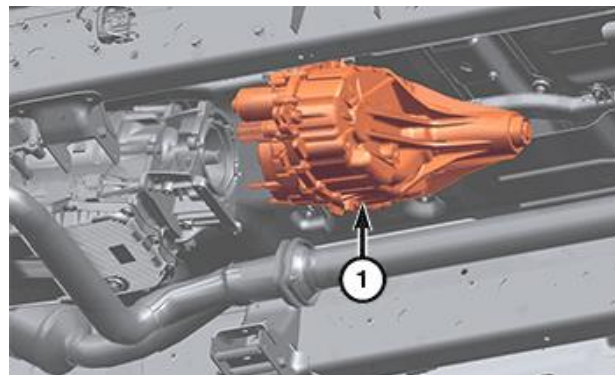
Figure 23 – Transfer Case

- 29. Remove the transfer case (1) from the transmission (Figure 23).

4. Install the **NEW** transfer case (1) to the transmission (Figure 23).
5. Install the six nuts securing the transfer case to the transmission. Tighten the nuts to 41 N·m (30 ft. lbs.) (Figure 22).

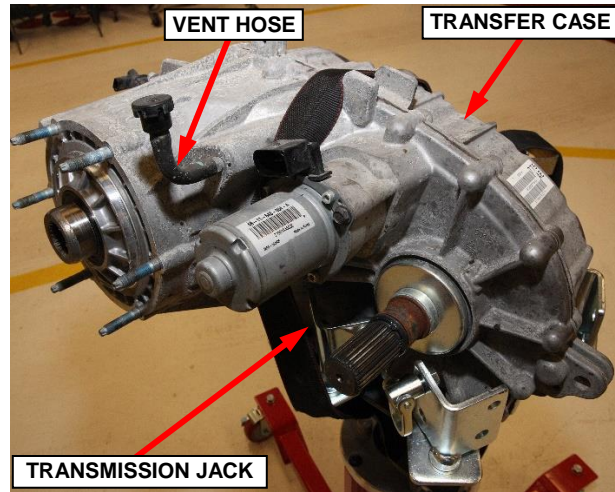
Figure 24 – Transfer Case Vent Hose

30. Remove and **SAVE** the vent hose from the transfer case (Figure 24).
31. Remove the transfer case from the transmission jack.

2. Secure the **NEW** transfer case onto the transmission jack to prepare for installation (Figure 24).
3. Install the vent hose onto the **NEW** transfer case (Figure 24).

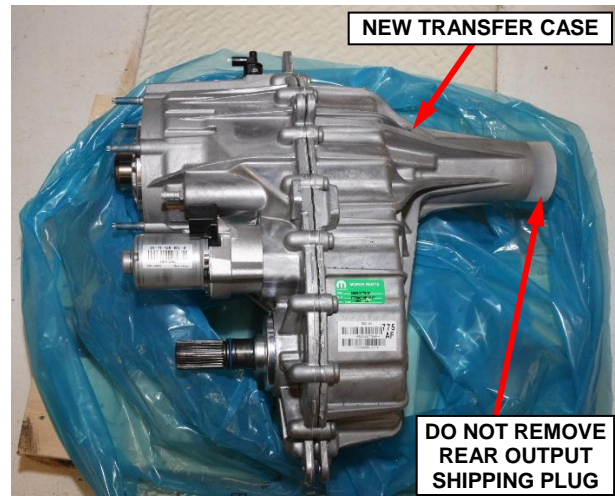
Figure 25 – NEW Transfer Case

1. Uncrate the **NEW** transfer case and save the shipping materials for return of the old transfer case for core deposit (Figure 25).

NOTE: The NEW transfer case comes prefilled with lubricant. Do NOT remove the rear output shipping plug until transfer case is installed in the vehicle and rear drive shaft is ready to be installed. Removal of shipping plug now may result in fluid loss during transfer case installation.

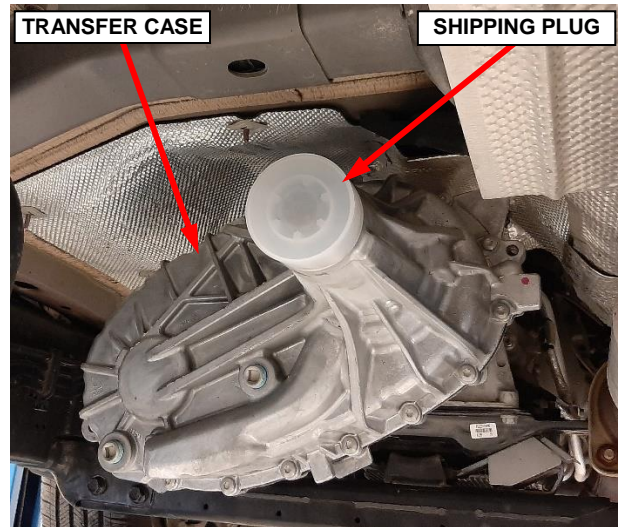
Figure 26 – Remove Shipping Plug

13. Remove the shipping plug from the rear output of the transfer case. Transfer the shipping plug to the old transfer case for core return (Figure 26).

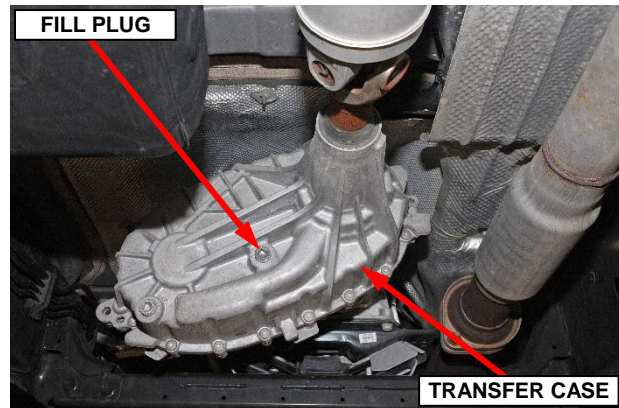
Figure 27 – Transfer Case Fill Plug

22. Remove the transfer case fill plug. Transfer case should be filled to the bottom edge of the fill plug opening (Figure 27).

23. If necessary, fill the transfer case to the bottom edge of the fill plug opening with T-Case BorgWarner lubricant, MOPAR part number 68049954AC (Figure 27).

24. Install the transfer case fill plug and tighten to 19 N·m (15 ft. lbs.) (Figure 27).
