Safety Recall

Code: 69AJ

Subject	Side Curtain Airbag(s)															
Release Date	March 11, 2020															
Affected Vehicles

Section B – Replacing Head Curtain Airbag(s)

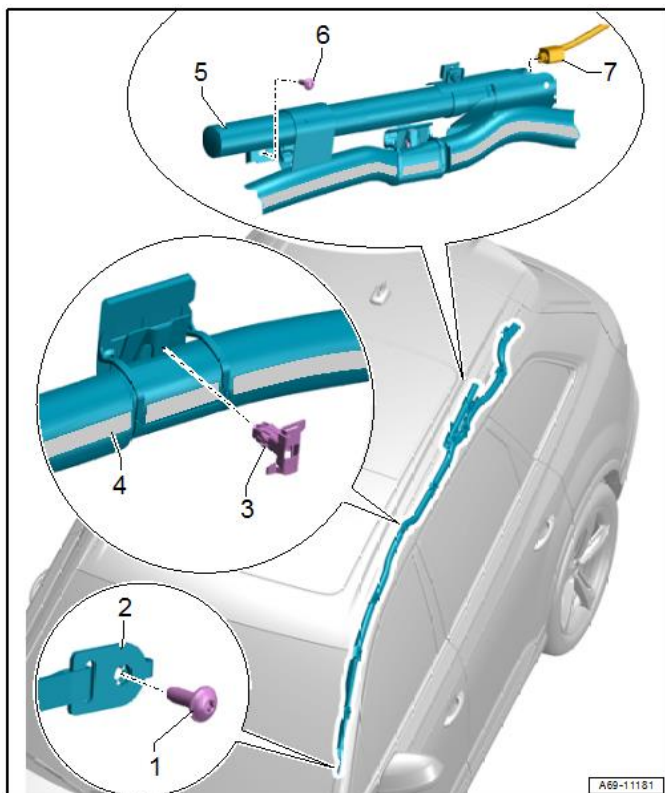
Replacing head curtain airbag(s):

- Bolt <1> requires replacement.

- Bolt <6> is pre-installed on the new head curtain airbag.

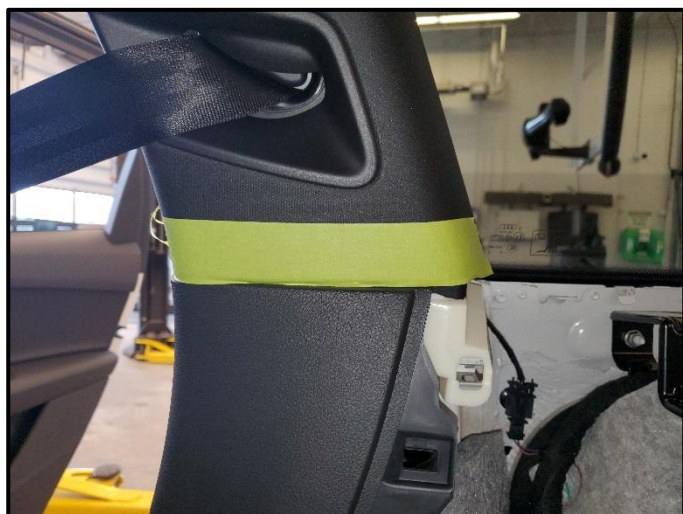
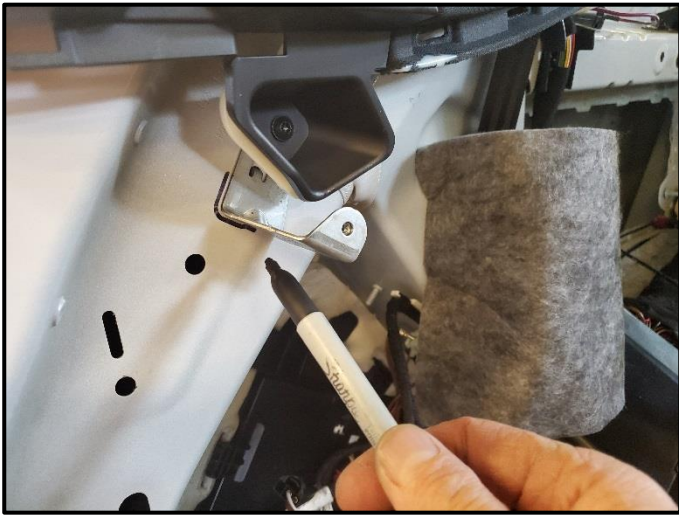
- Tape off trim panels prior to removal to avoid damaging the panels.

- When removing the left side luggage compartment trim, mark the position of the bracket for the switch assembly (if equipped) to ensure proper positioning during reinstallation.

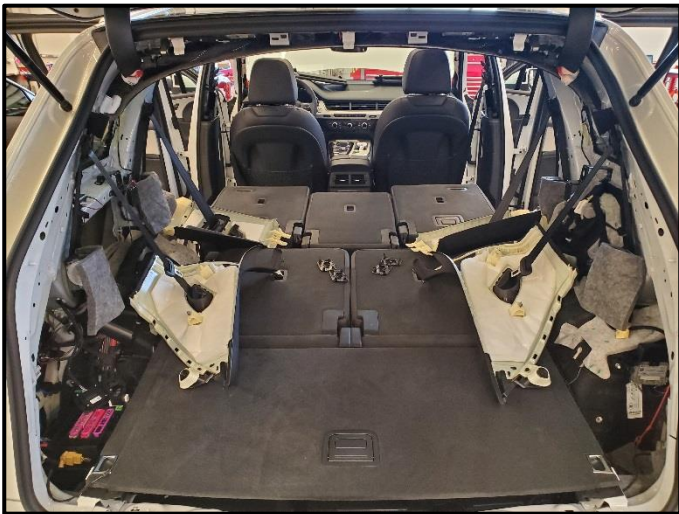
- The seat belts do not require removal during this repair so the pillar trims can remain in the vehicle.

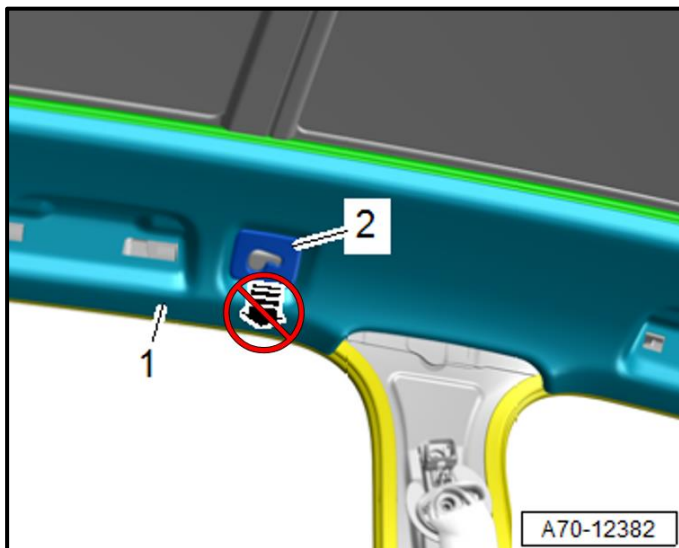
- The screen separator trim <2> does not have to be removed from the headliner <1> during this repair.

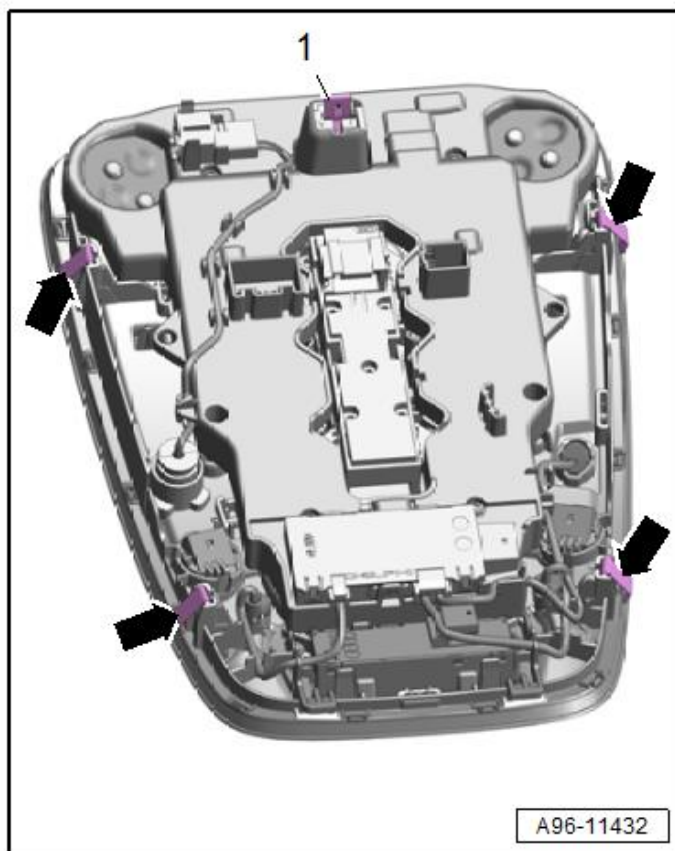
The roof module can be unclipped from the headliner after the headliner is lowered slightly. Doing this will allow for easier access to clips <arrows>.

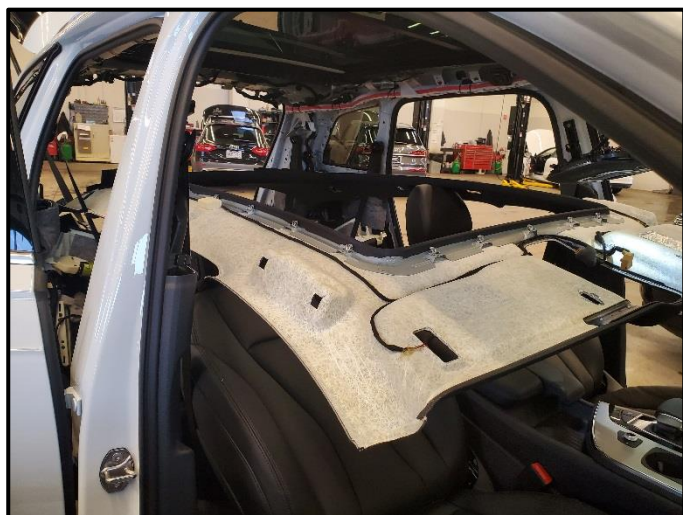
- Carefully rest the headliner on the seat headrests.

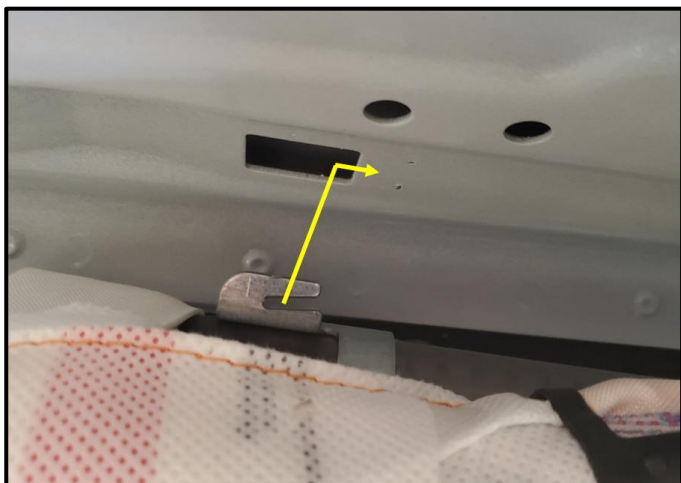
- When installing the new head curtain airbags, ensure the “hook” on the airbag engages onto the body correctly.

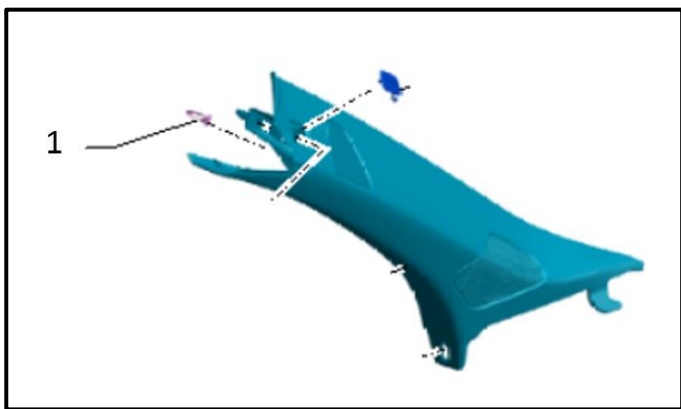
- Replace the A-pillar trim clamps <1>.

Part Number	Part Description
8Z0-867-276	A-pillar clamp

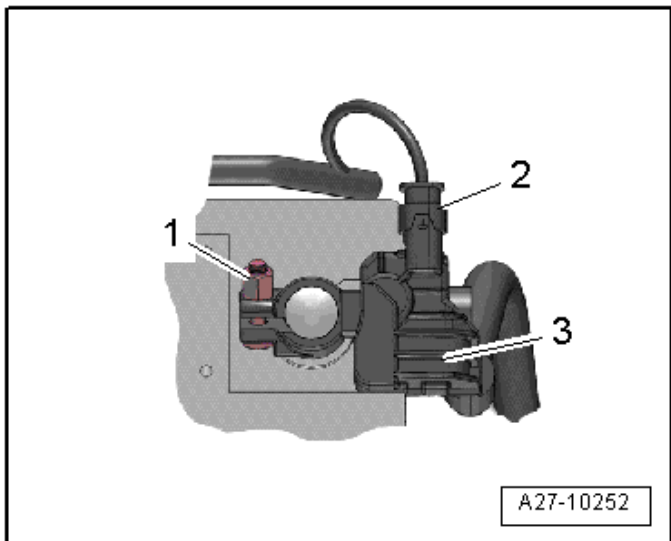
- When reconnecting the battery:
 - Disconnect the connector <2> from the Battery Monitoring Control Module -J367- <3>.
 - Attach the battery ground cable clamp by hand to the battery negative terminal and torque the nut <1> to 6 Nm.
 - Reconnect the connector to the Battery Monitoring Control Module - J367-.
