RECALL

R20AM Seat Barrier Install Behind Driver Seat Integrated 3-Point Seatbelt

Models Affected: 2008 through 2021 Model Year All American and Vision Buses

Issue: Certain buses may fail to conform to the Federal Motor Vehicle Safety Standard Number 222 "School Bus Passenger Seating and Crash Protection" requirements for the seat barrier behind the driver seat with integrated 3-point seat belt. The LH front passenger seat barrier may be incorrect and under floor mounting bracket may be incorrect or missing.

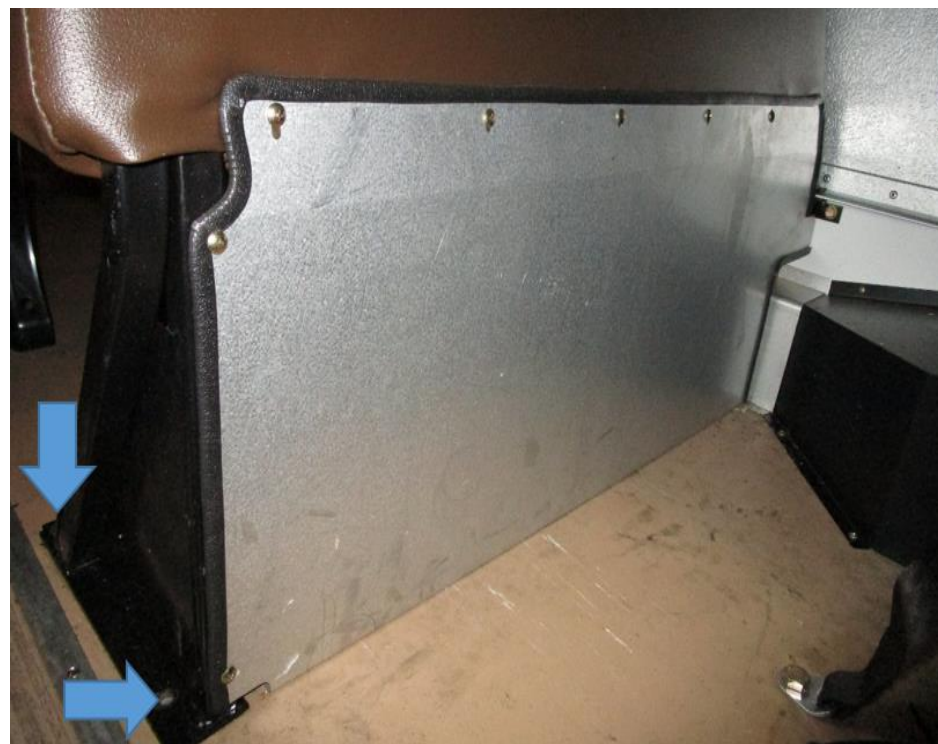
Photo 2

1. Remove and retain the two fasteners that secure the barrier leg to the floor. See photo (2)
2. If a modesty panel is installed, remove and retain all the fasteners that secure it to floor barrier and gusset. See photo (2)

1. Remove the two bolts that secure the barrier leg to the floor. See Photo (2)
2. Place the inside and outside reinforcement brackets into the proper location using the existing holes for the barrier leg, as referenced.
3. Secure the inside and outside reinforcement brackets into place using the 1/2-13 X 1 1/2, GR8, bolts included in the kit, (Torque to 70 ft/lbs.) See Photo (6) OR (7) DEPENDING ON YOUR VEHICLE
4. Once both reinforcement brackets are in place back drill the barrier leg holes using a 11/32" drill bit. (Under floor brackets must be located correctly, when back drilled for barrier bolts to go into them).
5. Install the barrier leg 5/16 bolts and nuts included in the kit and torque to 12-15 ft./lbs.

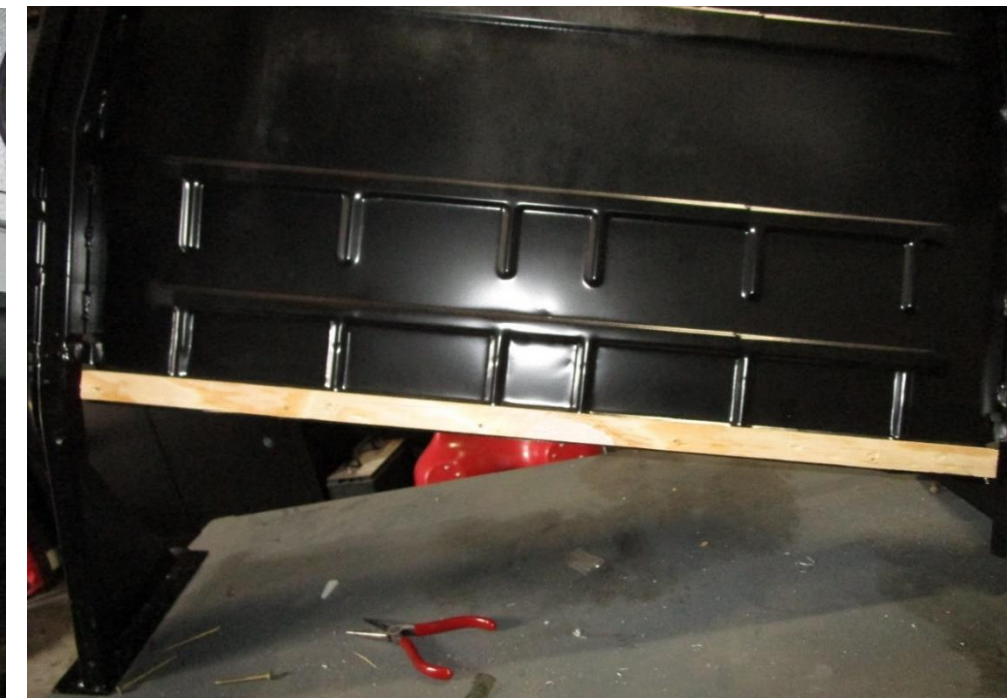
Photo 3

8. Once all the staples are removed from the barrier cover, remove the barrier cover and padding from the barrier frame.
9. Remove the tack strip from the barrier frame by removing the staples on the opposing side of the barrier frame. Photo (3)

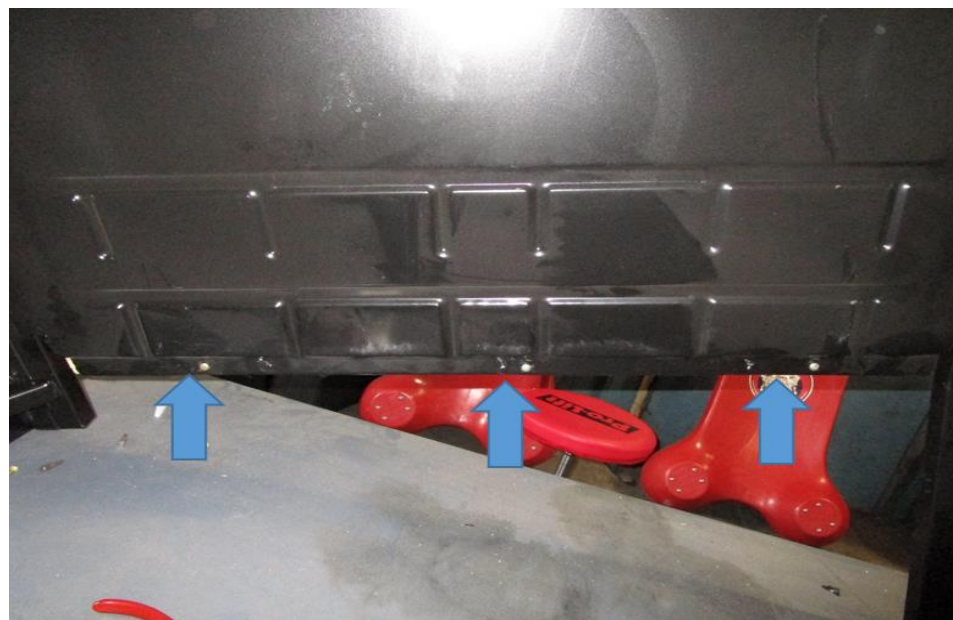
Photo 4

1. Using 7/32" drill bit, back drill three holes in the reinforced barrier frame where the tack strip is to be mounted. See Photo (4)
2. Place the tack strip into place on the barrier frame.

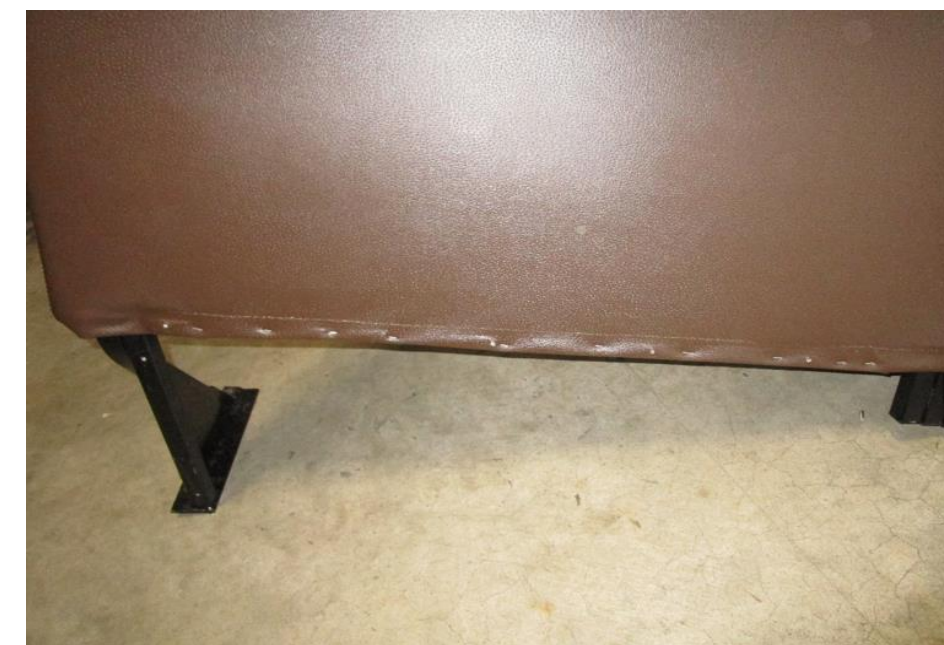
Photo 5

5. Pull the bottom rear of the barrier cover around to the tack strip and staple the cover to the tack strip.
6. Pull the front of the cover down to the tack strip and staple the cover to the tack strip. **Note:** Keep the staple line towards the bottom of the tack strip so that the staples will be covered by the barrier trim or modesty panel. See Photo (5)
