SOP02650 QAAR 9643 Add Protection to 12V Wire Routed Through Roof A/C Frame Tubing

Department: 32
 People Required: 1
 Time to Complete: 10min
 Date Created: Mar. 2, 2020
 Date Revised: Rev #:
 Created by Initial: GK Verified: HF

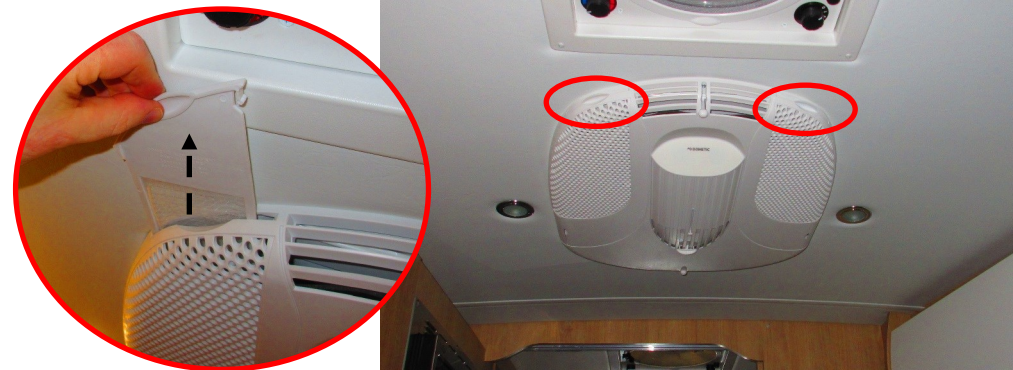
1

Make sure coach is not plugged in and AGS is disconnected so the air conditioner won't start.

You will need two lengths of 1/4" split tubing and a Phillips bit screw driver. (Do not use a power drill as some of the screws may strip.)

Remove each of the screens and set aside.
