Safety Recall

Code: 27H2

Subject Starter Generator

Release Date May 19, 2020

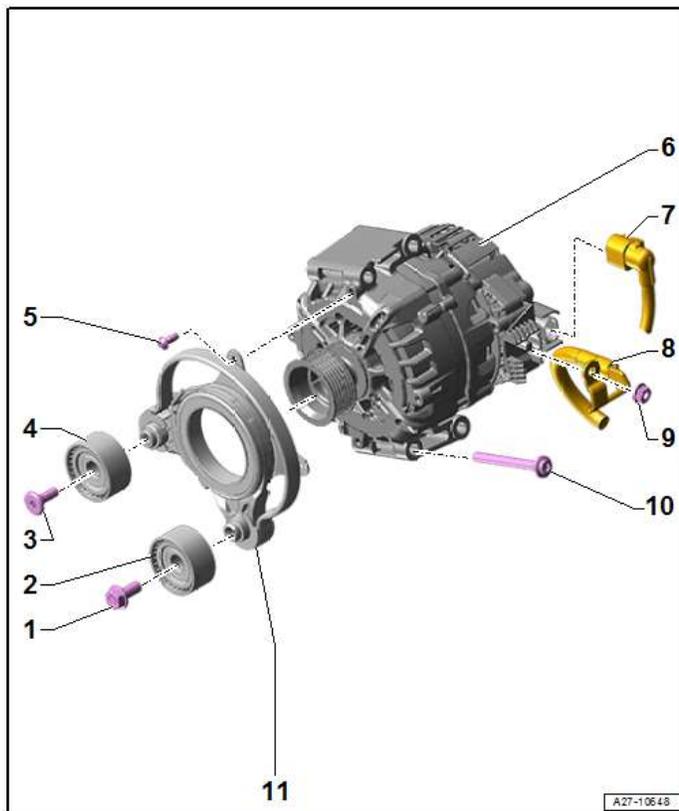
Repair Overview

- Replace starter generator.

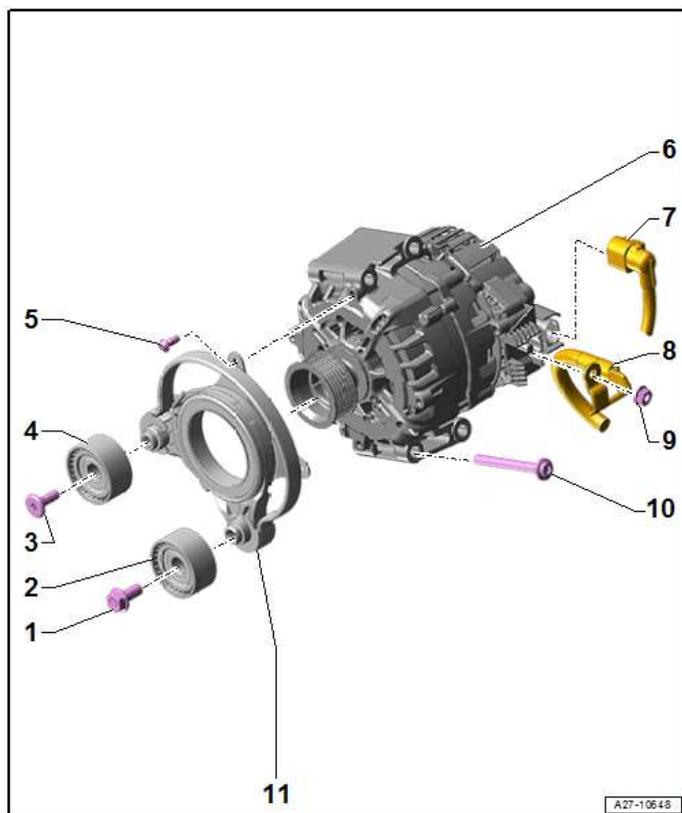
Section B – Repair Procedure

- Disconnect the battery with ignition switched off:
 - See ELSA Repair Manual: *Repair manual > Electrical System > Electrical Equipment > 27 Battery, Starter, Generator, Cruise Control > Battery > Battery, Disconnecting and Connecting > Battery, Disconnecting and Connecting*
- Remove ribbed belt from starter generator pulley:
 - See ELSA Repair Manual: *Repair manual > Engine > Servicing – 4-Cylinder 2.0L 4V TFSI Engine (EA 888 Generation III) > 13 Crankshaft, Cylinder Block > Cylinder Block, Belt Pulley Side > Ribbed Belt, Removing and Installing*
- Replace starter generator <6>:
 - See ELSA Repair Manual: *Repair manual > Electrical System > Electrical Equipment > 27 Battery, Starter, Generator, Cruise Control > Generator > Generator, Removing and Installing > Starter Generator C29, Removing and Installing, Vehicles with 2.0L TFSI Engine (0K4)*
 - Replace bolts <5> and <10>.

Part Number	Part Position
N -910-968-01	5
N -107-655-01	10
