IMPORTANT SAFETY RECALL NOTICE 18E-109

NHTSA ID: 18E109

PRODUCT BULLETIN – IDENTIFYING MOUNTING WASHER

PRODUCT BULLETIN – REPLACING MOUNTING WASHER

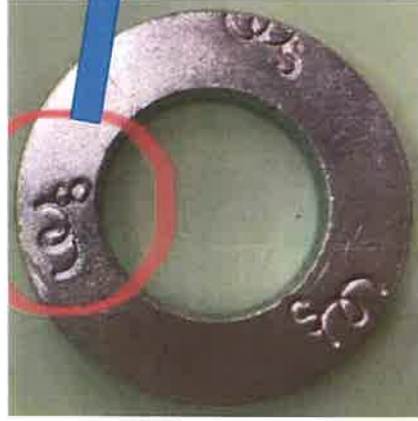
1. Mounting Flat Washer with stamped logos (as pictured) may have compromised material properties. TSE recommends replacing the washer. Washers can be obtained from TSE free of charge.
2. Washers without logos are not affected and can be used normally.
3. Please reference TSE Brakes TSB#2019-001 for the proper procedure to replace washers.

Identifying Logo
