Dealer Service Instructions for:

## **Safety Recall W22 / NHTSA 20V-183 Front Axle Differential**

**2019 (WK) Jeep® Grand Cherokee**

**2019 (WD) Dodge Durango**

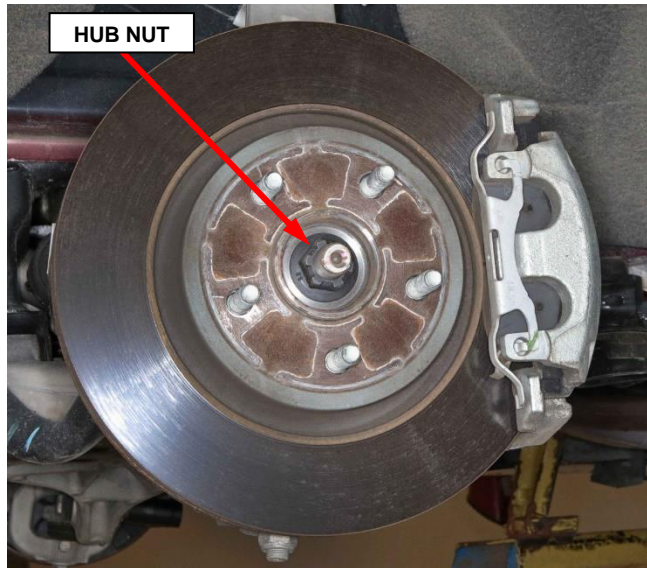
Figure 1 – Front Hub Nut

4. Remove the hub nut from the halfshaft and **discard**. The used hub nut is not reusable (Figure 1).

22. Install the **NEW** hub nut to the halfshaft. Tighten the nut to 310 N·m (229 ft. lbs.) (Figure 1).

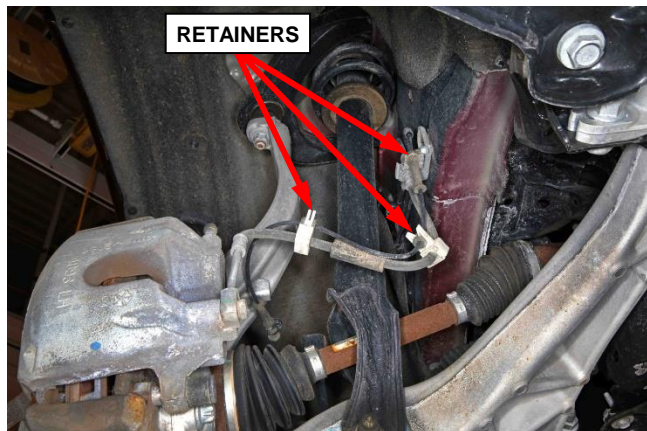
Figure 2 – Wheel Speed Sensor Wire Harness Retainers

5. Release the wheel speed sensor wire harness from the retainers along the brake hose (Figure 2).

17. Remove the support from under the lower control arm.
18. Position the tie rod ends into the steering knuckle then install the **NEW** nut securing the tie rod end. Tighten the nut to 95 N·m (70 ft. lbs.) (Figure 5).
19. Install the brake caliper and adaptor bracket assembly into position on the brake rotor and steering knuckle. Ensure the brake hose is properly routed and not twisted (Figure 3).
20. Install the bolts securing the brake caliper adaptor bracket to the steering knuckle. Tighten the bolts to 170 N·m (125 ft. lbs.) (Figure 3).
21. Install the wheel speed sensor wire harness to the retainers along the brake hose (Figure 2).

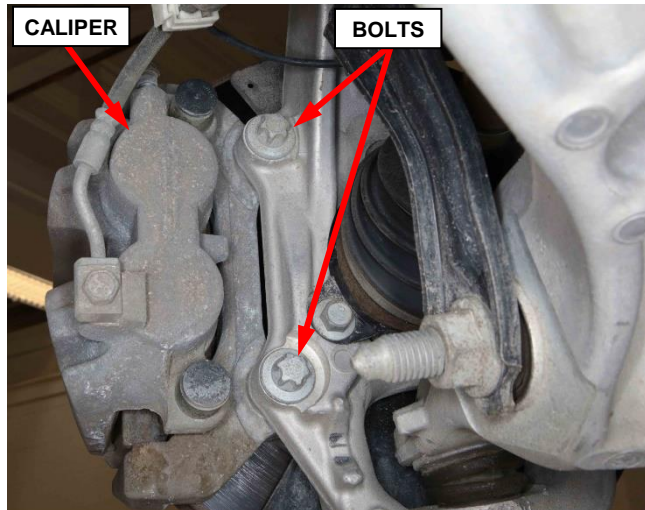
**Figure 3 – Brake Caliper Adaptor Bolts**

6. Remove and **SAVE** the bolts (1) securing the brake caliper adaptor bracket to the steering knuckle (Figure 3).

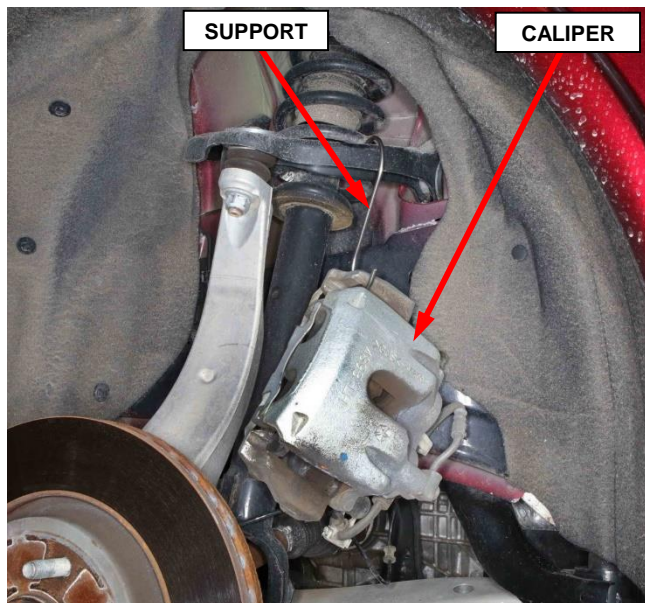
**Figure 4 – Support Brake Caliper**

7. Remove and support the brake caliper and bracket assemblies. Do **NOT** allow the brake caliper to hang by the brake hose (Figure 4).

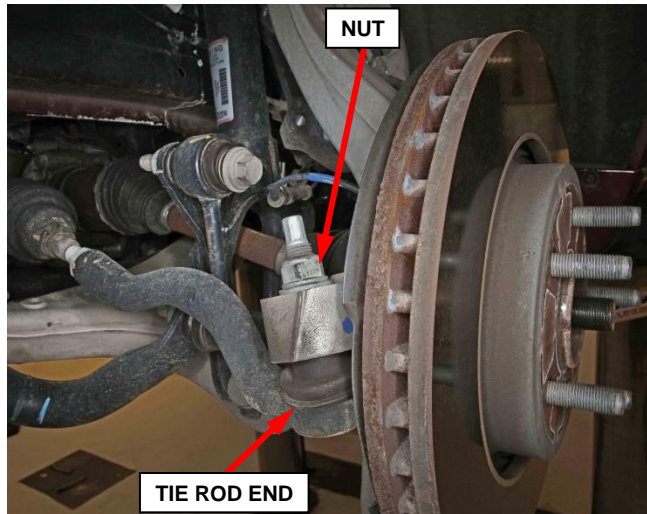
**Figure 5 – Outer Tie Rod End Nut**

8. Remove and **DISCARD** the tie rod nuts (1) (Figure 5).

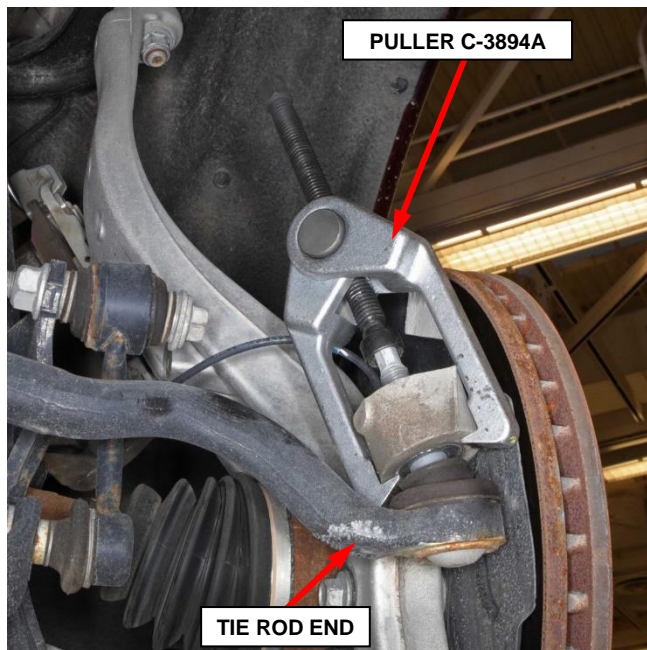
**Figure 6 – Separate Outer Tie Rod End**

9. Using Tie Rod Puller C-3894A, separate the tie rod ends from the steering knuckles (Figure 6).

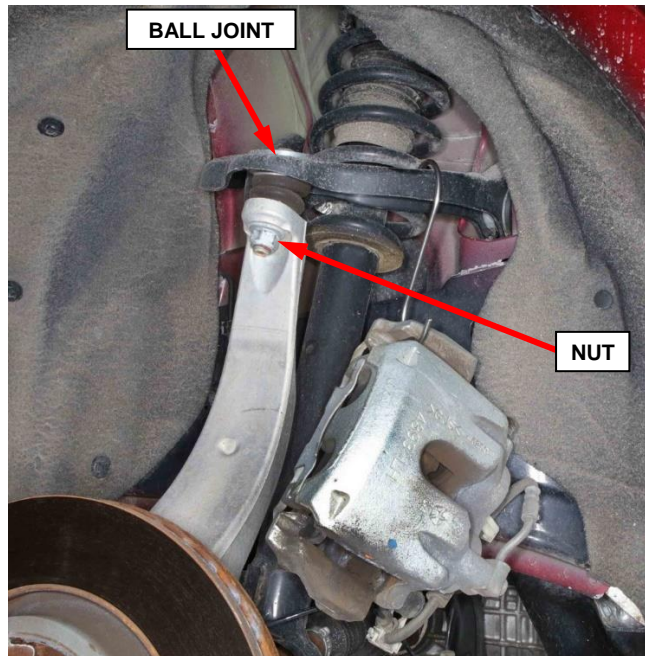
**Figure 7 – Upper Ball Joint Nut**

10. Remove and **DISCARD** the upper ball joint nuts (Figure 7).

14. Raise and support the lower control arm in order to insert the **NEW** bolt through the front strut clevis bracket and the lower control arm (Figure 19).
15. Install the **NEW** nut to the strut clevis bracket bolt, then raise the lower control arm to vehicle ride height before tightening the strut clevis bracket nut to 255 N·m (188 ft. lbs.) (Figure 9).
16. Position the upper control arm ball joint into the steering knuckle then install the **NEW** nut securing the ball joint. Tighten the nut to 165 N·m (122 ft. lbs.) (Figure 7).

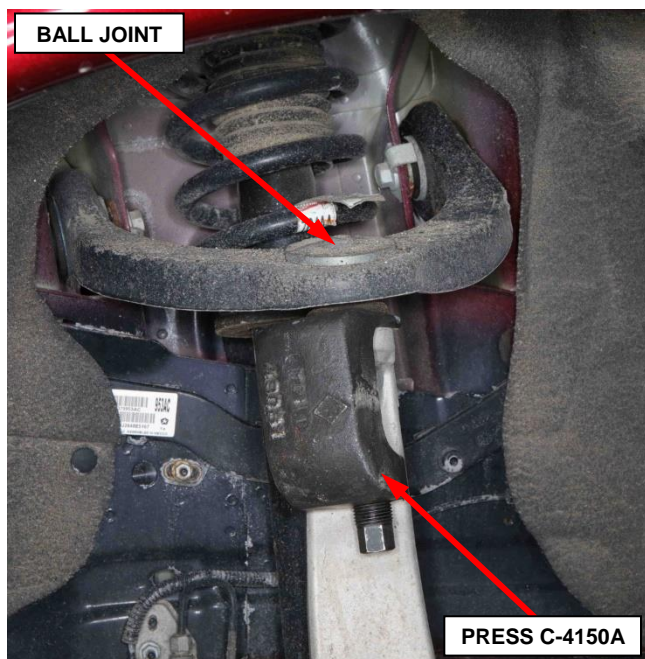
**Figure 8 – Separate Upper Ball Joint**

11. Using Ball Joint Press C-4150A, separate the ball joints from the steering knuckles (Figure 8).

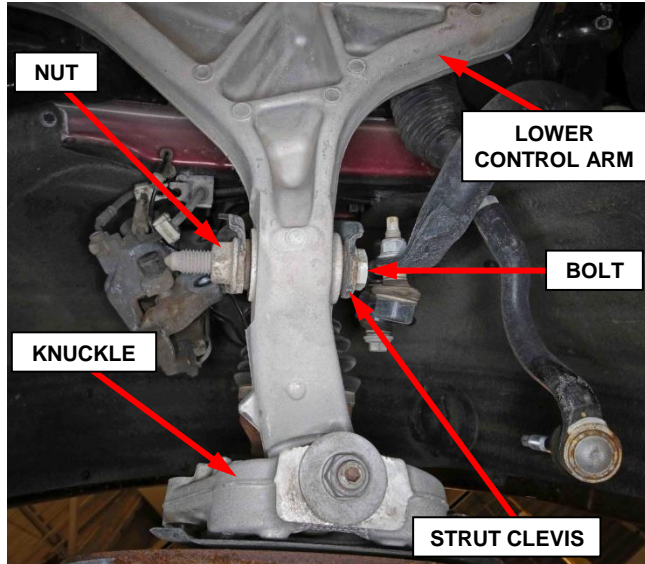
**Figure 9 – Front Strut Clevis Bolt and Nut**

12. Remove and **DISCARD** the front strut clevis bolt and nut (Figure 9).

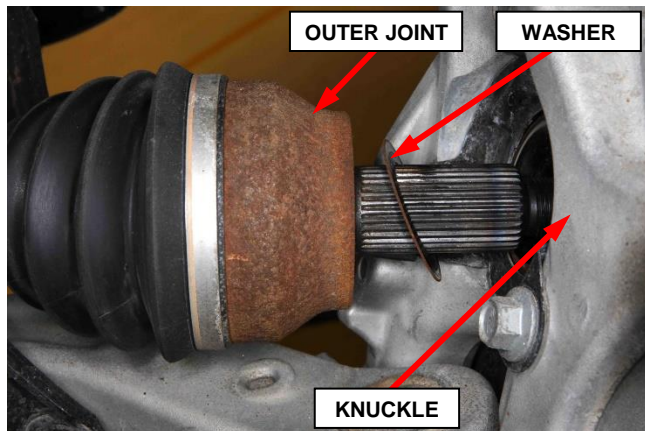
**Figure 10 – Outer Half Shaft Joint**

13. While positioning the steering knuckle down and away, separate the outer half shaft joint from the hub (Figure 10).

14. Remove and **DISCARD** the washer from between the outer half shaft joint and hub (Figure 10).

- If equipped:** Install the skid plate to the front suspension cradle. Tighten the fasteners to 28 N·m (21 ft. lbs.) (Figure 11).
- Lower the vehicle slightly to an appropriate working height.
- Install **NEW** washers between the outer half shaft joint and hub (Figure 10).
- While positioning the steering knuckle down and away, insert the outer half shaft joint into the hub (Figure 10).

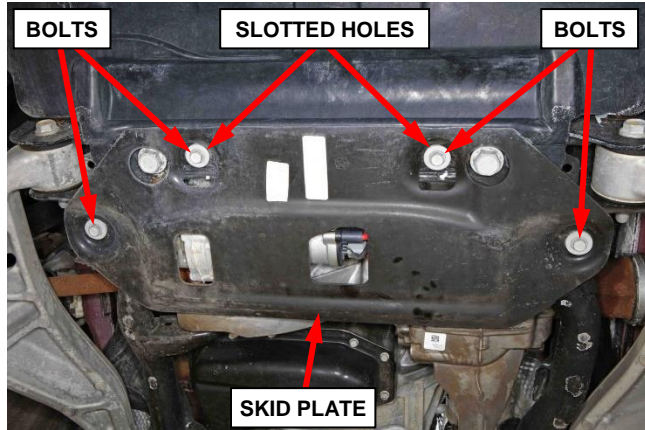
**Figure 11 – Suspension Skid Plate**

16. **If equipped:** Remove and **SAVE** the bolts and skid plate from the front suspension cradle (Figure 11).

**NOTE:** The skid plate forward two holes are slotted, it is not necessary to fully remove the forward bolts. Only the rearward bolts must be fully removed.

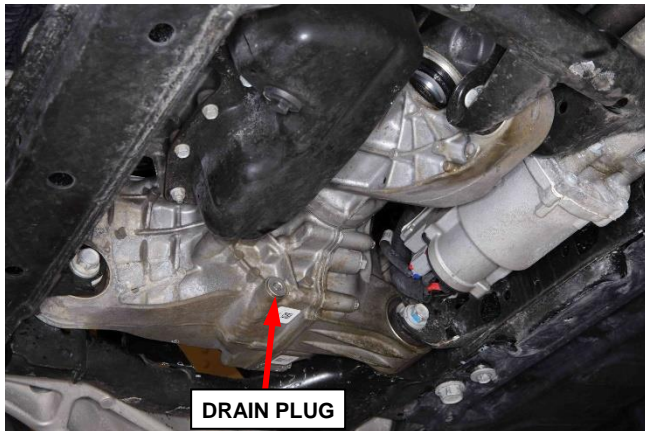
**Figure 12 – Drain Lubricant**

17. Drain and properly dispose of the front axle differential lubricant (Figure 12).

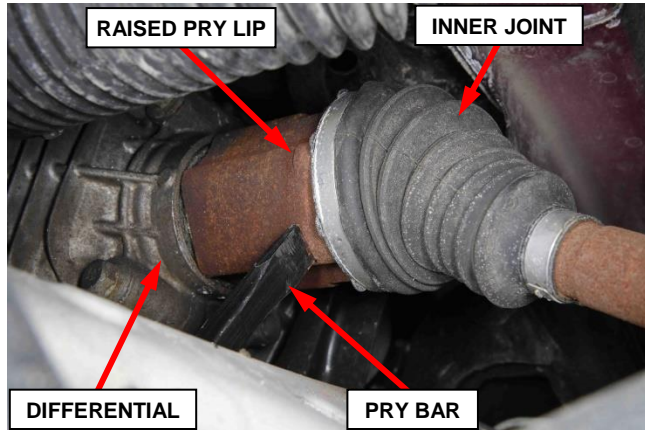
**Figure 13 – Inner Half Shaft Joint**

- Using a pry bar, separate the inner half shaft joints from the front differential (Figure 13).

**NOTE:** It is not necessary to completely remove the half shafts from the vehicle, as long as they are fully disengaged from the front differential.

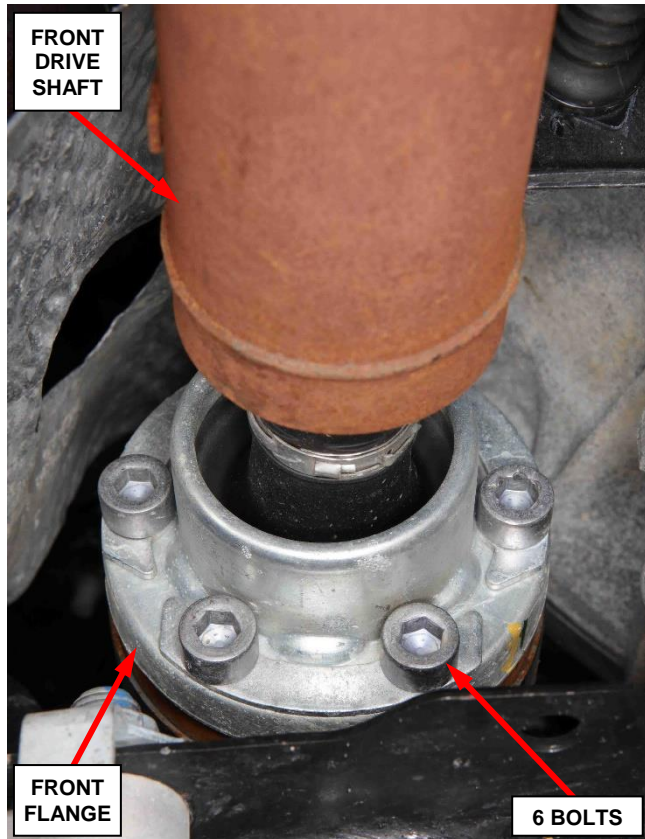
**Figure 14 – Front Drive Shaft Joint**

- Remove and **DISCARD** the six bolts securing the front drive shaft joint flange to the front differential pinion flange (Figure 14).

- Separate the front drive shaft joint flange from the front differential pinion flange (Figure 14).

3. Install **NEW** fasteners that secure the front differential to the suspension cradle. Tighten the fasteners to:
  - Bolts M12: 118 N·m (87 ft. lbs.) (Figure 15).
  - Bolt and Nut M10: 61 N·m (45 ft. lbs.) (Figure 15).
4. Remove the transmission jack.
5. Ensure vent hose orientation is correct, facing upward (Figure 16).
6. Install the front drive shaft joint flange to the front differential pinion flange (Figure 14).
7. Install **NEW** fasteners securing the front drive shaft joint to the front differential pinion flange. Tighten the fasteners to 55 N·m (41 ft. lbs.) (Figure 14).
8. Remove the shipping plugs from the **NEW** front differential (Figure 17).

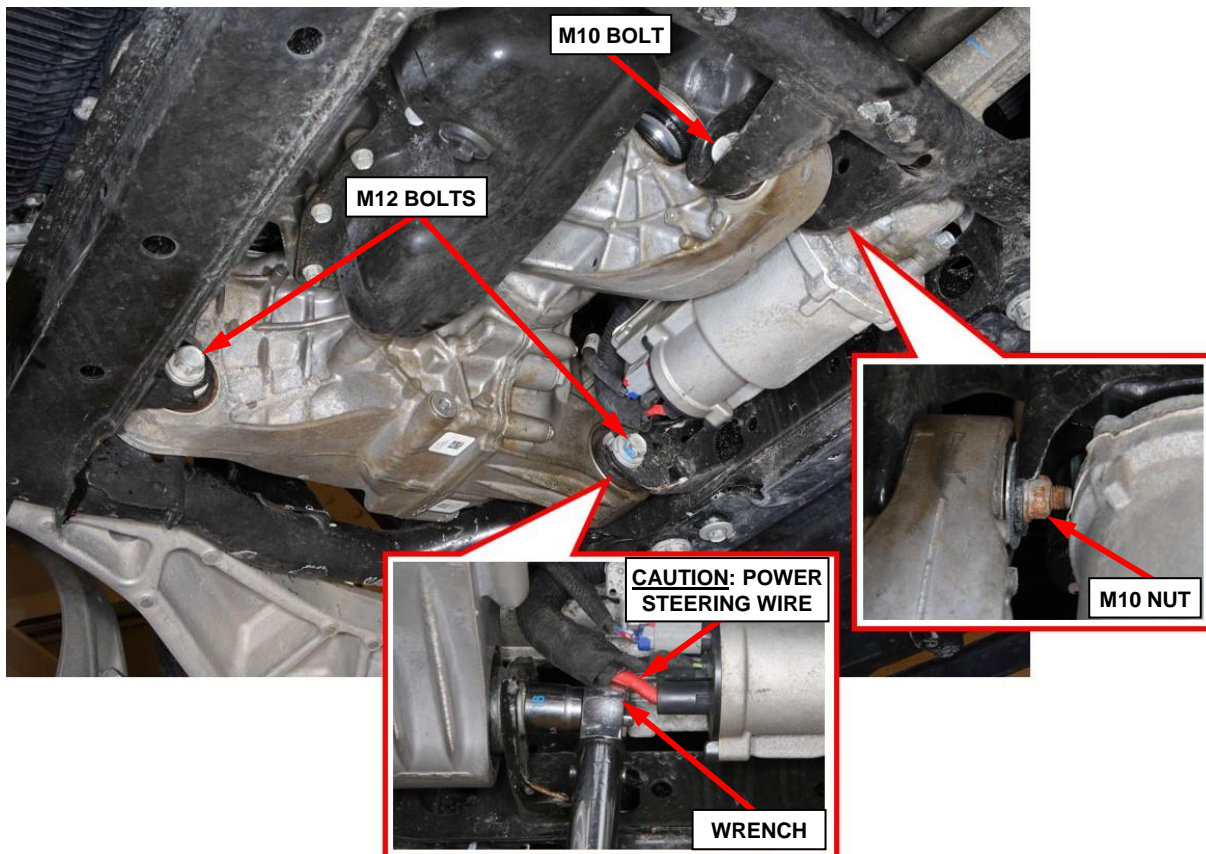
**Figure 15 – Differential Fasteners**

21. Support and secure the front differential on a suitable transmission jack.
22. Remove and **DISCARD** the nut and three bolts securing the front differential to the suspension cradle (Figure 15).

**CAUTION:** Take care to not damage the power steering gear electrical wire insulation during front differential bushing bolt removal.

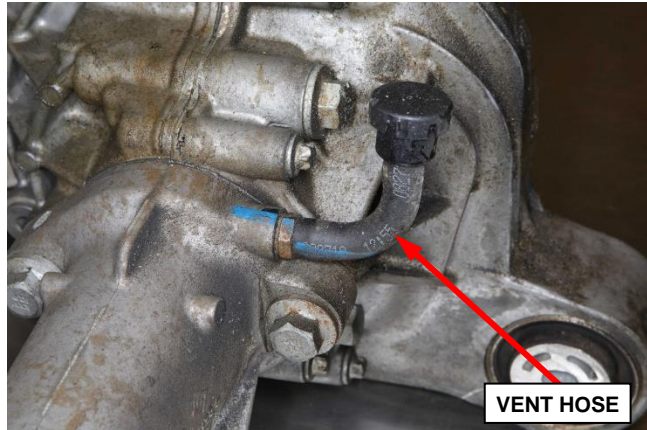
**Figure 16 – Differential Vent Hose**

**CAUTION:** During front differential removal, do not tilt the front differential too much toward the vent hose or the vent internal filter may saturate with differential lubricant rendering it inoperable. If that happens, the vent will require replacement (Figure 16).

24. Remove and **SAVE** the vent hose from the **OLD** front differential (Figure 16).
25. Remove the **OLD** front differential from the transmission jack and secure the **NEW** front differential on the transmission jack.

1. Install the vent hose to the **NEW** front differential (Figure 16).
2. Using the transmission jack, raise and position the **NEW** front differential into the vehicle.

**CAUTION: During front differential installation, do not tilt the front differential too much toward the vent hose or the vent internal filter may saturate with differential lubricant rendering it inoperable. If that happens, the vent will require replacement (Figure 16).**

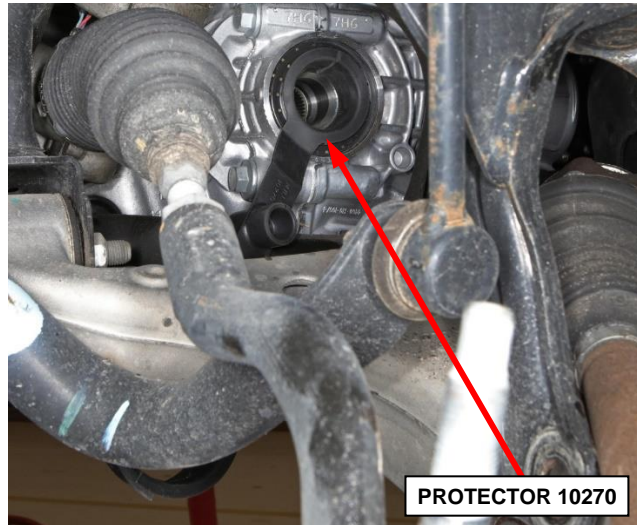
**Figure 18 – Half Shaft Seal Protector**

- Using Half Shaft Protector 10270, protect the front differential seals while inserting the inner half shaft joints into the front differential. Ensure the joint is fully inserted and retaining clip is engaged (Figure 18).
