# **TECHNICAL INSTRUCTIONS**

**SAFETY RECALL 20TA07**

**BACKUP LAMPS MAY BECOME INOPERATIVE**

**CERTAIN 2020 COROLLA HATCHBACK**

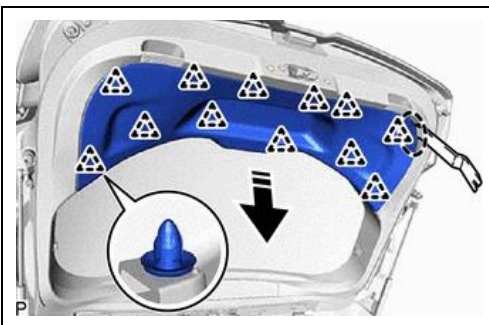
### 6. REMOVE BACK DOOR TRIM PANEL

- a. Disengage the 12 clips using a trim panel tool.

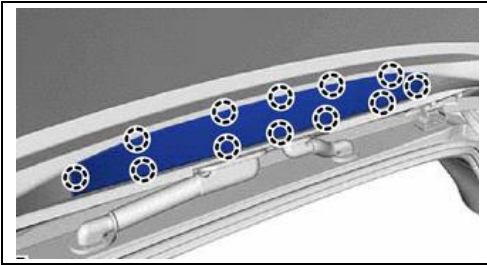
**7. REMOVE SERVICE HOLE PANEL**

a. Disengage the 12 claws.

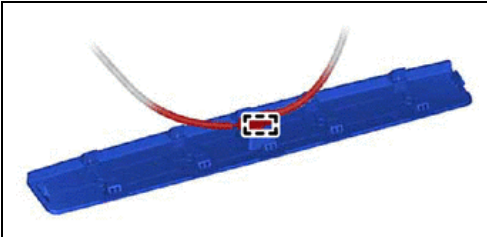
b. Disengage the clamp to separate the wire harness.

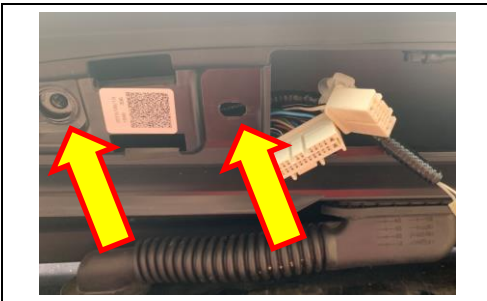
**8. REMOVE BOLT AND CLAMP**

a. Remove the bolt behind the Service Hold Panel Cover.  
b. Remove wire harness clamp.

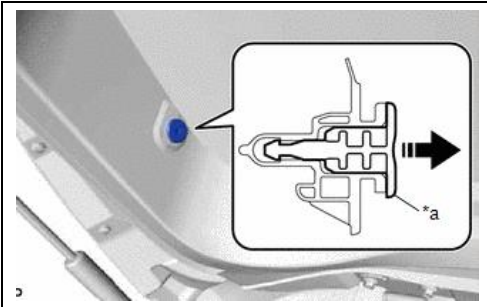
**9. REMOVE PACKAGE TRAY TRIM GARNISH LH**

a. Disengage the inner section of the Trim Garnish LH as shown.

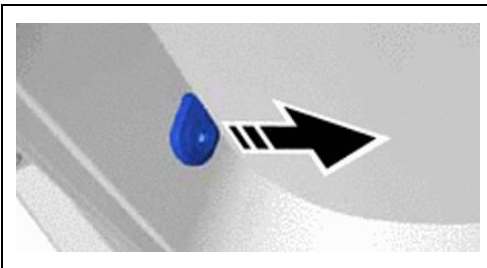
b. Remove the outer section of the Trim Garnish LH by pulling outward.

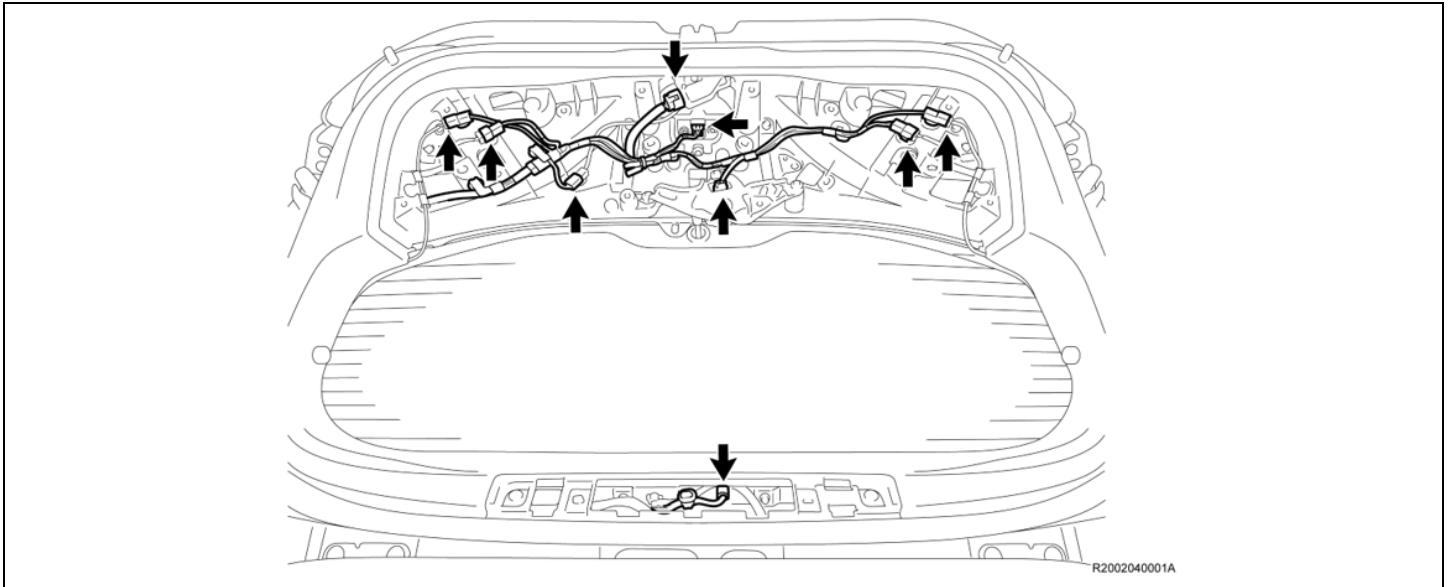
c. Disconnect the 9 connectors as shown in the illustration

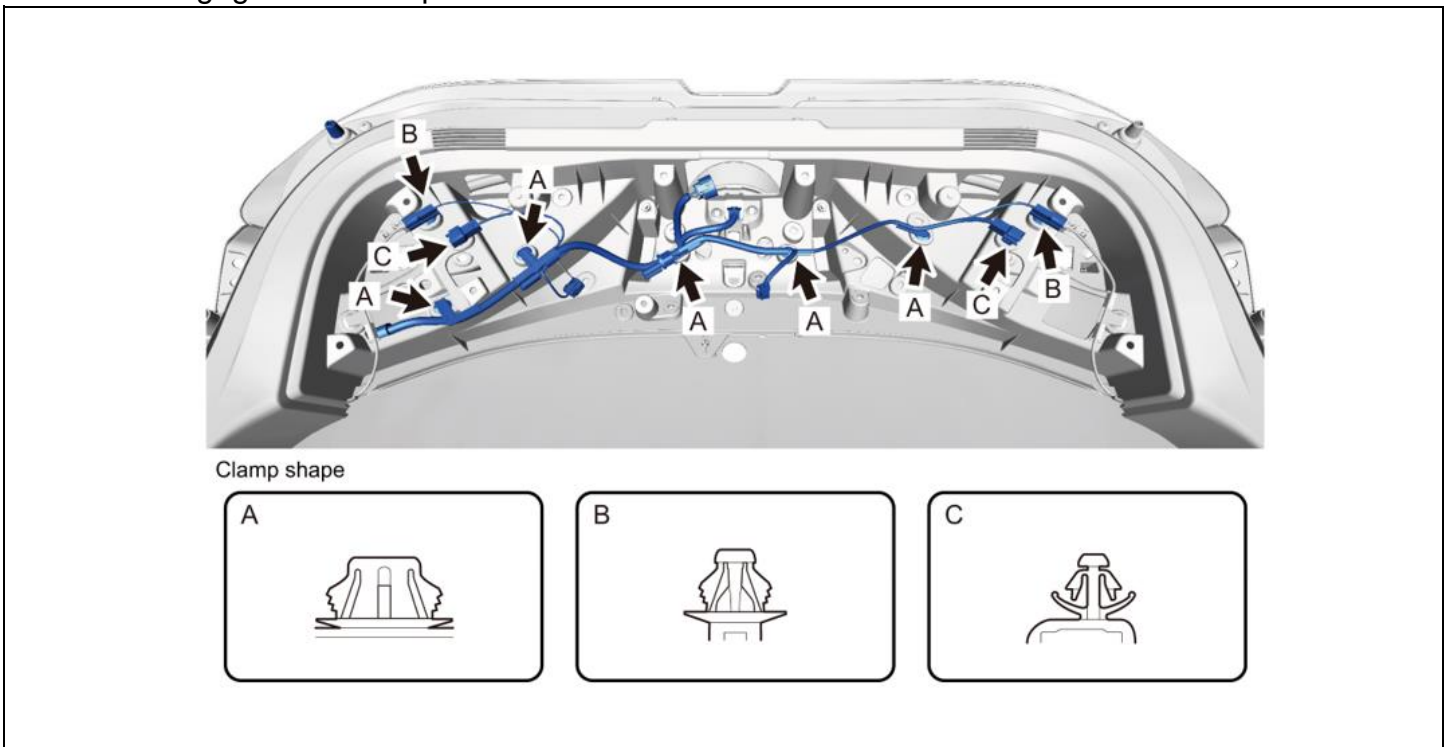
d. Disengage each clamp as indicated.

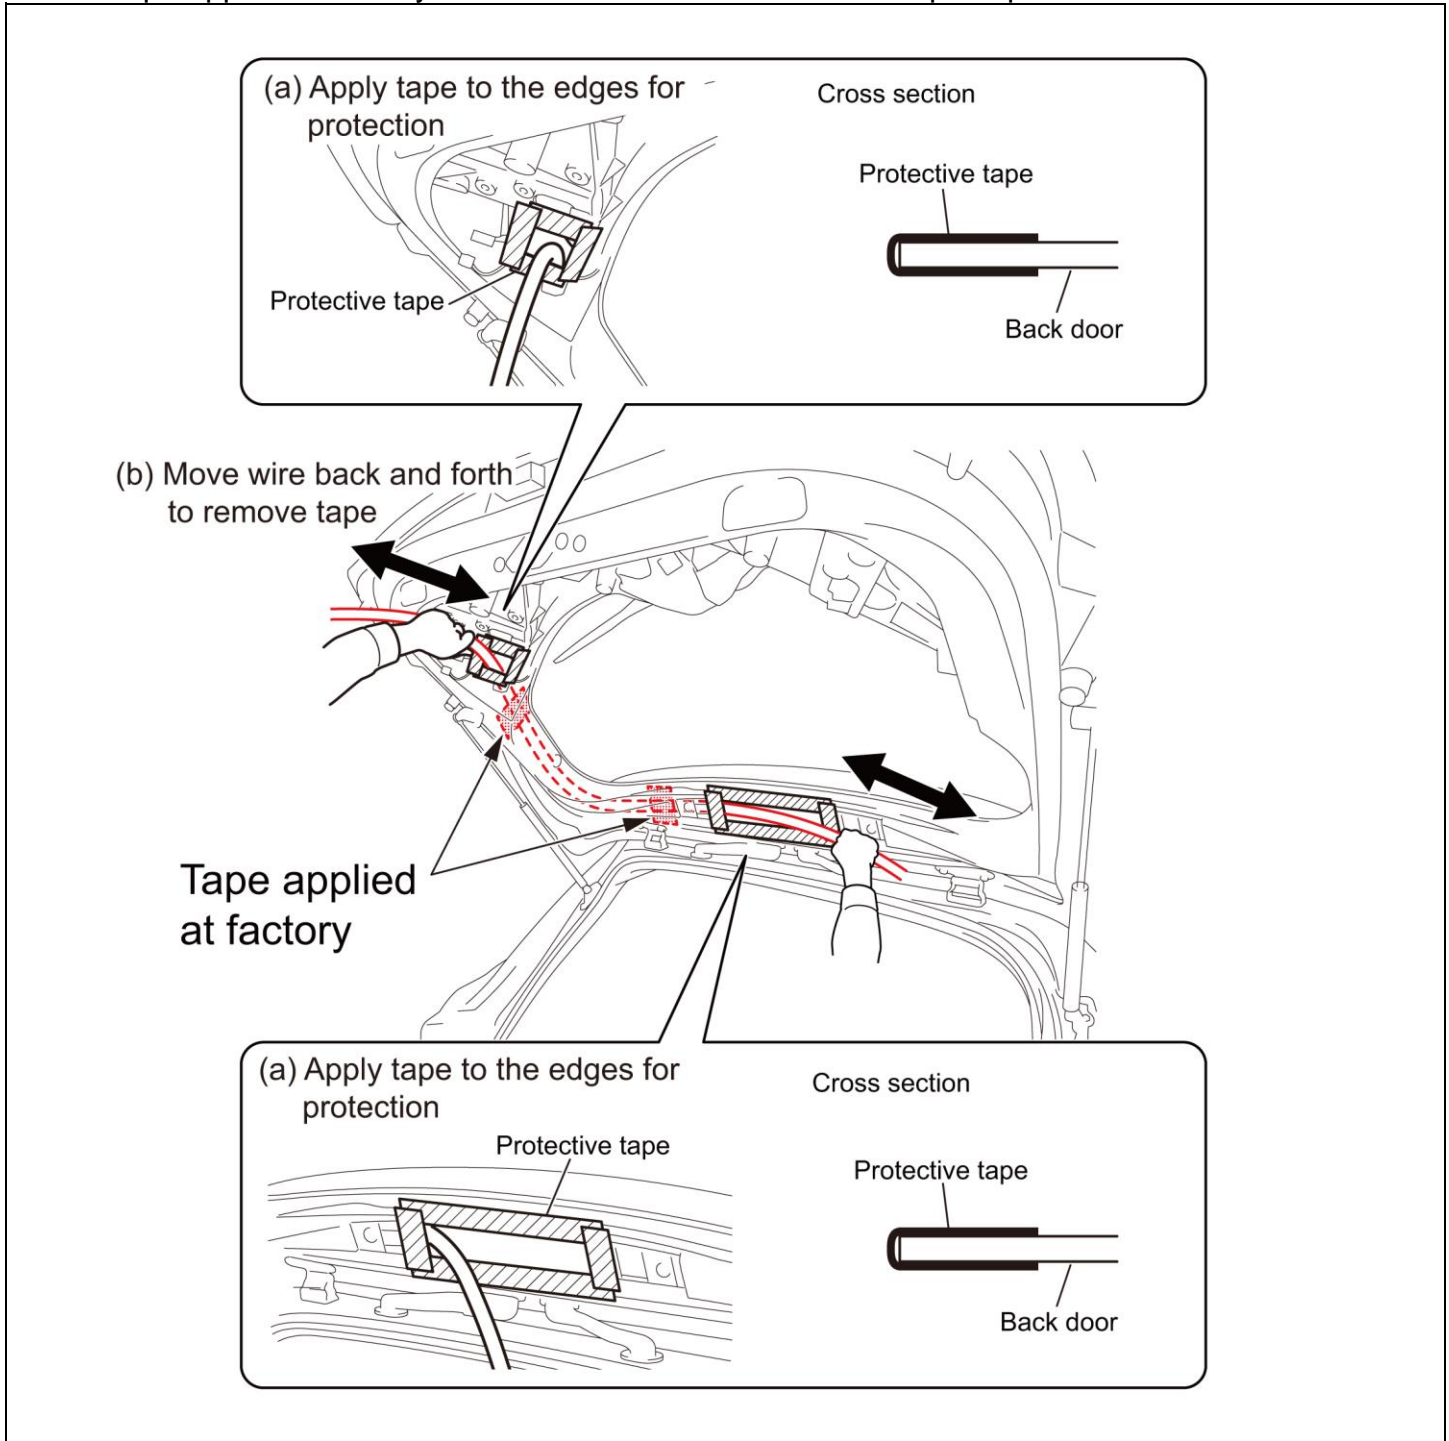
## 11. REMOVE THE HARNESS RETENTION TAPE

During production, the No.2 back door wire harness is held to the inside of the door panel with tape before attaching the inner and outer door panels. It will be necessary to separate the tape from the wire harness before the installation of the new harness begins.

- a. Apply protective tape to the edges of the service hole for protection.
- b. **Move the No.2 back door wire forward and back about 4"-5"** in order to separate the tape applied at factory. You should be able to hear the tape separate.

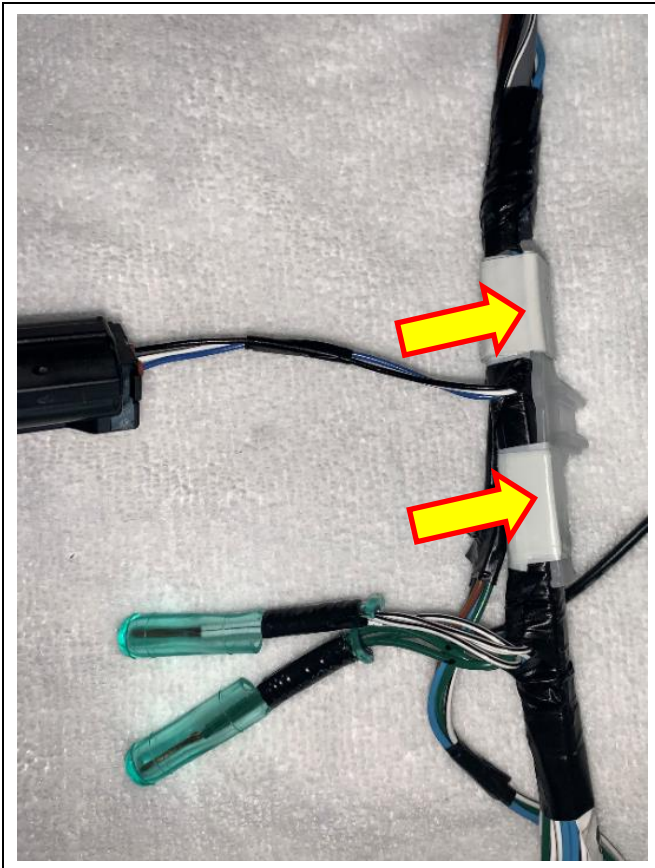
- Cut the white tape on the upper wire harness clamp and remove the clamp.
- Cut the 2 pieces of black tape and remove the tape.
- Cut the two pieces of white tape and remove the clamp.

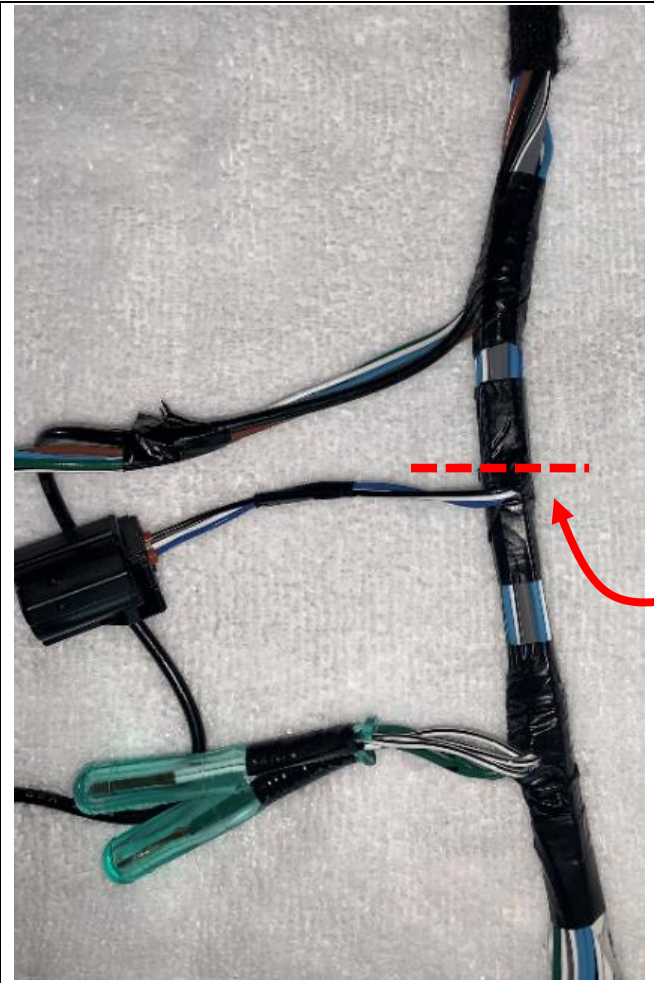
**CUT HERE**

d. Cut the original harness just above the white, blue and black wires that protrude from the harness.

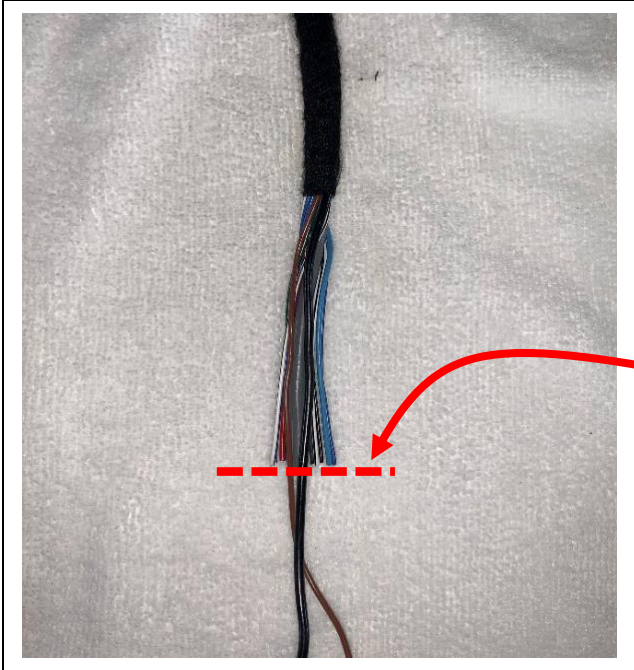
**CUT HERE**

- f. Cut the 2 remaining wires to the same length as the remaining harness.

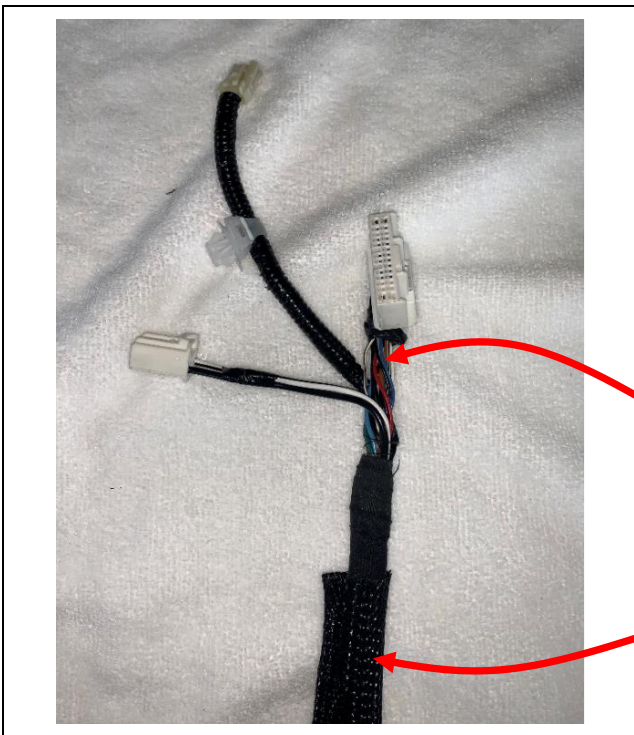
- 1. **INSTALL BRAIDED SLEEVE**
  - a. Slide the Braided Sleeve over the *NEW* harness at the end with the 3 connectors.

**NEW HARNESS**

**BRAIDED SLEEVE**

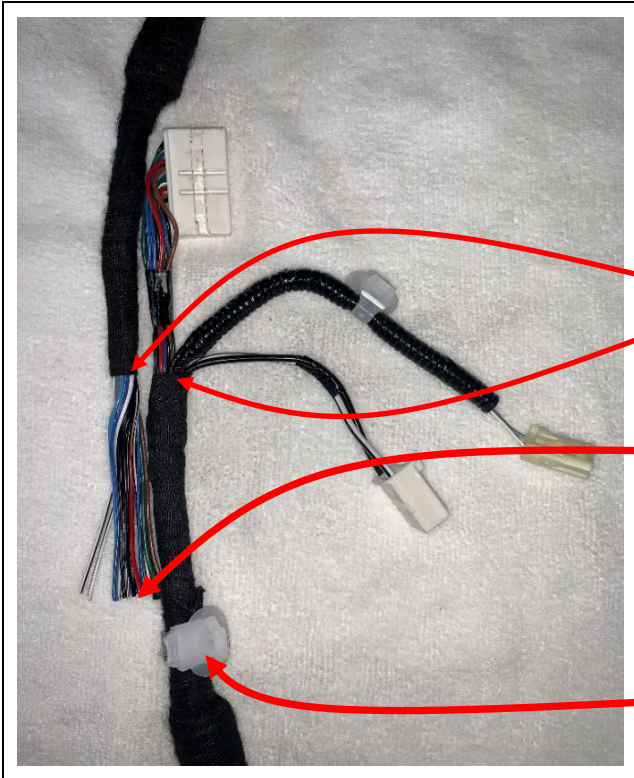
b. Line up the **NEW** harness with the original harness to tape them together. Overlap the **NEW** harness and the original harness as shown in the diagram.

**Harness wrap from each harness lines up with each other**

**END OF ORIGINAL HARNESS**

**WIRE HARNESS CLAMP ON NEW HARNESS**

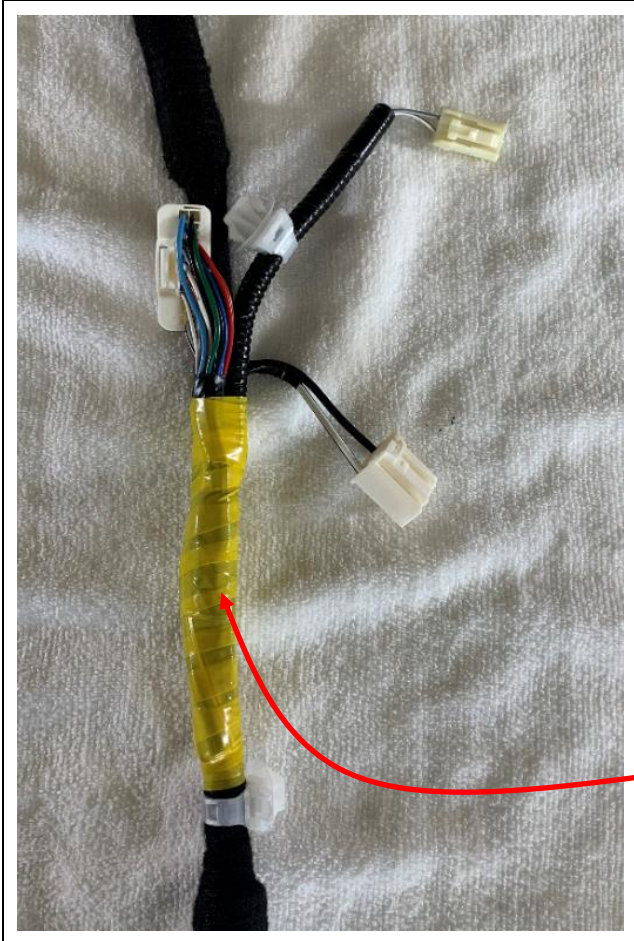
c. Using electrical tape, wrap the section between the connectors and the wire harness clamp. **Overlap the previous row by about 25%.** Using too much tape will reduce the flexibility of the harness and make it more difficult to pull the harness through the rear hatch.

*Note: **Yellow tape** was used to show the wrapped area. Any color electrical tape is acceptable to use.*

**BE SURE TO WRAP THE HARNEESES TOGETHER TIGHTLY AS THIS IS A CRITIAL CONNECTION THAT MUST NOT FAIL WHEN PUSHING THE HARNESS THROUGH THE REAR HATCH.**

**Overlap the previous row by about 25%**

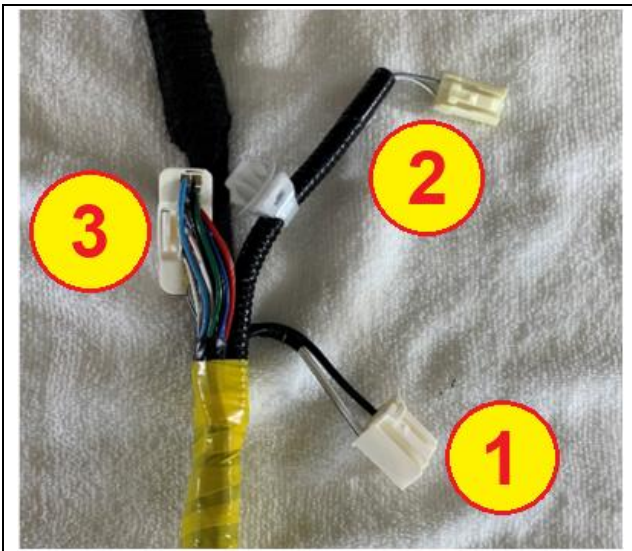
### CONNECTOR #'s:

NOTE: The three connectors shown will be attached to harness assembly in the following steps. The numbers shown on this diagram will indicate the order of operations.

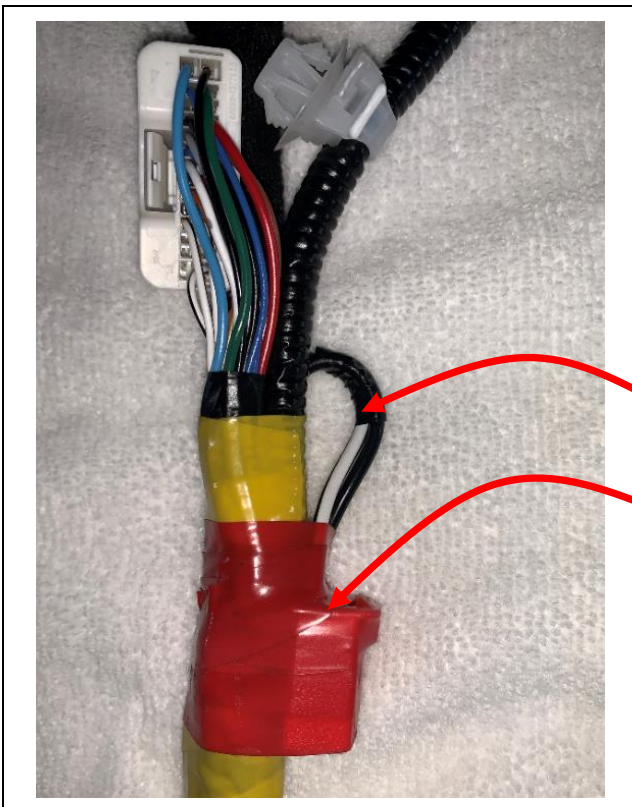
- d. Fold connector #1 backwards onto the main harness, leaving a loop at the top.
- e. Wrap connector #1 in electrical tape to retain it to the main harness. **It is not necessary to wrap it more than three or four times, as too much tape will reduce the flexibility of the harness and make it more difficult to pull through the rear hatch.**

**CREATE A LOOP WITH THE WIRES**

**TAPE CONNECTOR #1 TO THE HARNESS**

**Note: Red tape was used in this step to show the wrapped area.**

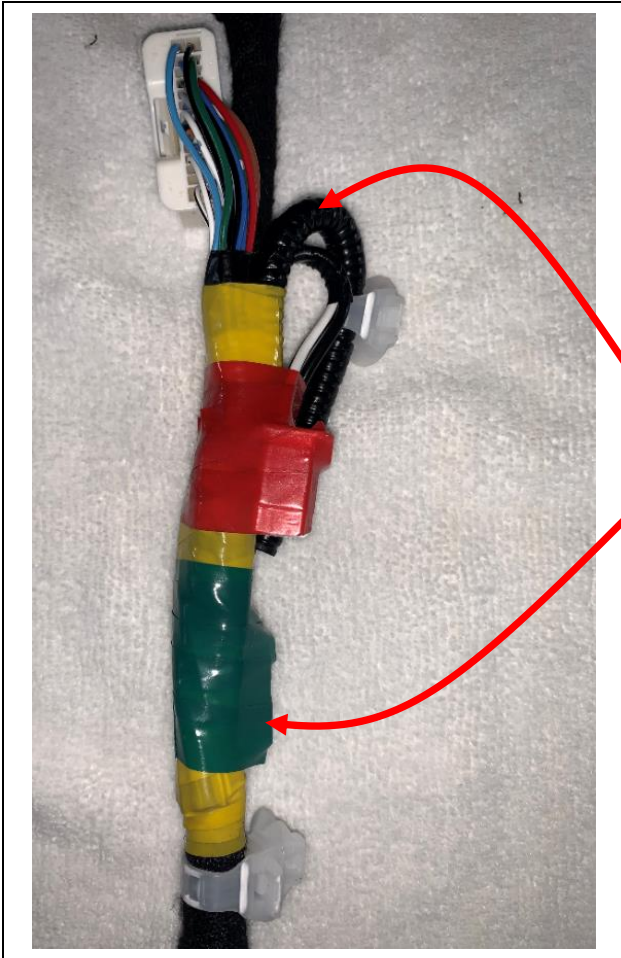
- f. Fold connector #2 backwards onto the main harness, leaving a loop at the top.
- g. Wrap the connector in electrical tape to retain it to the main harness. **It is not necessary to wrap it more than three or four times, as too much tape will reduce the flexibility of the harness and make it more difficult to pull through the rear hatch.**

**CREATE A LOOP WITH THE WIRES**

**TAPE CONNECTOR #2 TO THE HARNESS**

**Note: Green tape was used in this step to show the wrapped area.**

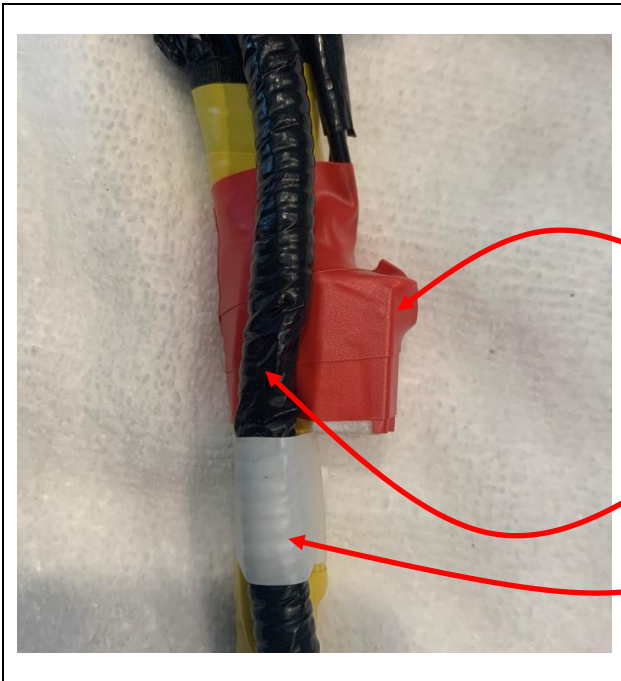
- h. Position the wires for connector #2 under connector #1 to reduce the overall diameter of the assembly.
- i. Place a piece of tape around the wire to hold it in position.

**Connector #1**

**Position the wire for connector #2 under connector #1**

**Apply tape to hold the wire into position.**

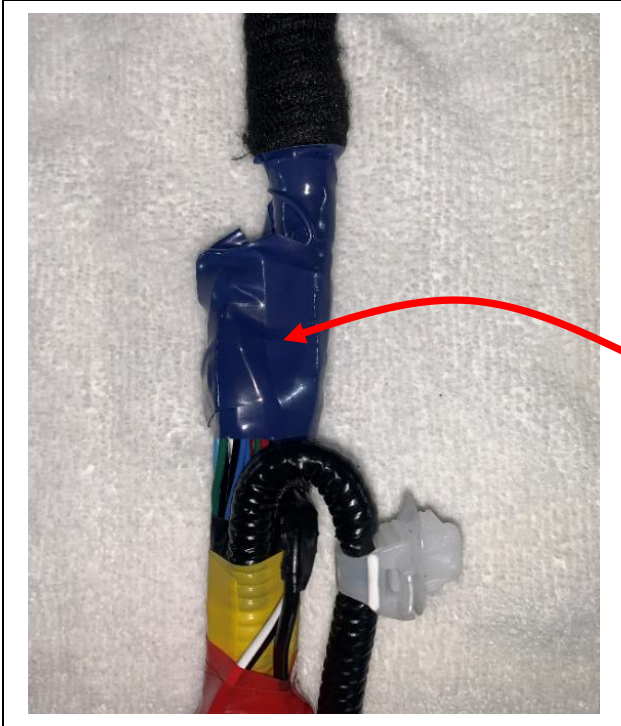
- j. Wrap connector #3 in electrical tape to secure it to the main harness. Do not fold it backward like the other 2 connectors. **It is not necessary to wrap it more than three or four times, as too much tape will reduce the flexibility of the harness and make it more difficult to pull through the rear hatch.**

**TAPE CONNECTOR #3 TO THE HARNESS**

**Note: Blue tape was used in this step to show the wrapped area.**

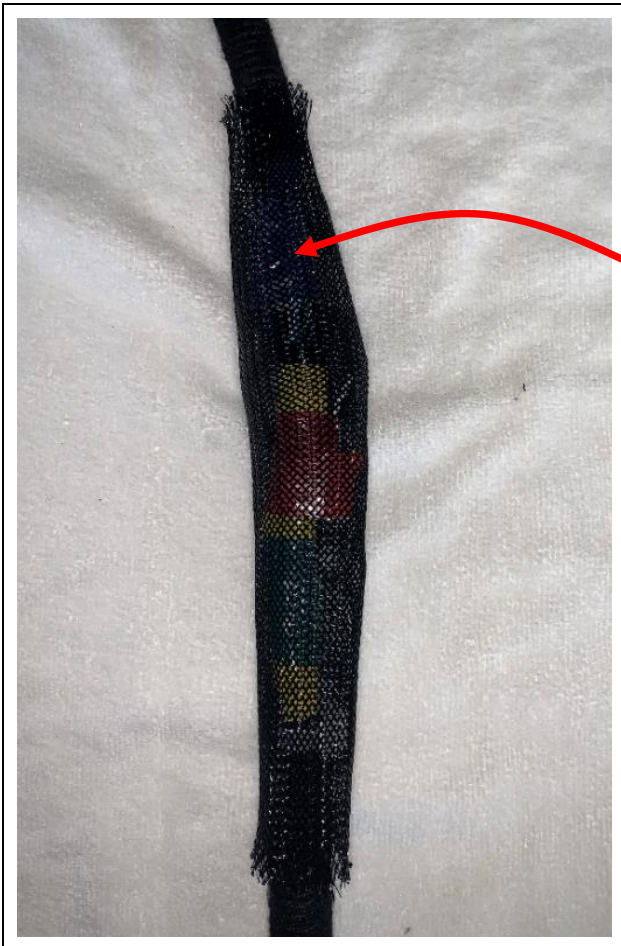
- k. Slide the braided sleeve over the connections and space it evenly at both ends.

**SLIDE THE BRAIDED SLEEVE OVER THE CONNECTIONS**

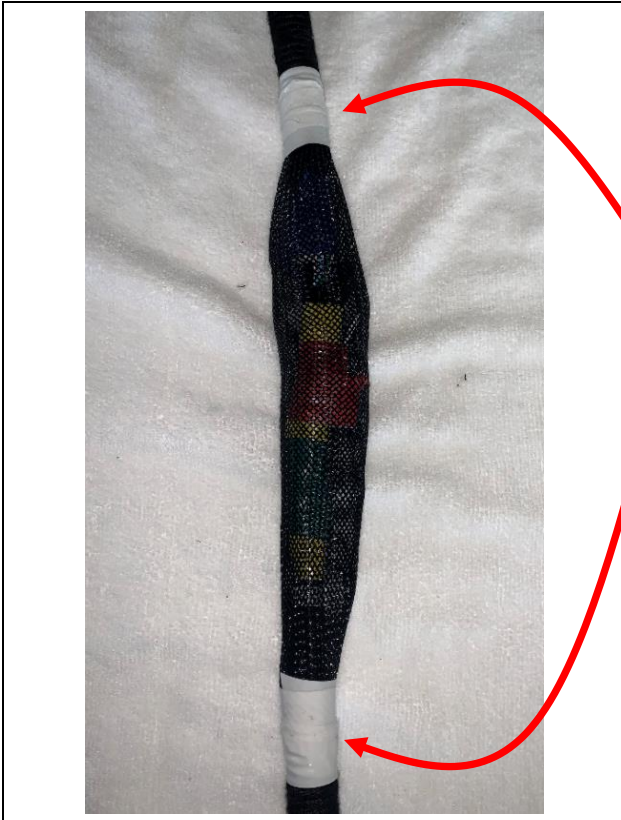
- l. Tape one end of the braided sleeve to securely attach it to the main harness.
- m. Pull the sleeve downward to remove the slack and tighten the sleeve against the harness.
- n. Tape the other end of the sleeve to securely attach it to the main harness.

**TAPE THE BRAIDED SLEEVE TO THE MAIN HARNESS**

**Note: White tape was used in this step to show the wrapped area.**

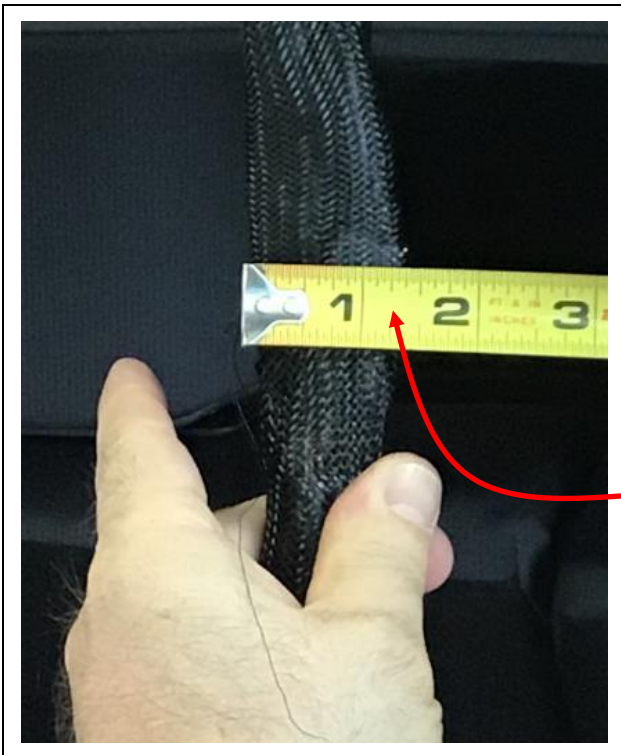
- o. Inspect the harness to insure it's no more than 1¼" (32mm) at its widest point. If you find an area that is too wide, it will be necessary re-position the connectors and wires to reduce the overall diameter.

**Note: If the diameter exceeds 1¼" (32mm), it will not pass through the rear hatch.**

**Maximum diameter is 1¼" (32mm)**

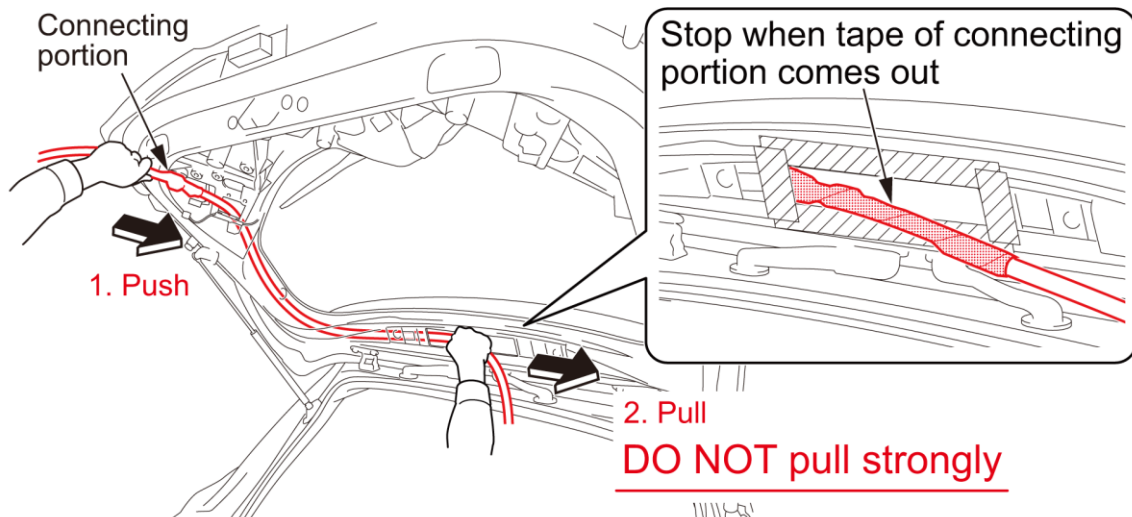
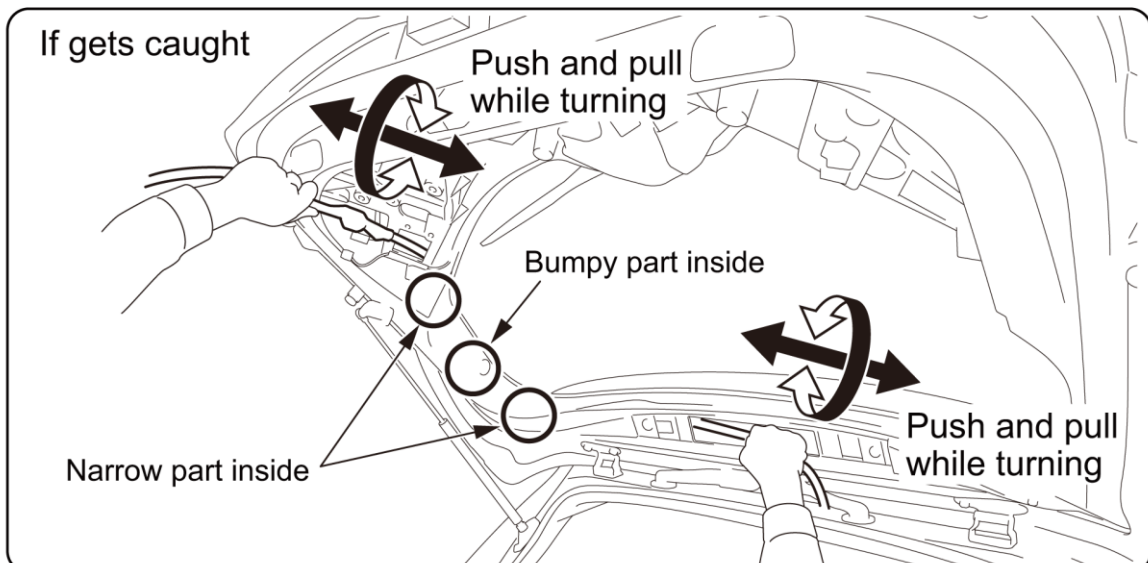
- Hold the wire harness with both hands as shown in the illustration.
- PUSH** the **NEW** harness into the back door. It should only move a few inches at a time.
- Lightly pull** the other end of the harness, but only to remove the slack that was created by pushing.
- Repeat these steps above until the overlapped section comes out of the service hole.

**DO NOT attempt to forcibly "pull" the harness through the hatch. It will catch internally on the ribs and braces of the hatch. It will work much better to "push" it though. Only pull the harness to remove the slack that was created from pushing.**

- **DO NOT pull strongly, or the connecting portion may become disconnected.**
- **If the harness gets caught, repeat pushing and pulling the wire while turning it. By turning, pushing and pulling, the harness will be released.**

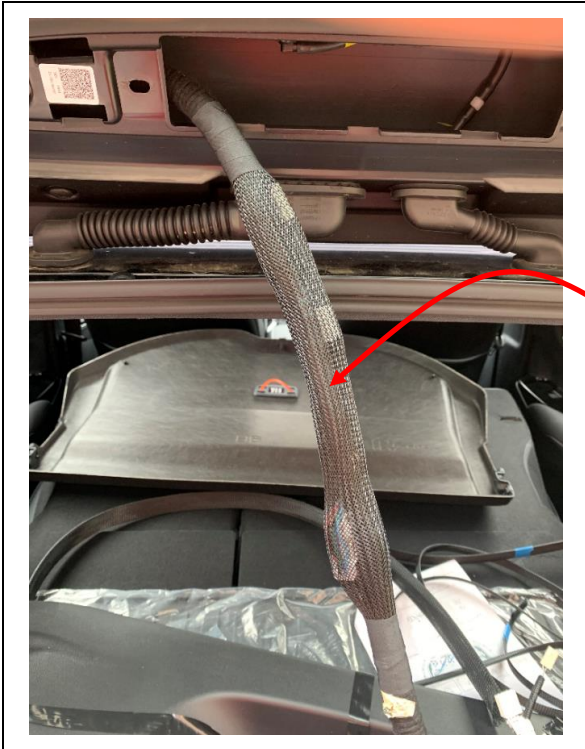
- b. Once the spliced section of the harness has been pushed through the upper service hole, remove the sleeve and separate the original harness from the **NEW** harness.

Remove the sleeve and separate the original harness from the **NEW** harness.

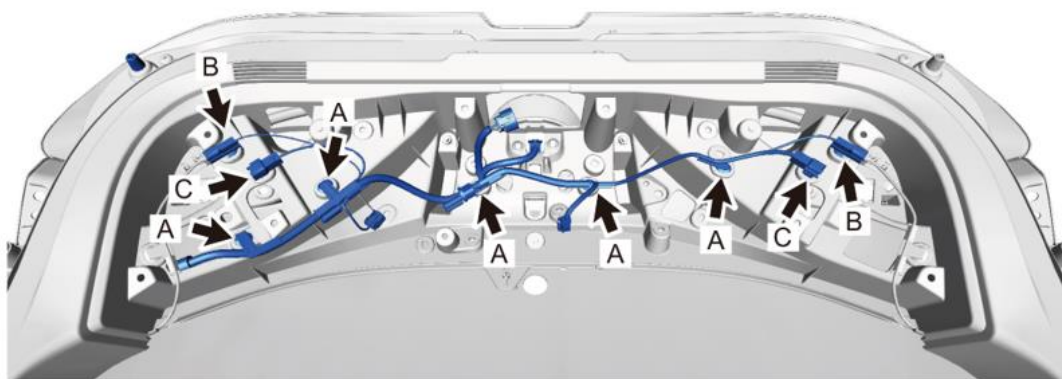
Clamp shape

- a. Engage each clamp of the harness as indicated.

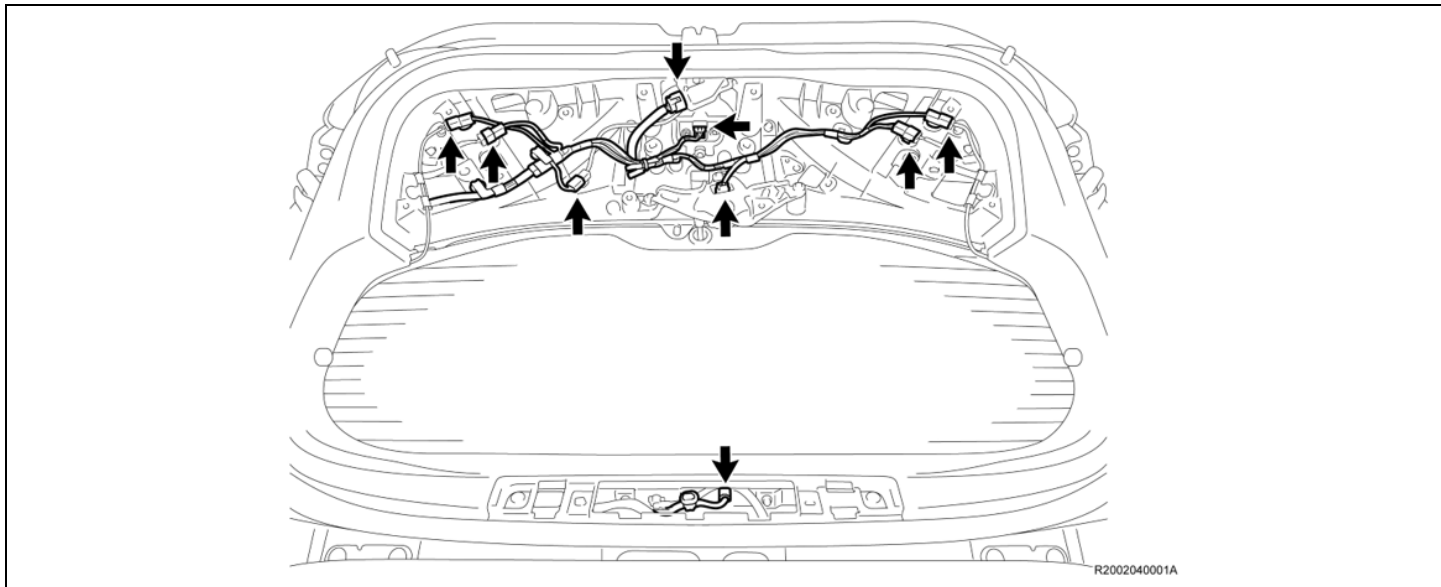
b. Connect the 9 connectors as shown in the illustration

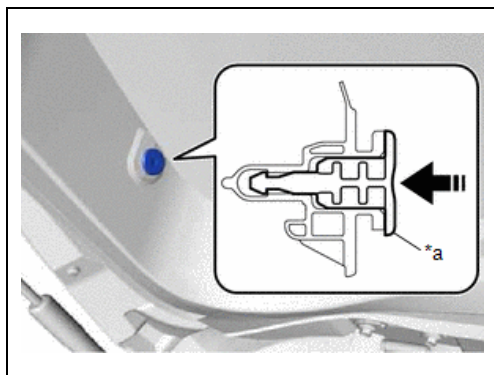
- c. Install the Trim Garnish LH first inserting the outer section, then the inner section.

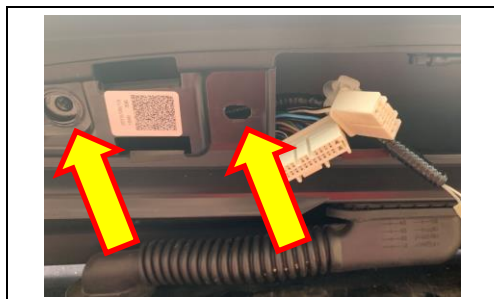
**3. INSTALL BOLT AND CLAMP**

- a. Install the bolt behind the Service Hold Panel Cover.
- b. Install the wire harness clamp.

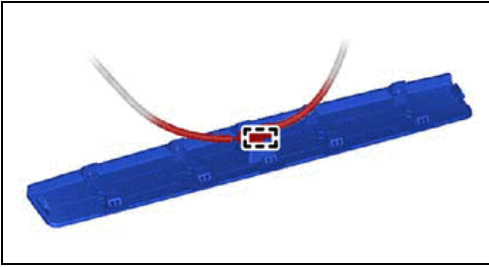
#### 4. INSTALL SERVICE HOLE PANEL

a. Engage the clamp to separate the wire harness.

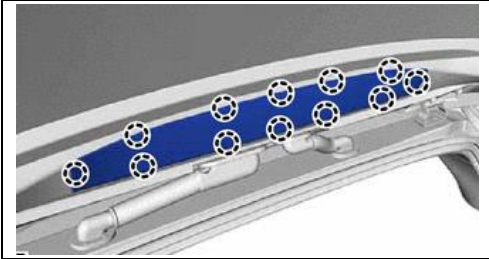
b. Engage the 12 claws.

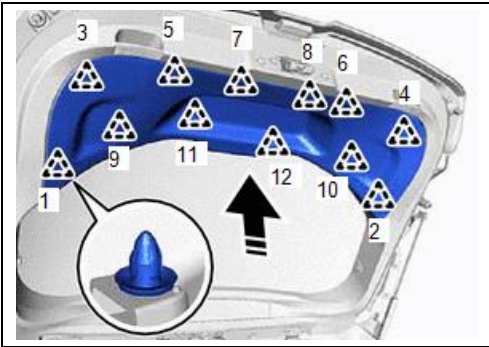
#### 5. INSTALL BACK DOOR TRIM PANEL

a. Engage the 12 clips.
