SIB 65 10 20

RECALL CAMPAIGN 20V-243: HEAD AIR BAG (RIGHT SIDE)

Replace the right-hand head air bag according to repair instructions:

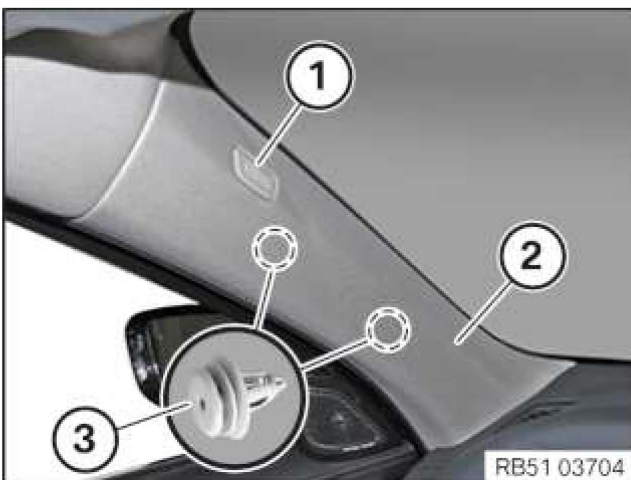
- Unclip cover panel (1) and unscrew the bolt below it.
- Detach A-pillar trim panel (2) from the clips (3) and remove upward.

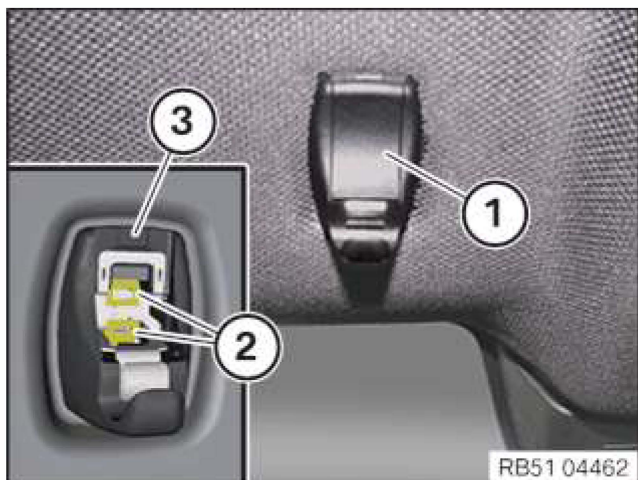
- Pull out the cover (1).
- Push the clamps (2) together and pull the counter support (3) out of the headlining.

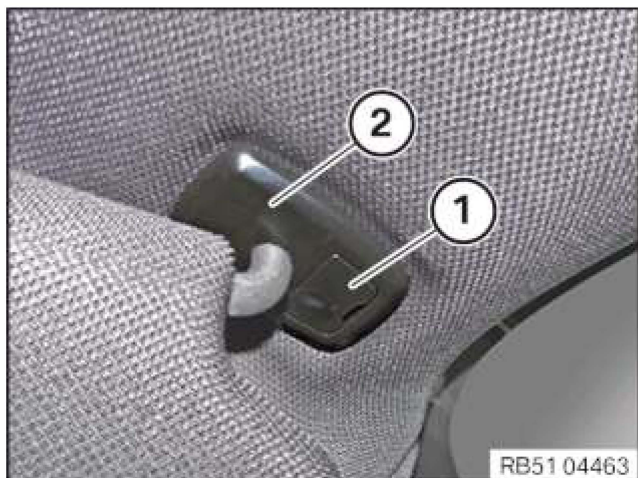
- Pull out the cover (1).
- Detach the sun visor (2) from the counter support.
- Disengage the sun visor (2) in front downward and guide it out of the headlining to the rear.
- Unlock associated plug connection and disconnect.

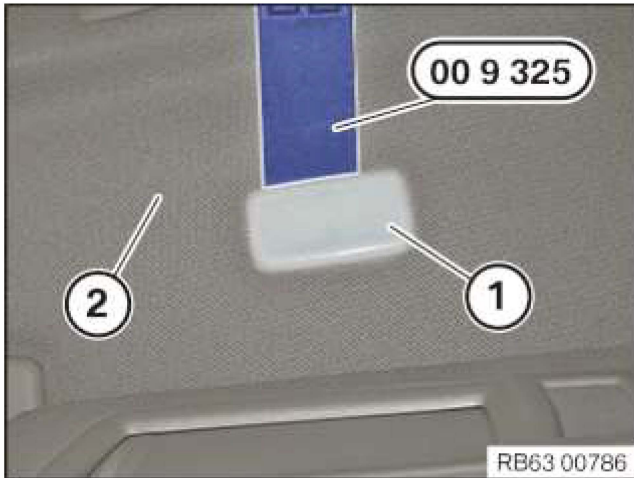
- Lever out the vanity mirror light (1) using special tool 0 496 569 (00 9 325) from the headlining (2).

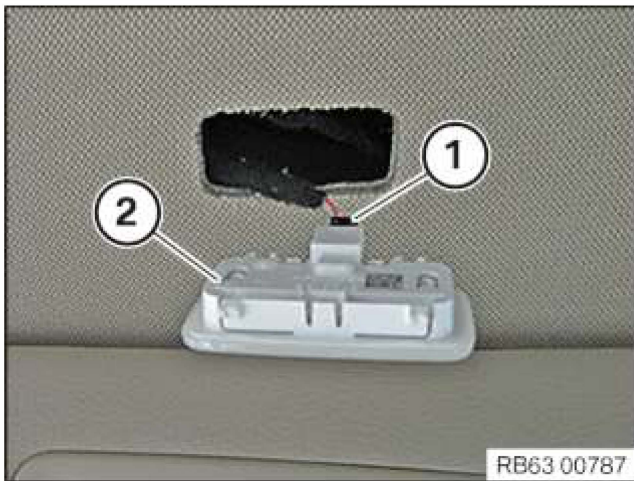
- Unlock and disconnect connector (1).
- Remove the vanity mirror light (2).

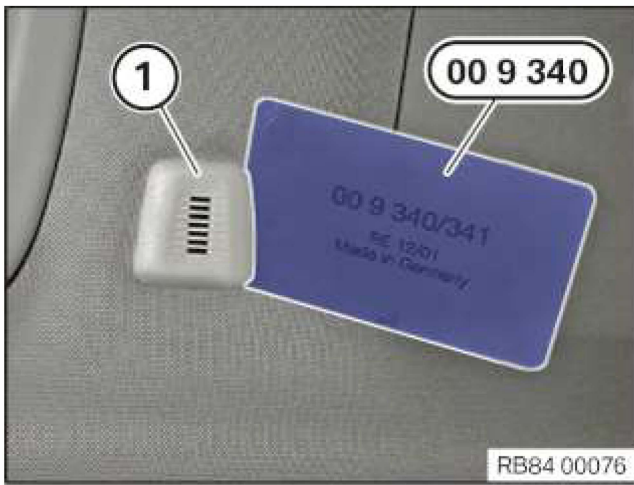
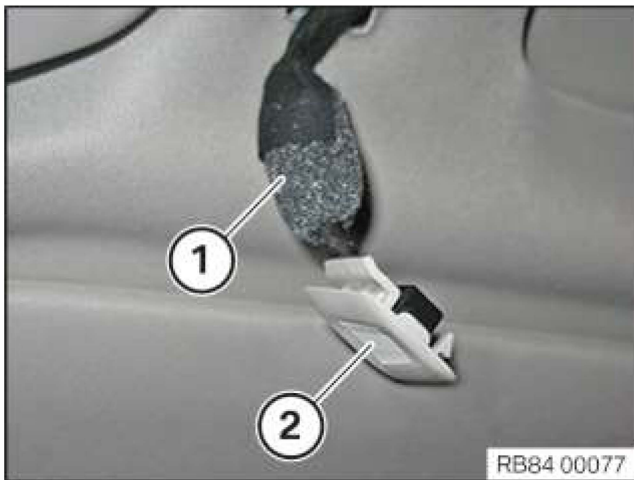
- Lever out the hands-free microphone (1) with the special tool 0 493 687 (00 9 340).

- Open the insulation (1).
- Unlock plug connection and disconnect.
- Remove the hands-free microphone (2).

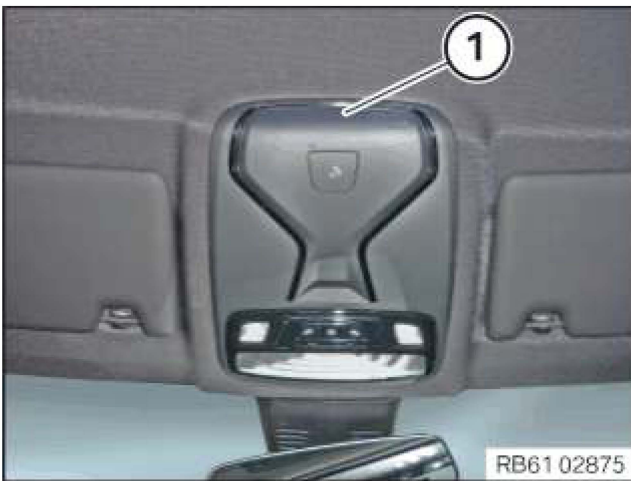
- Unclip the cover (1).

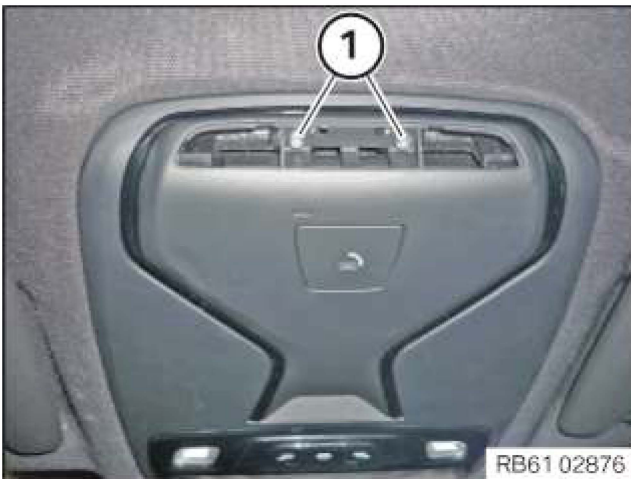
- Loosen screws (1).

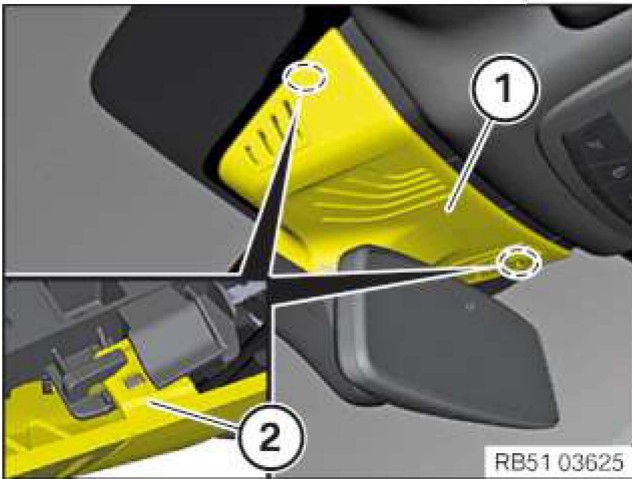
- Push the cover (1) upwards slightly in the marked areas and unclip it from the detents (2) towards the rear.

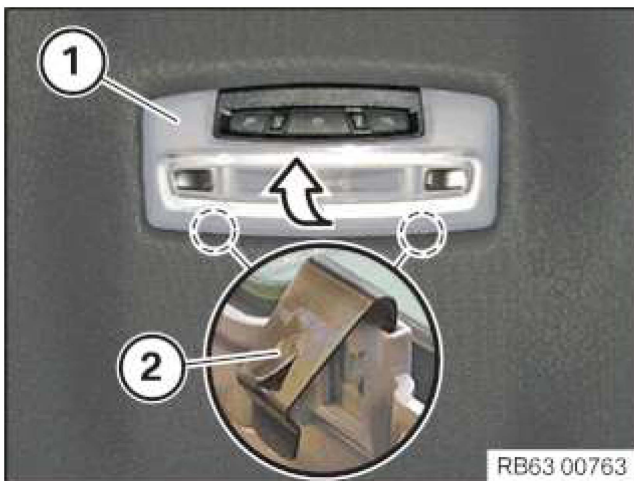
- Lever out the interior roof light (1) from the clamps (2) in the arrow direction using the special tool 0 496 569 (00 9 325).
- Disconnect the respective plug connection.

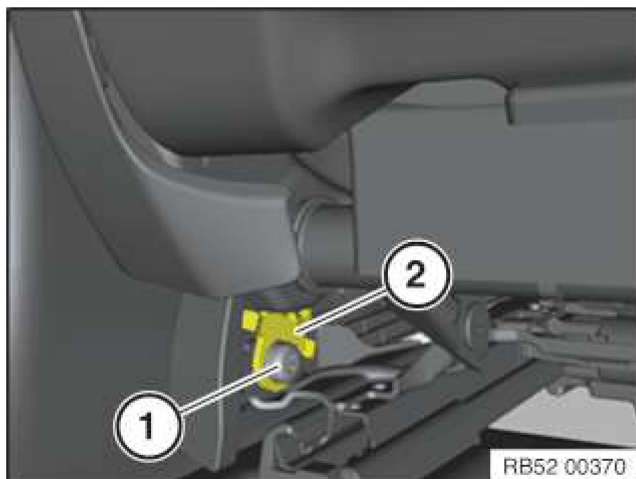
- Adjust the front seat completely to the front and top.
- Loosen screw (1).
- Remove end lining (2).

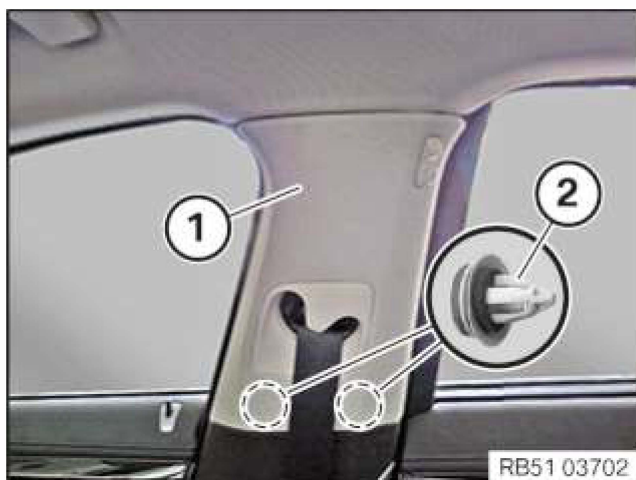
- Release the B-pillar trim panel (1) from the clips (2) and remove downwards out of the roofliner.
- Remove the B-pillar trim panel (1) and thread out the safety belt at the same time.

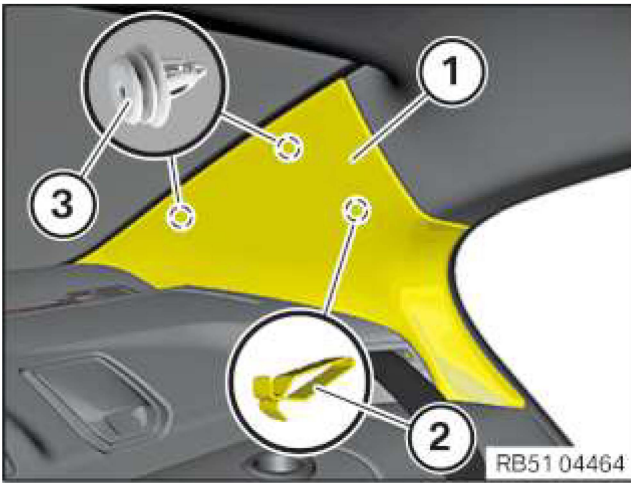
- Disengage the C-pillar trim panel (1) inward from

the clamp (2) and the clips (3).

- Feed the C-pillar trim panel (1) out and upwards.

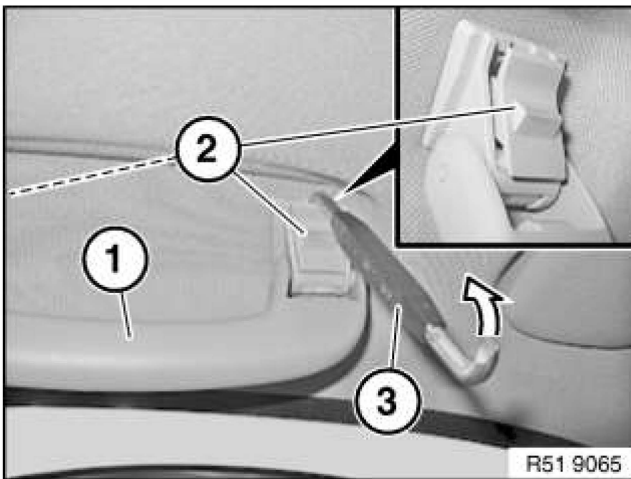
- Expand the grab handle (1) towards the bottom.
- Disengage and remove the locking insert (2) with an angle screwdriver (3) as shown.

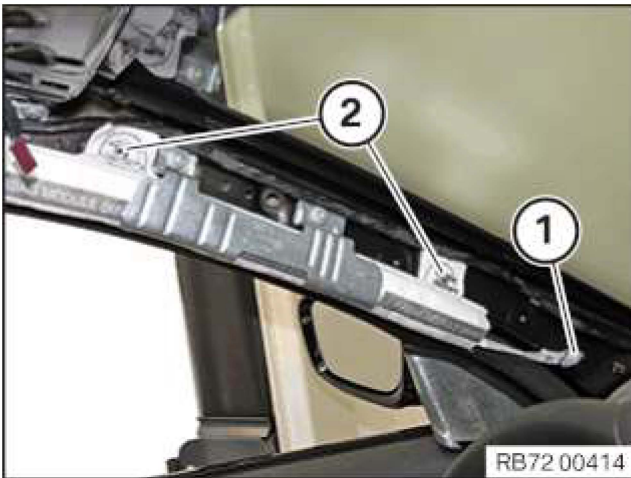
- Loosen screw (1).
- Unlock and detach the clamps (2) with the special tool 2 230 142 .

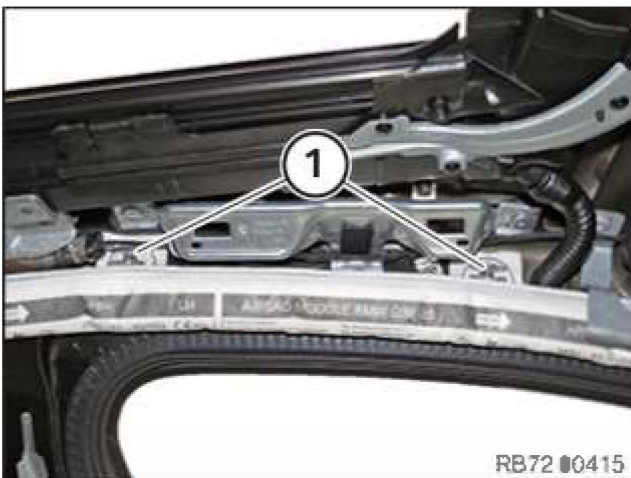
- Unlock and detach the clamps (1) with the special tool 2 230 142 .

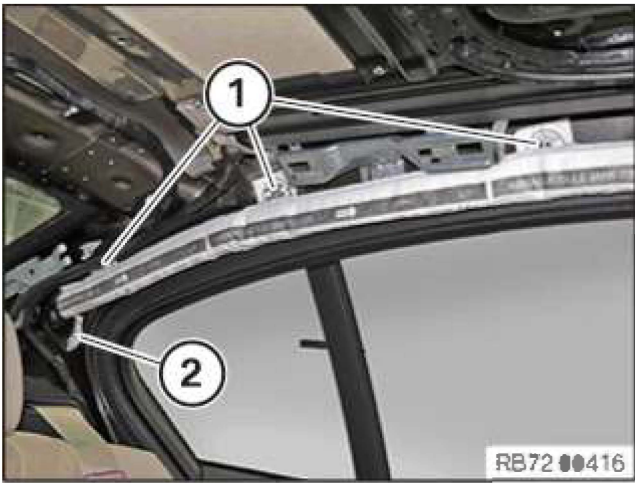
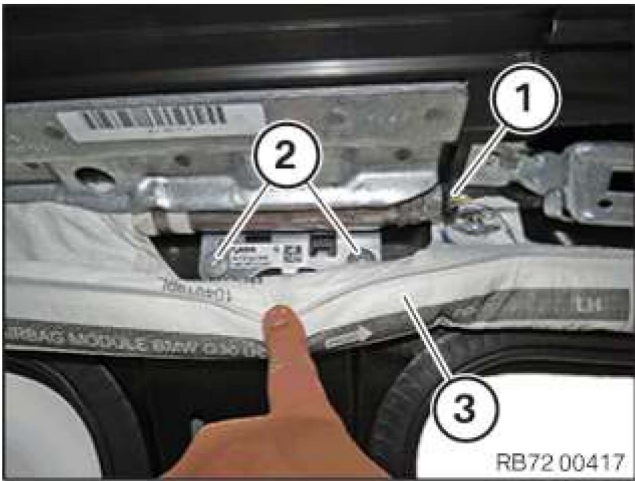
- Unlock and detach the clamps (1) with the special tool 2 230 142 .
- Loosen screw (2).

- Unlock plug connection (1) and disconnect.
- Loosen screws (2).
- Take off the folding pack (3) with the gas generator.

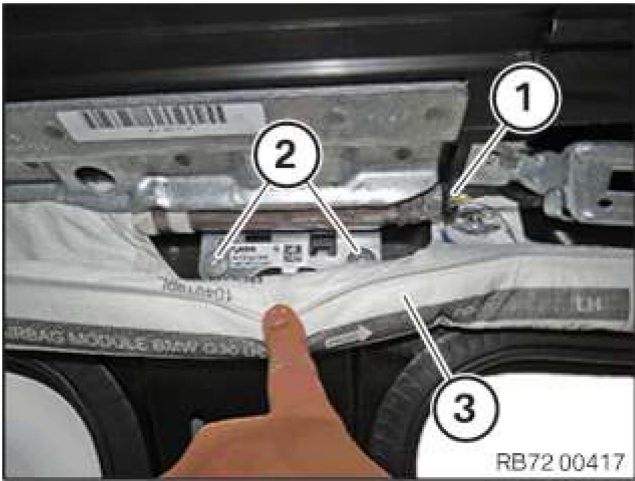
- Insert the folding pack (3) with the gas generator.
- Tighten down screws (2).

Tightening torques

Head airbag
8Nm

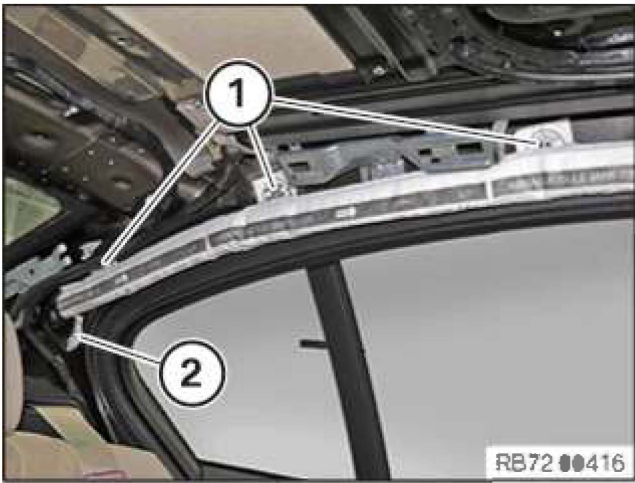
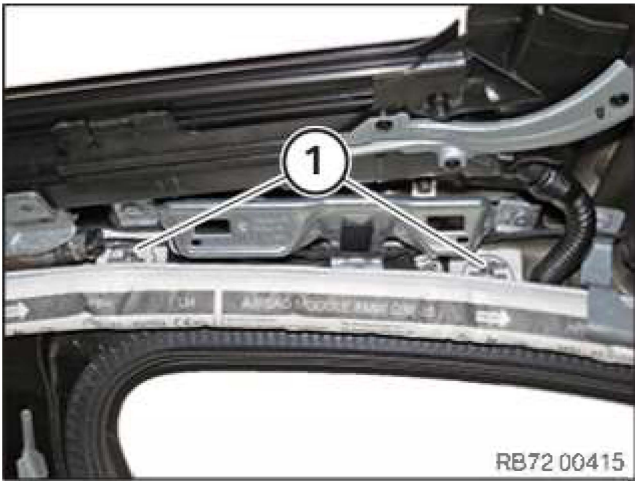
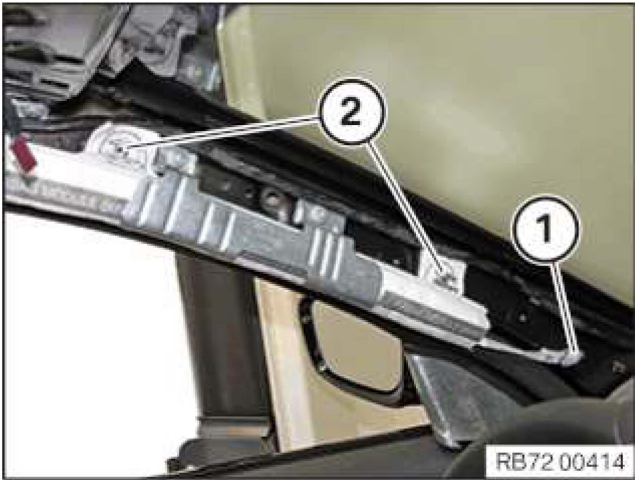
- Connect connector (1).

- Insert the clamps (1).
- Make sure that the clamps (1) are correctly fitted in the body.
- Tighten down screw (2).

8Nm
--	-----

- Insert the clamps (1).
- Make sure that the clamps (1) are correctly fitted in the body.

- Insert the clamps (2).
- Make sure that the clamps (2) are correctly fitted in the body.
- Tighten down screw (1).

Head airbag	
	8Nm

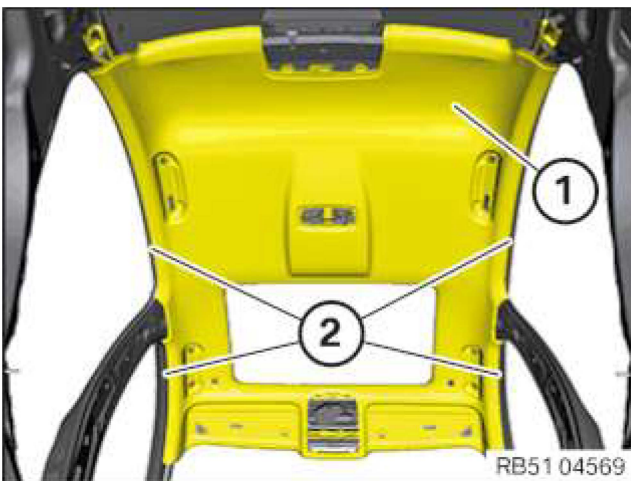
- Guide the headlining (1) into the relevant edge protection (2) with the help of a support person.

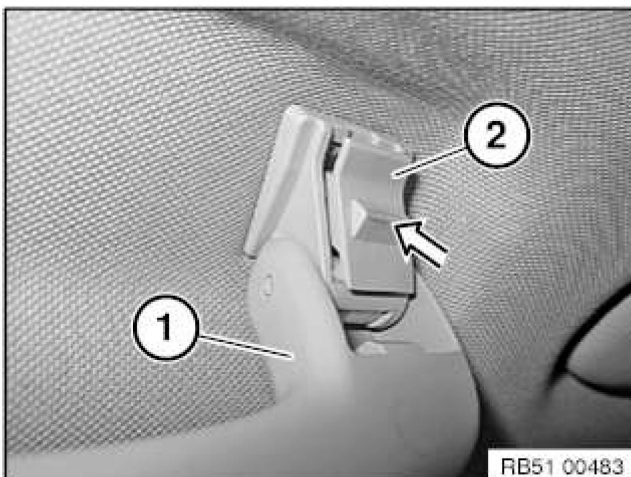
- Insert the grab handle (1) into body.
- Correctly clamp in the grab handle (1), as otherwise the locking inserts (2) on the grab handle (1) cannot correctly engage.
- Engage the locking inserts (2) on both sides of the grab handle (1).

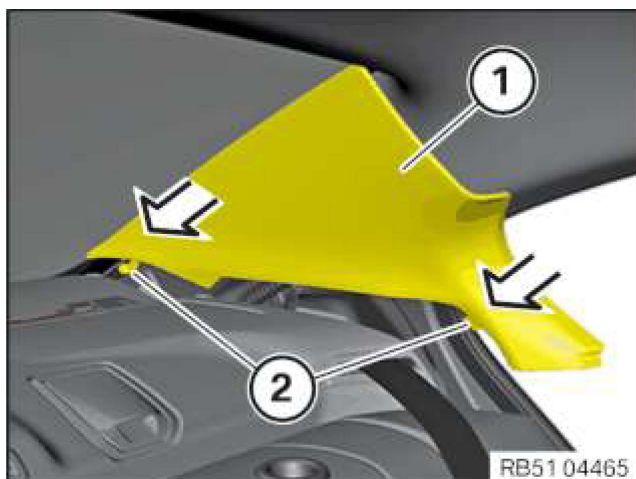
- Feed the C-pillar trim panel (1) with the guides (2) in arrow direction into the rear deck.

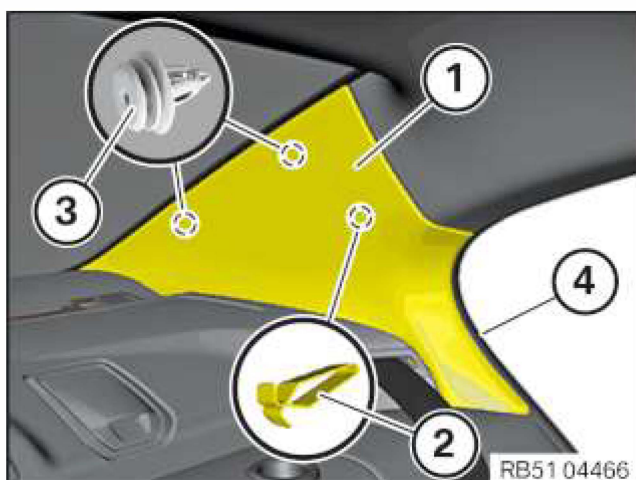
- Clip in the C-pillar trim panel (1) at the clamp (2) and at the clips (3).
- Make sure that the edge protection (4) is fitted correctly.

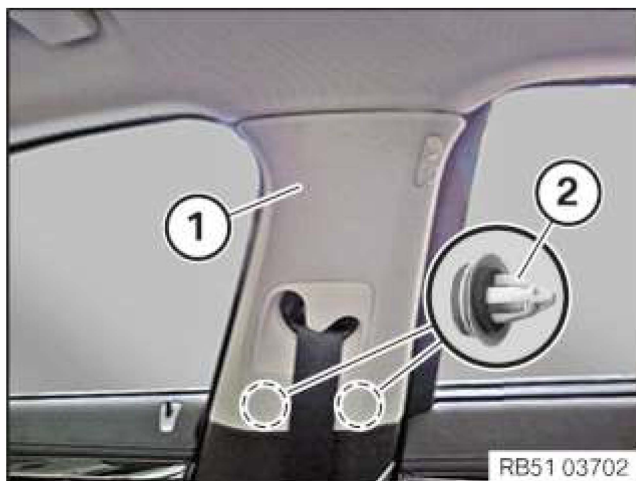
- Attach the B-pillar trim panel (1) and guide in the safety belt.
- Guide in the B-pillar trim panel (1) at the top at the roofliner and clip into the clips (2).
- Check the front and rear of the B-pillar trim panel (1) for the correct fit at the edge protection.

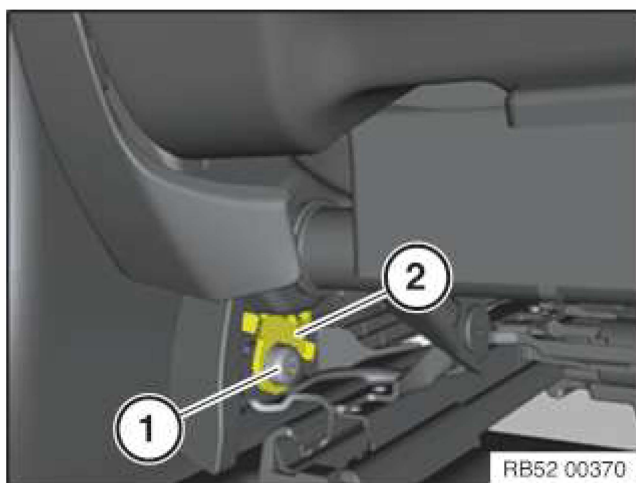
- Adjust the front seat completely to the front and top.
- Insert the end fitting (2).
- Renew the screw (1).

Seat belt strap fitting to seat mechanism

M10
Renew screw.

tightening torque
42Nm

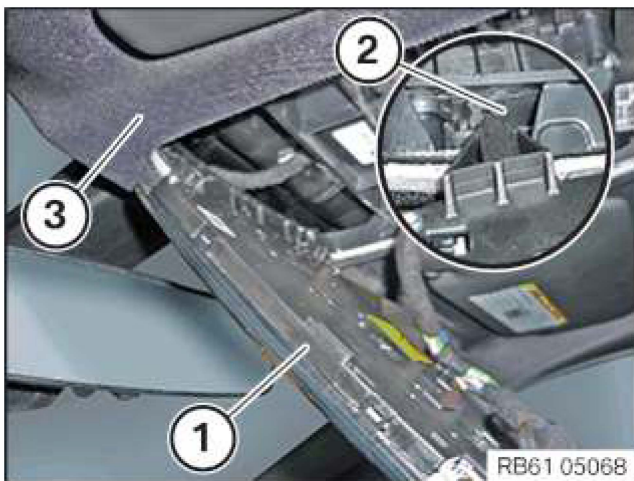
- Thread the roof function center (FZD) (1) as shown at a steep angle into the two guides (2) on the headlining(3).

Whilst doing this, make sure that the headlining is not deformed.

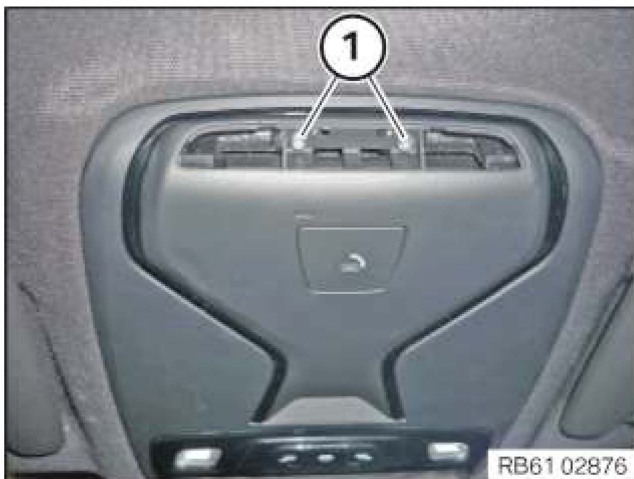
- Tighten down screws (1).

Roof function center

tightening torque
1.2Nm

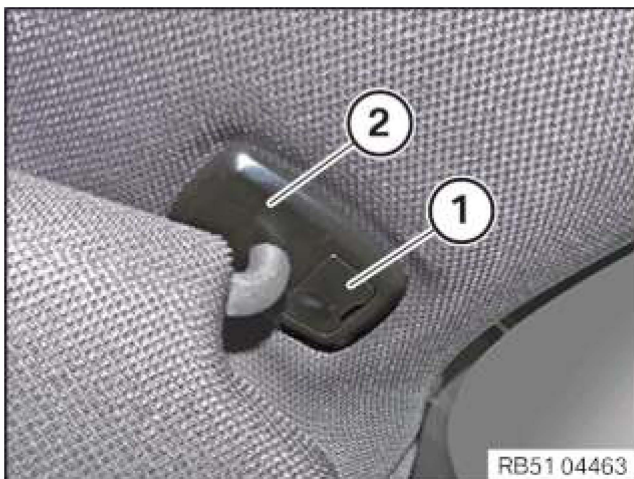
- Connect the sun visor (2) with the corresponding connector.
- Guide the sun visor (2) into the headlining.
- Use cover (1).
- Attach the sun visor (2) on the counter support.

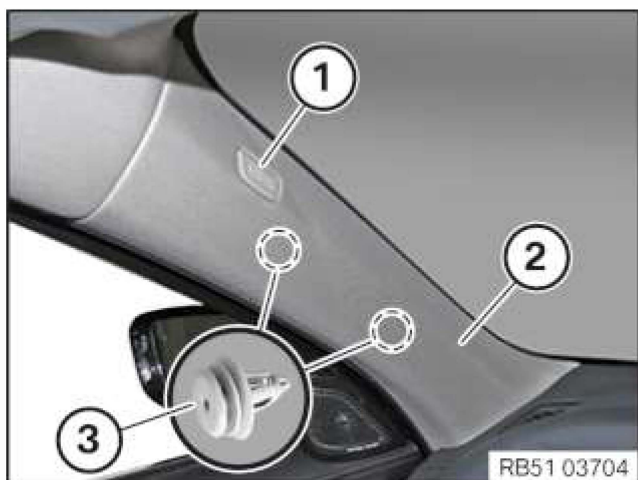
- Insert the A-pillar trim panels (2) and clip into the clips (3).
- Tighten down screw.
