**BLUE BIRD**

**R20AR**

**SUBJECT:** R20AR – Air Conditioner Circuit Breaker Installation

## R20AR – Air Conditioner Circuit Breaker Installation

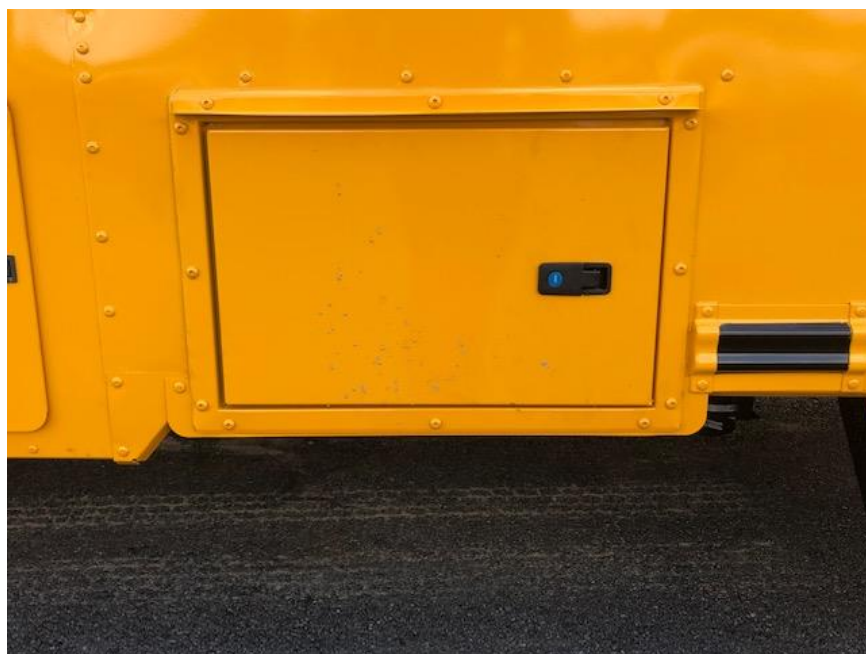
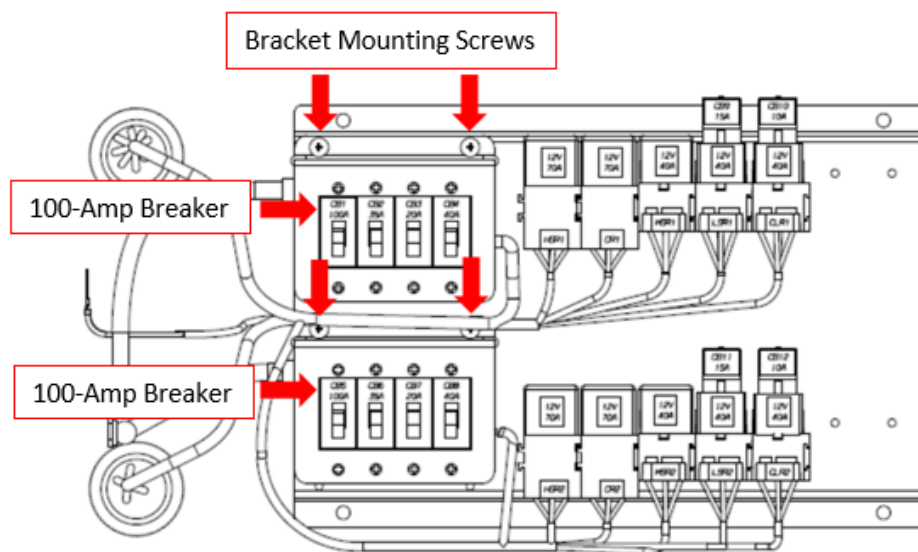
Compartment Door

1. Locate the 100-amp air conditioner circuit breakers. Note: The 100-amp breakers are identified on the decal that is located on the inside of the air conditioner electrical compartment cover.
  - a. For Vision and Front Engine All American, the circuit breakers are in the air conditioner electrical compartment which is on the left-hand skirt panel rear of the battery compartment.

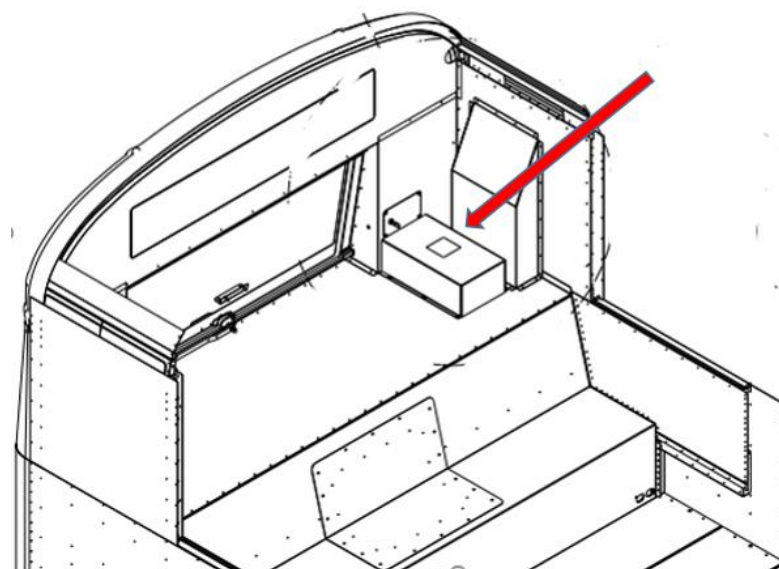
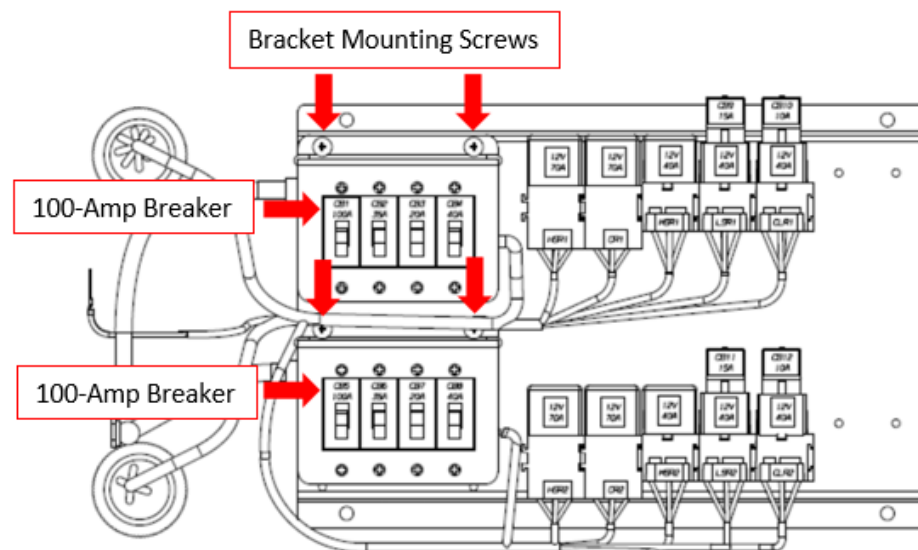
b. For Rear Engine All American, the circuit breakers are in the air conditioner electrical compartment, which is located on the rear davenport deck.

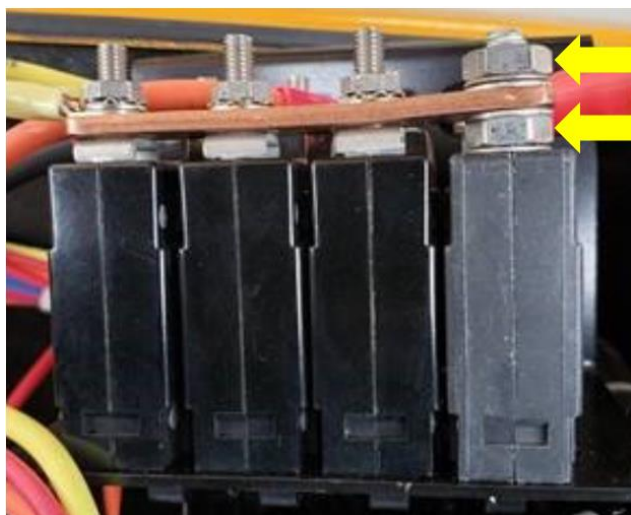
(Photo A) Correct

- a. Washers and #1/4-20 nut installed on top of the bus bar, as required.
- b. A #1/4-20 nut or spacer installed under the bus bar, as required.

2. Visually inspect 100-amp circuit breakers for correct installation of hardware and any signs of thermal damage. As required, use a Phillips screwdriver to remove bracket mounting screws to access rear side of circuit breakers. Note: A mirror or cell phone camera can be used to visually inspect the rear side of the circuit breakers. Refer to (Photo A) on page 3 for Correct installation of hardware.

3. Refer to (Photo A) for Correct installation of hardware. If installation of hardware is correct and no visible signs of thermal damage, replace bracket mounting screws using Phillips screwdriver. Reconnect batteries or turn battery disconnect switch on if equipped, and return bus to service.

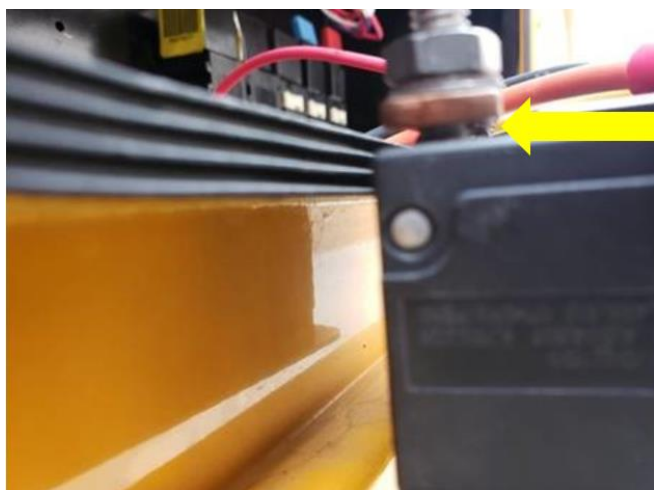
(Photo B) Incorrect

- c. A #1/4-20 nut or spacer was NOT installed under the bus bar, as required.

4. Note: On some buses the #1/4-20 nut below the bus bar was NOT installed. Refer to (Photo B) for Incorrect installation. Add #1/4-20 nut if it was not installed. Torque #1/4-20 nut to 30-35 IN-LBS.

Note: Torque #10-32 nuts to 15-20 IN-LBS, if required.
