Safety Recall

Code: 38C7

Subject	Transmission Oil Pipe																							
Release Date	June 05, 2020																							
Affected Vehicles

Subject: Safety Recall 38C7 – Transmission Oil Pipe

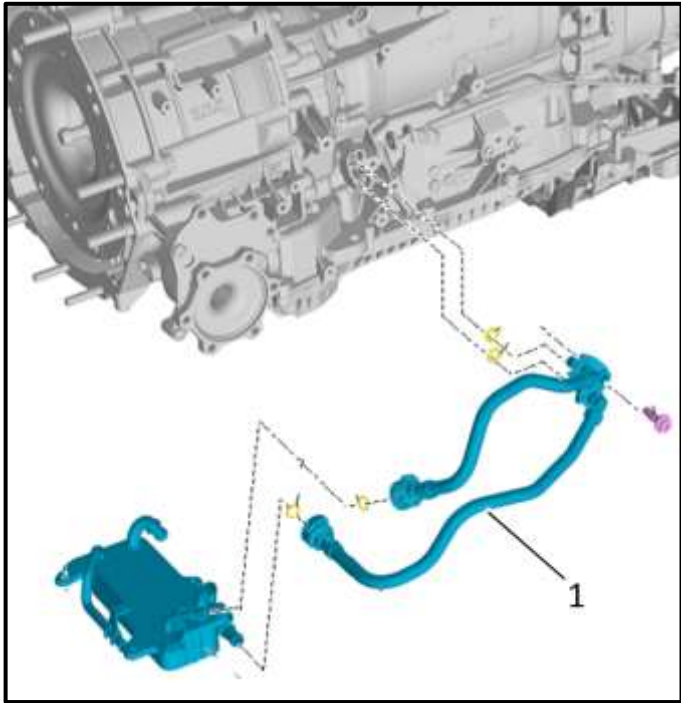
Repair Overview

- Inspect transmission oil pipe <1> production date and replace if necessary.

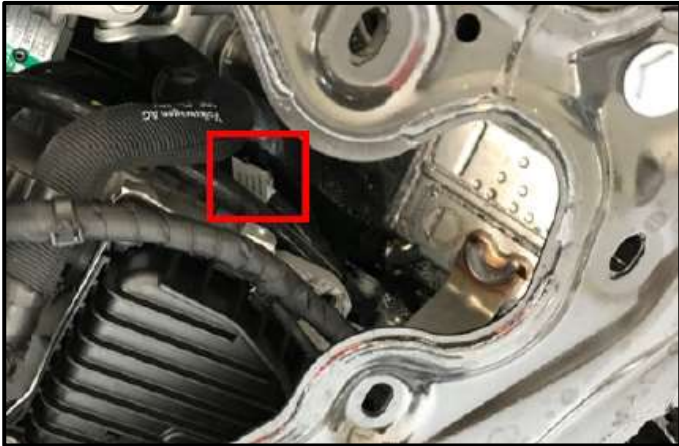
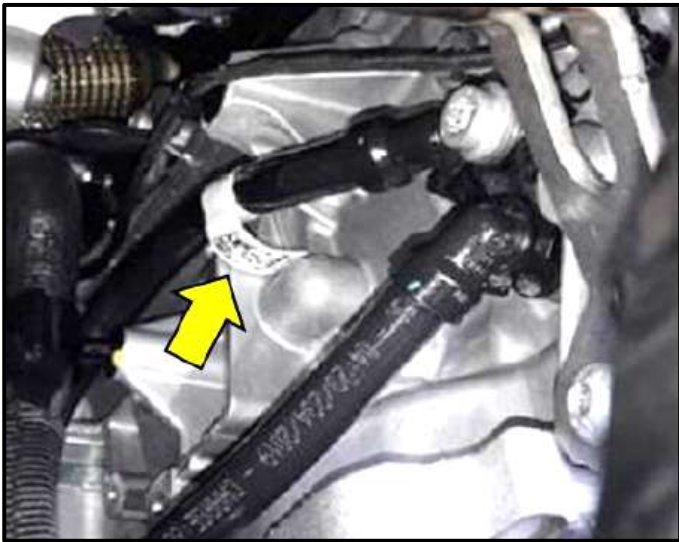
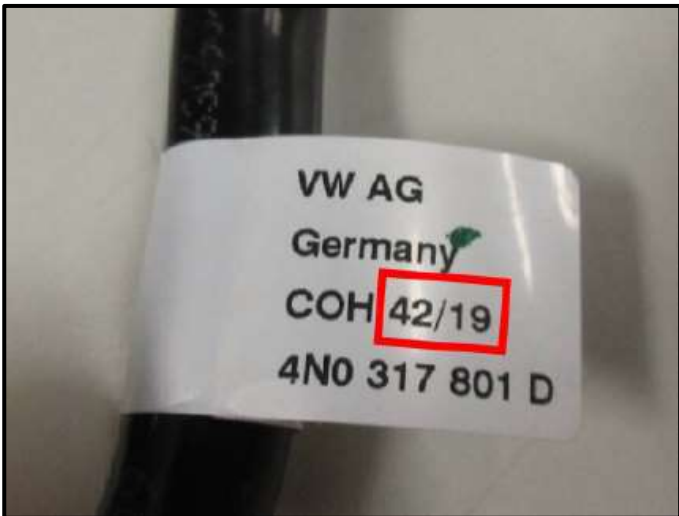
Section B – Transmission Oil Pipe Inspection

- Remove noise insulation.
 - See ELSA Repair Manual: *Repair manual > Body > Body Exterior > 66 Exterior Equipment > Noise Insulation*
- Inspect the label on the transmission oil pipe.
 - The week the transmission oil pipe was produced is printed on the label.
 - If week 36/19 up to and including week 42/19 is printed:
 - The transmission oil pipe must be replaced.
 - Proceed to Section C.
 - If the label indicates a different week:
 - No further work is necessary.
 - Reinstall noise insulation in the reverse order of removal.
 - Proceed to Section D.

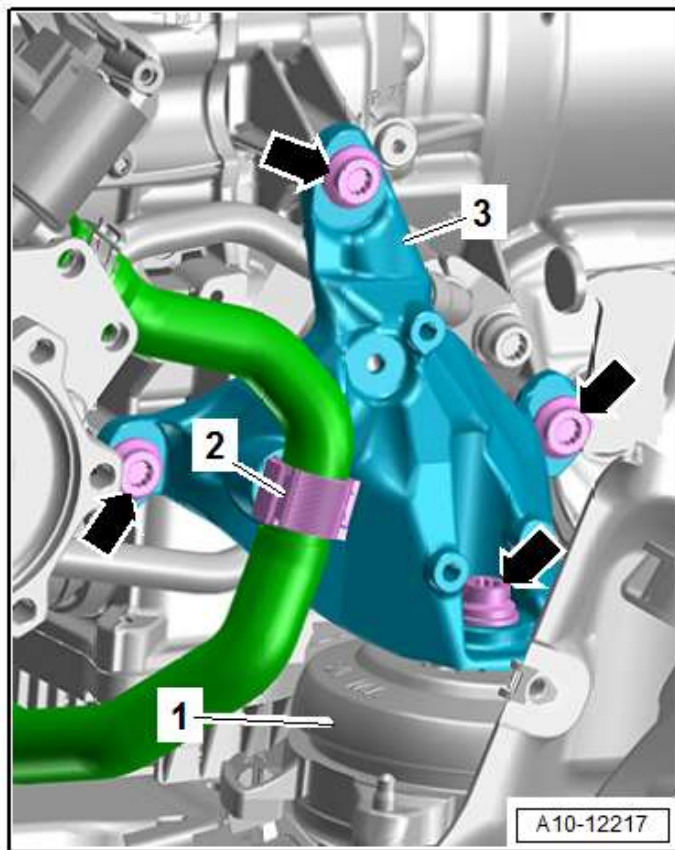
Vehicle with Criteria F8 ONLY – Remove the left side transmission mount:

- See ELSA Repair Manual: *Repair manual > Engine > 6-Cylinder Direct Injection 3.0L 4V TFSI Engine EA839 > 10 Engine Assembly > Assembly Mounts > Transmission Mount, Removing and Installing > Left Transmission Mount, Removing and Installing*

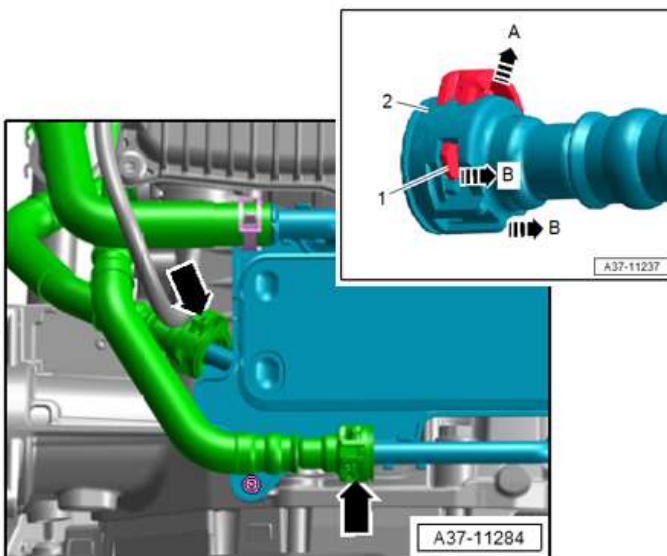
Disconnect ATF lines from ATF cooler:

- To disconnect the lines <arrows>, release the clip <1> from the connector coupling <2> in direction of <B arrows> and lift in direction of <A arrows>.

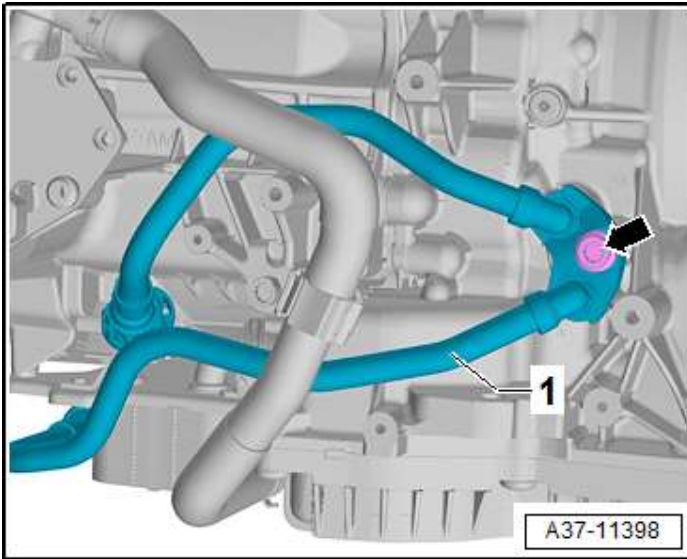
Replace transmission oil line:

- Remove the bolt <arrow>.
- Remove the ATF line <1> from the transmission.
- Installation is the reverse order of removal.

- Torque bolt <arrow> to 20 Nm.

- Remove any plugs on the ATF lines and on the transmission that were installed during removal.
- The ATF cooling function will not work and the transmission will be damaged if the plugs are forgotten.

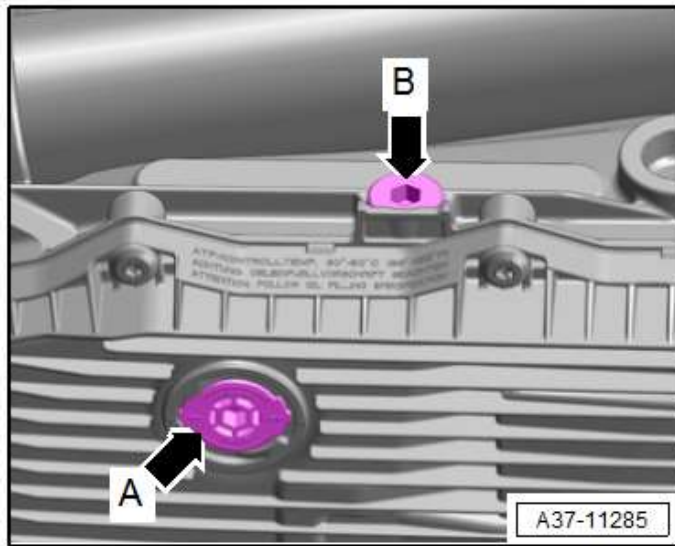
Check ATF Level:

- See ELSA Repair Manual: *Repair manual > Drivetrain > 8-Speed Automatic Transmission 0D5 > 37 Controls, Housing > ATF > ATF Level, Checking*
- Torque fill plug to 30 Nm.
- Install noise insulation in the reverse order of removal.

Unlike the description in the repair manual, the plug for the ATF level check and filling opening is not always to be replaced after checking the ATF level. The existing plug can be reused once. The plug for ATF level check and filling opening is only to be replaced if there is visible damage or dirt (the plug is only available in repair set 0D5-398-048).
