SIB 65 11 20 RECALL 20V-283: ROLLOVER SENSOR

2020-05-29

RE: Recall 20V-283: Rollover Sensor – B65 11 20

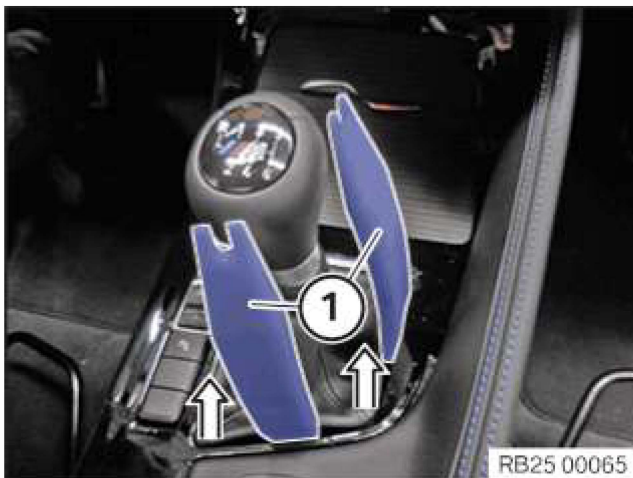
Remove gearshift lever cover

- Use wedges (1) to unclip the gaiter and pull it off upward.

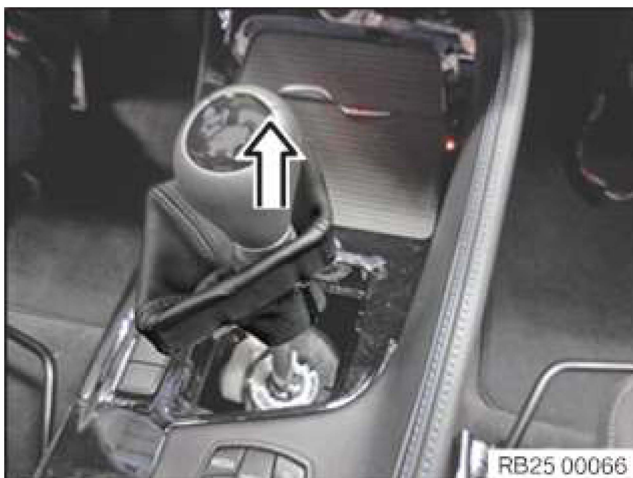
- Remove the gearshift lever knob and the gaiter by means of a powerful jolt vertically upwards.
In doing so, the tie rod must not be bent or damaged.
- Ensure that the gearshift lever knob is not twisted when removing, otherwise the anti-twist lock in the gearshift lever knob will be sheared off.

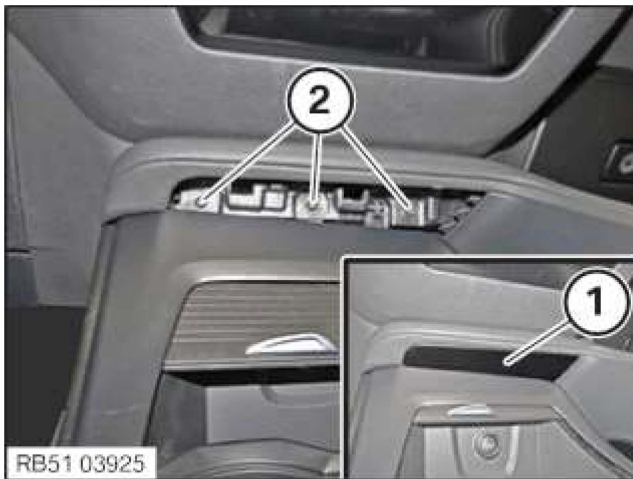
- Lever out and remove cover (1) with the special tool 0 496 571 (00 9 327).
- Loosen screws (2).

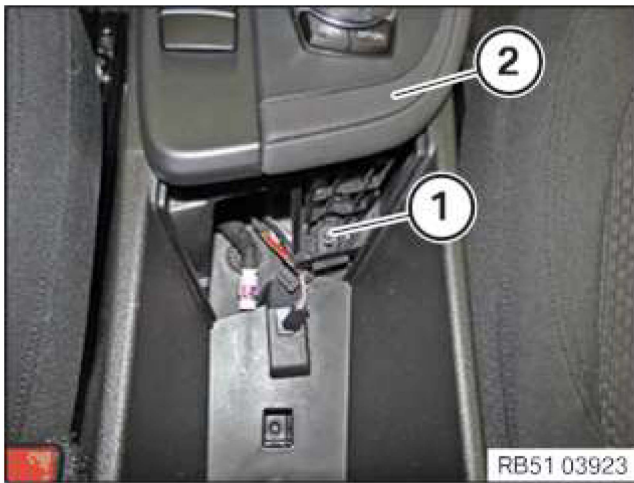
- Loosen screw (1).
- Remove decorative trim (2) and disconnect all the plug connections.
- Remove decorative trim (2).

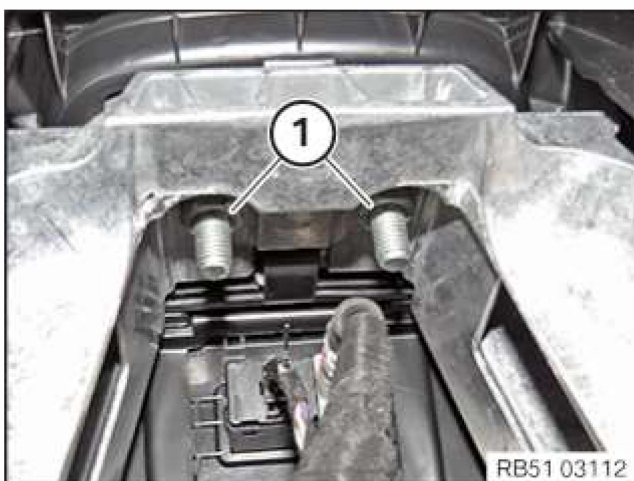
► Removing the centre armrest

- Release nuts (1) and remove centre armrest upwards.

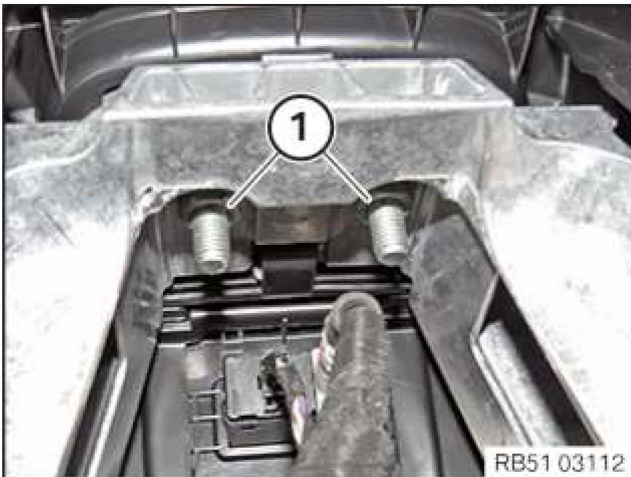
► Installing the centre armrest

- Install the centre armrest and tighten nuts (1).

Nut M8

Tightening torque 21,4Nm

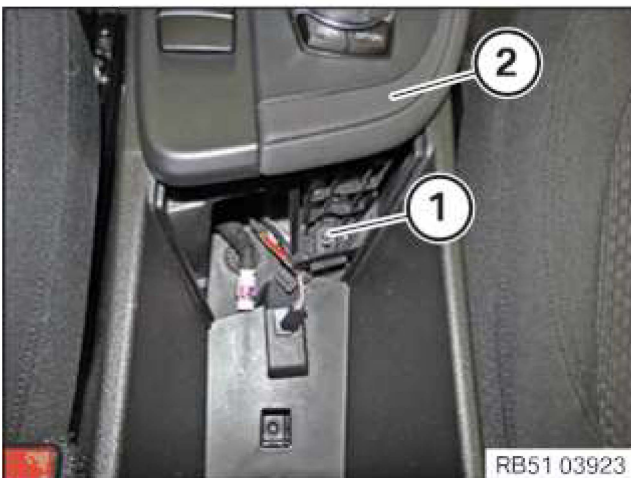
Installing the decorative trim to the centre console

- Connect all connectors.
- Install decorative trim (2).
- Tighten down screw (1).

Tightening torque
1,8Nm

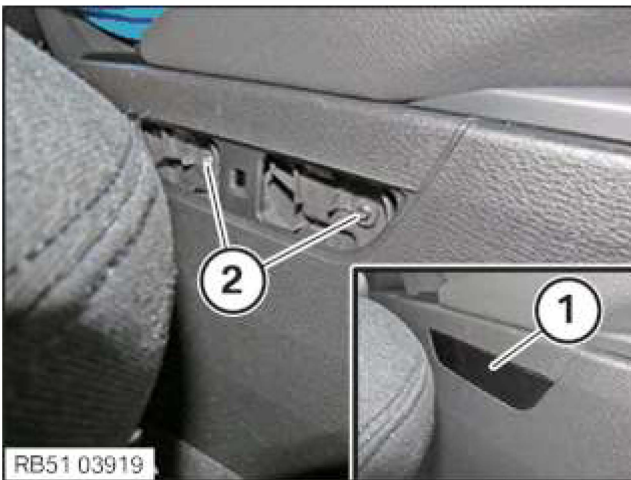
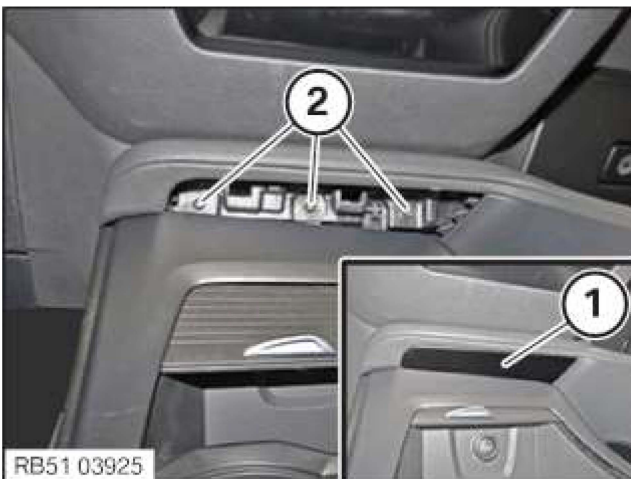
- Insert the insert (1).

- Tighten down screws (2).

- Install cover (1) and engage.

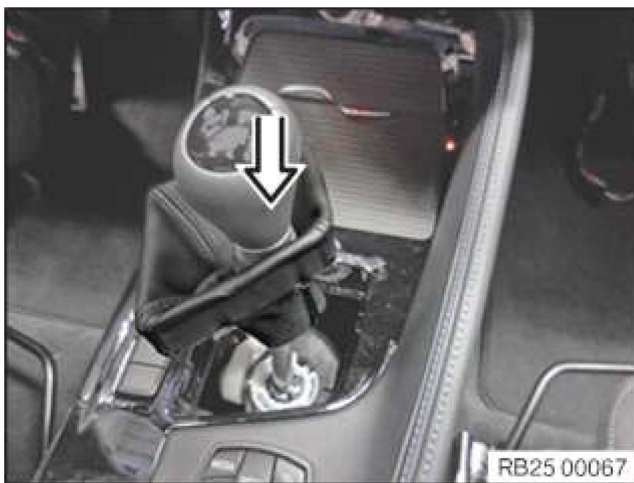
Installing the gearshift lever cover

- Place the gearshift lever knob on gearshift lever and align by lightly pressing in the direction of travel.

The anti-twist lock must bite.

- Press the gearshift lever knob with the palm of the hand until it can be felt to engage.

When installing, the tie rod of the gearshift lever must not be bent.

- Clip in gaiter (arrows).
