RE: **Recall Campaign Launch Notification**
Incorrect Passenger-Side Airbag Module Installed
MY 12 C204 Coupe (C-Class)

Campaign No.2020060011, June 2020

SUBJECT: **Model C-Class Coupe vehicles (C204 platform)**
Model Year 2012
Replace Incorrect Front Passenger-side Airbag

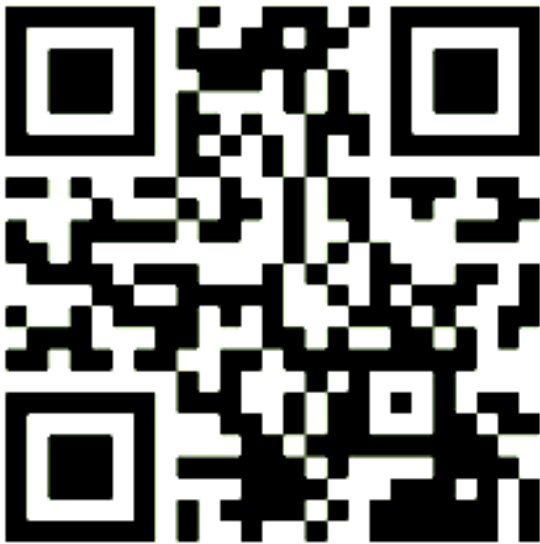
Figure 1

- Download app from Apple® store for iPhone® or Google® play for Android® (same as any other app download) then scan the QR code below to continue download (follow on-screen instructions).

- To install and transmit the data a WiFi connection is required.
- After downloading the App, a one-time security authentication is required by means of encrypted QR code. Verification can be performed by scanning the QR code below, before using the application.

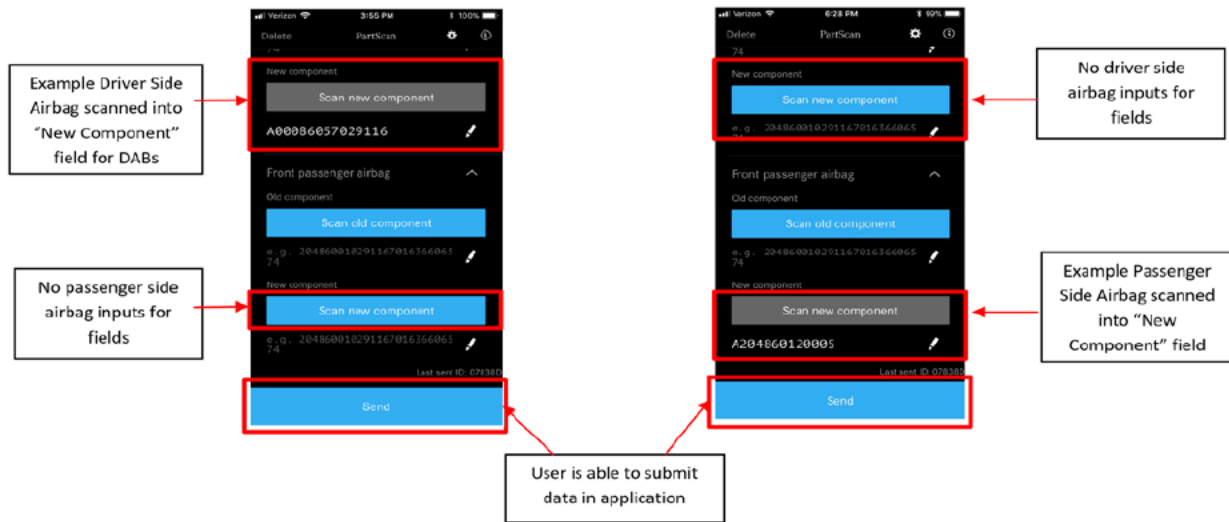
- The PartScan App must be utilized properly for every airbag recall repair in this campaign.
- If the VIN is missing, illegible or incomplete, it must be entered manually
- The airbag barcode scan may only be skipped if the barcode is missing, illegible or incomplete.
- **Never** scan a “dummy” barcode to skip the entry fields – See Example below
 - **When only the driver airbag** replacement is required, skip the passenger airbag scan by leaving fields blank.
 - **When only the passenger airbag** replacement is required scan and only press the passenger airbag “scan old component”.
- Always make sure the proper airbag is scanned in the respective entry field in the App (driver airbag for driver-side, passenger airbag for passenger-side)
- Part Scan Examples: Driver-side airbag only and Passenger-side airbag only scans

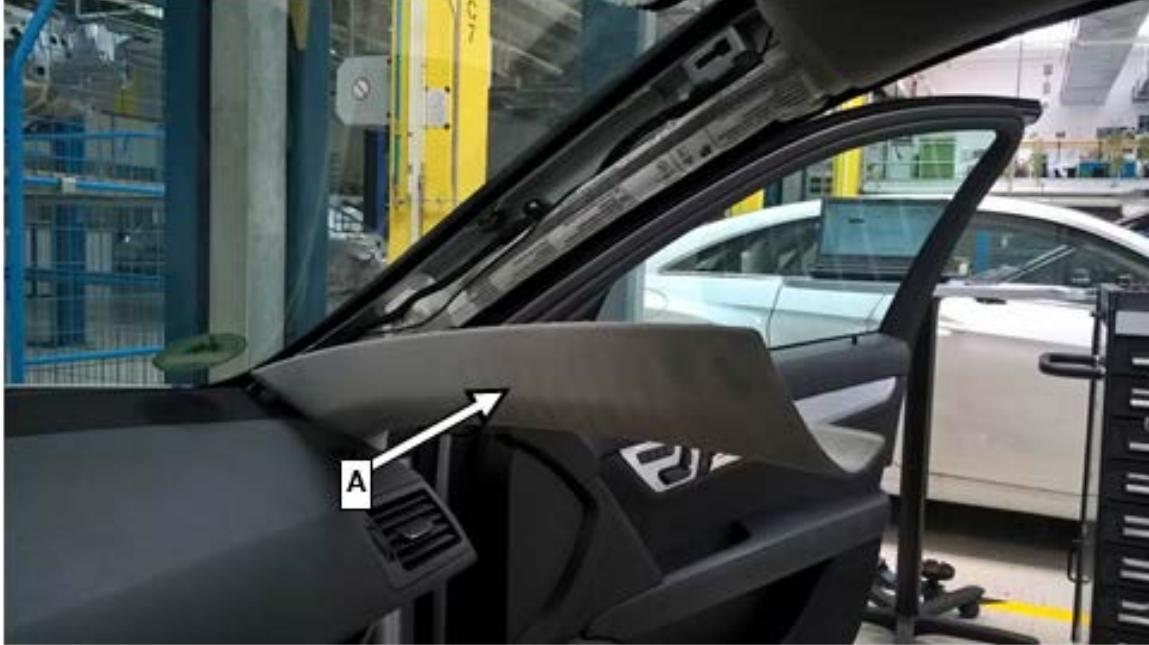
Figure 2

1. Disconnect ground line from the on-board electrical system battery.
2. Remove right A-pillar trim (**A, figure 2**).

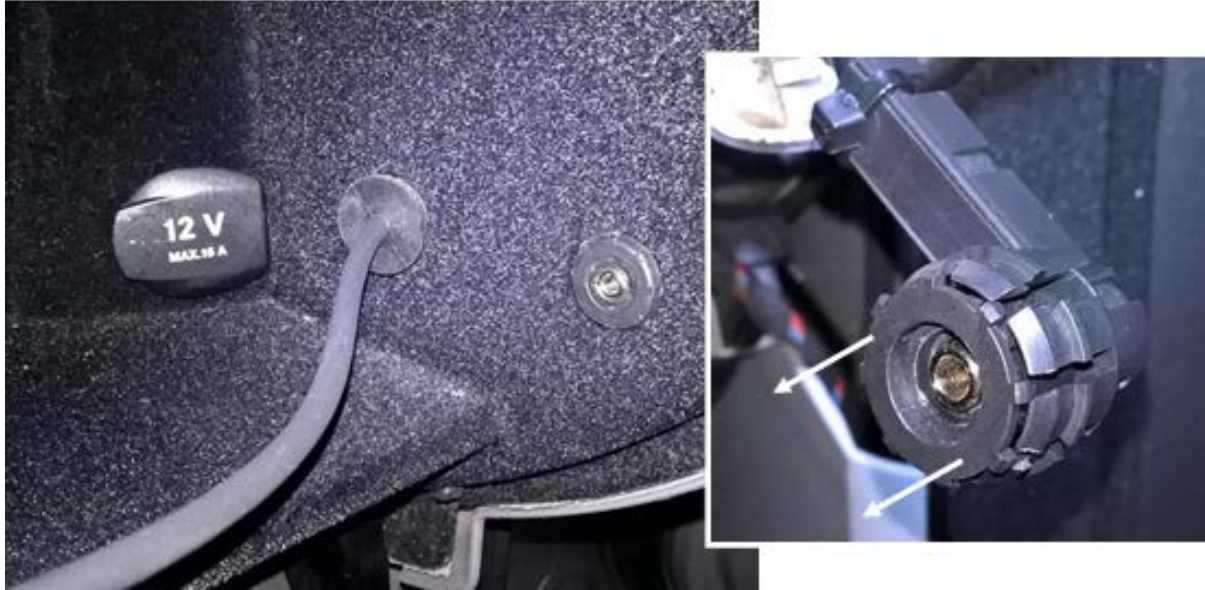
Figure 3

i Release inner retaining ring (**figure 3**) at the AUX connection towards the inside. The connection can then be removed from the glove box housing.

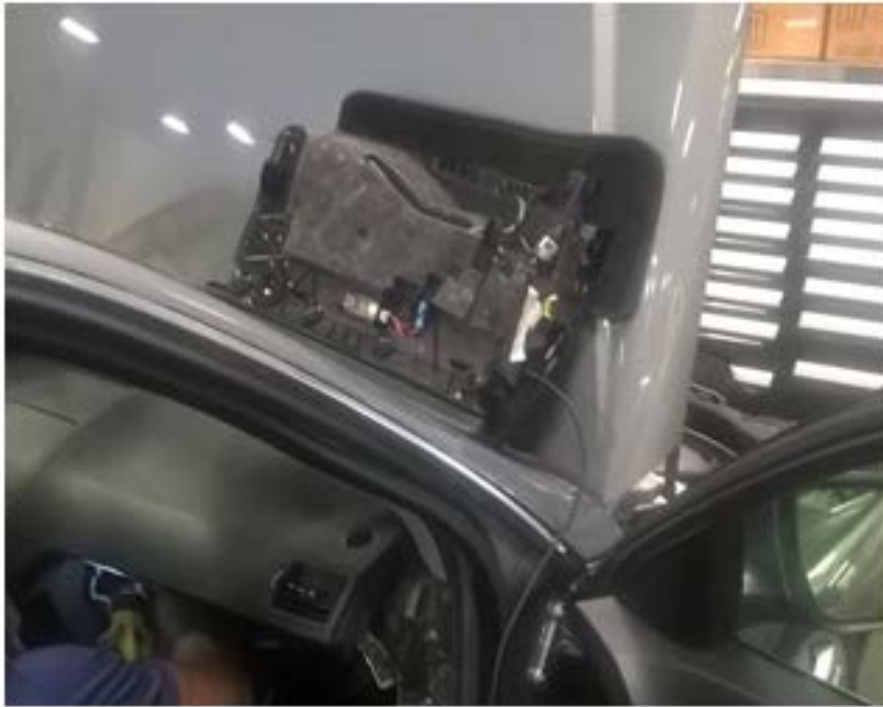
Figure 4

i Pull out the iPod cable as far as possible and set down glove box housing on the windshield **with** exterior iPod cable connected (**figure 4**).

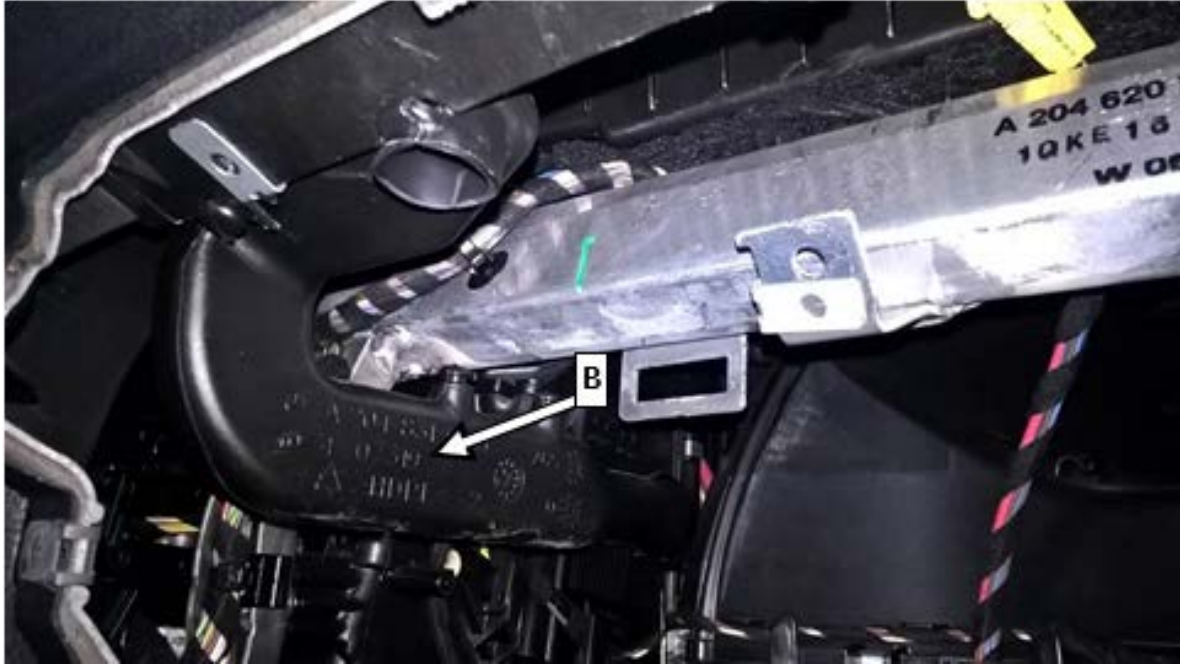
Figure 5

4. Remove air duct (**B, figure 5**) above the glove compartment.

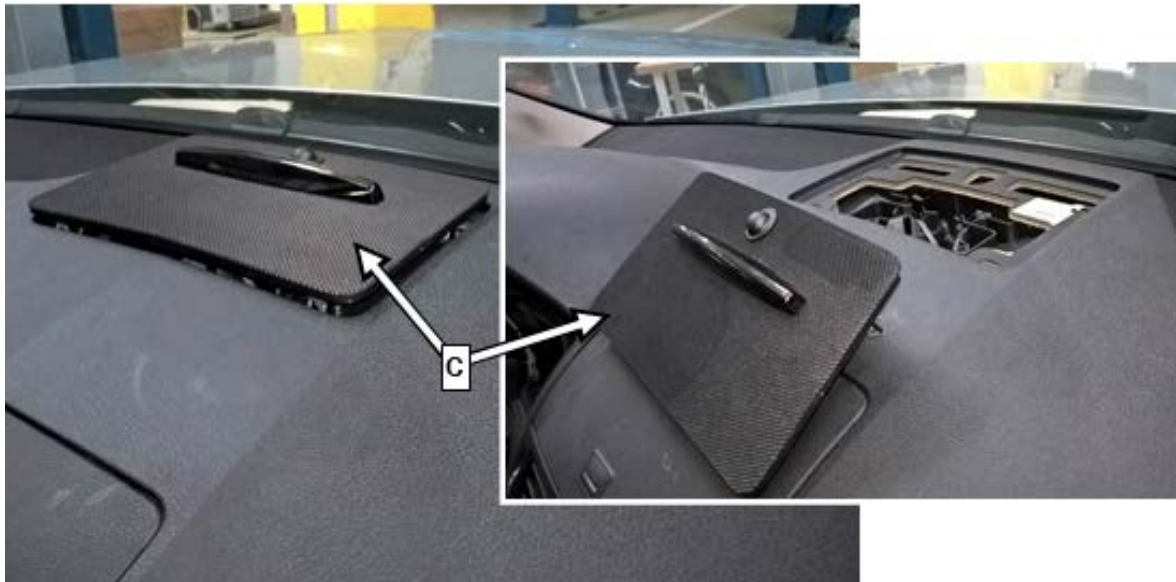
Figure 6

5. Unclip and remove cover (**C, figure 6**) at the instrument panel on top.

i With a sound system, also remove speaker under the cover.

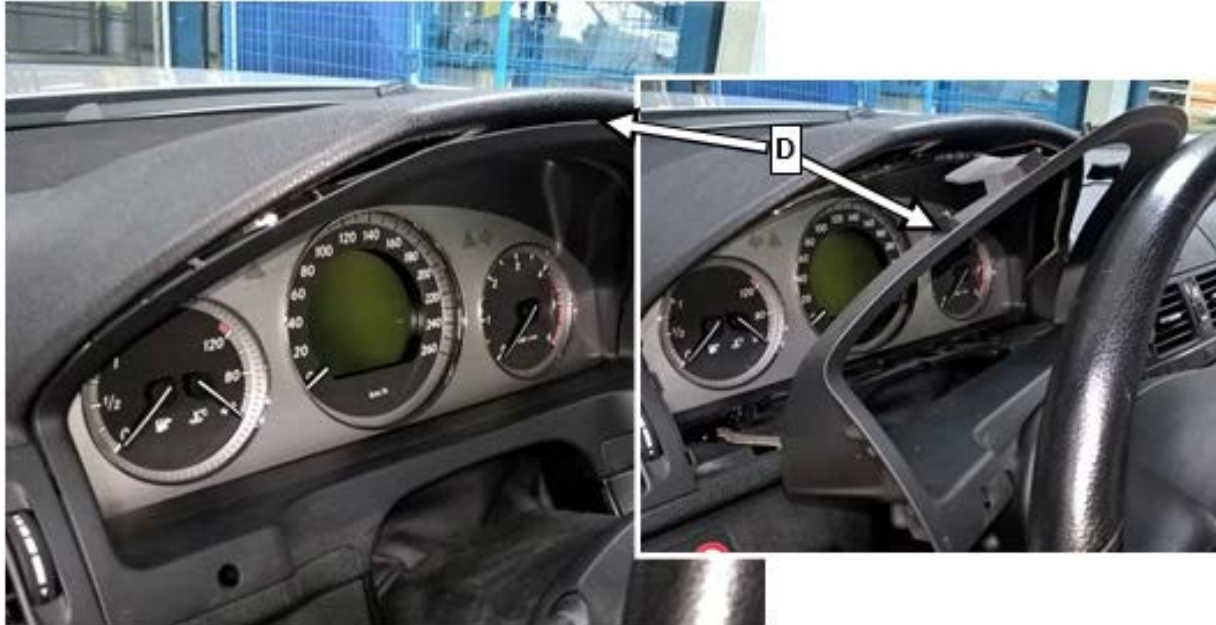
Figure 7

8. Remove trim (**D, figure 7**) around the instrument cluster.

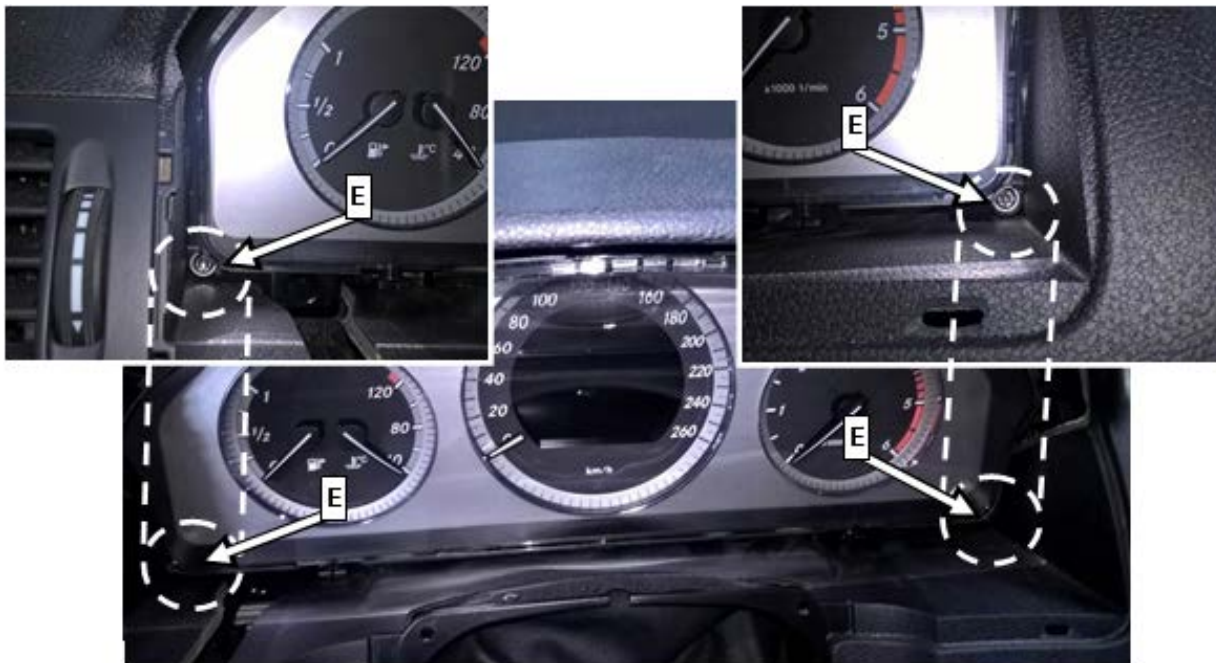
Figure 8

9. Remove the two bottom threaded connections (**E, figure 8**) of the instrument cluster.

i These screws are simultaneously fasteners for the instrument panel.

i The upper two screws do not need to be removed.

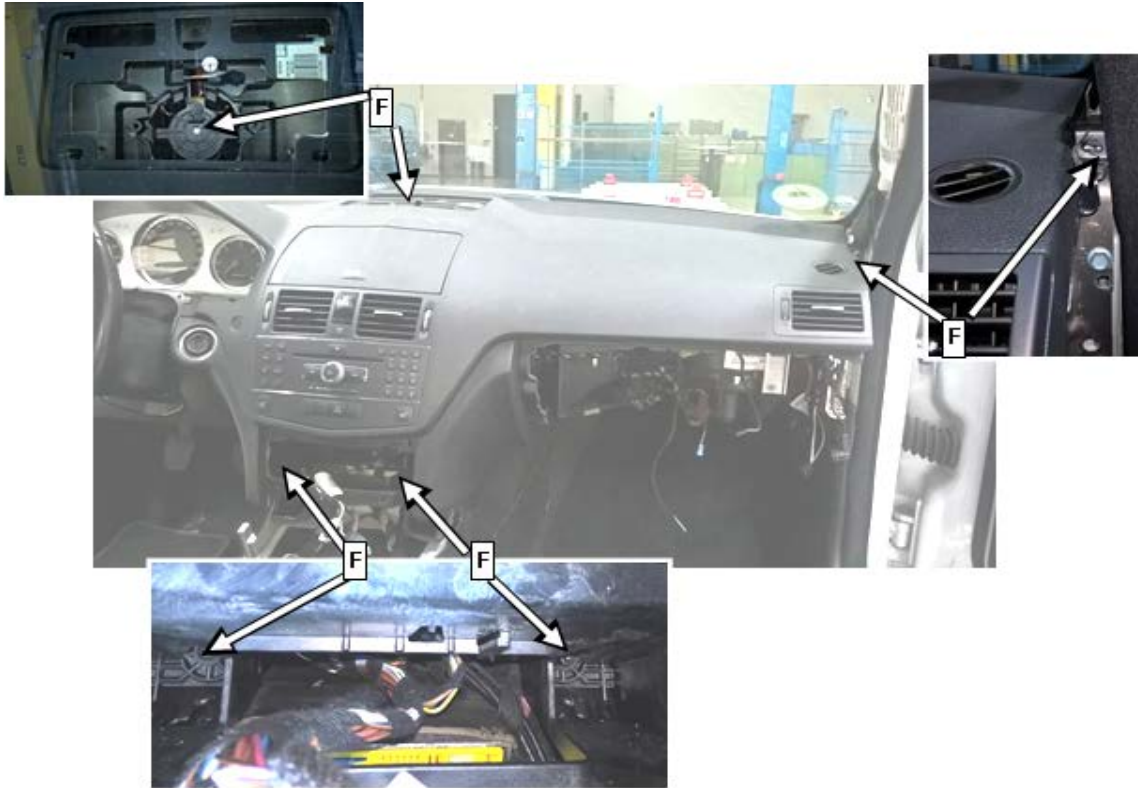
Figure 9

10. Remove four screws (F, figure 9) for fastening the instrument panel

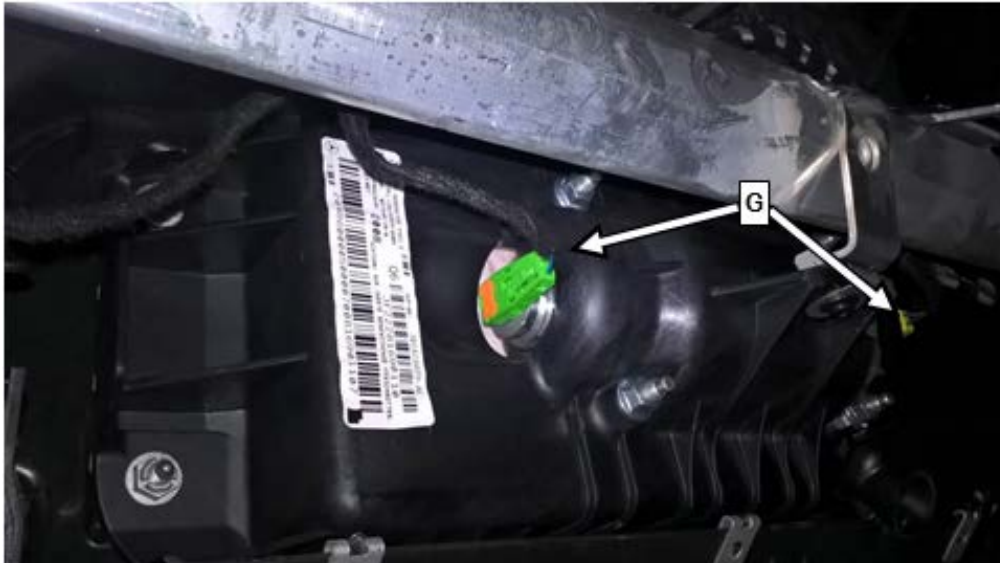
Figure 10

11. Disconnect electrical contacts (G, figure 10) at the front passenger airbag.

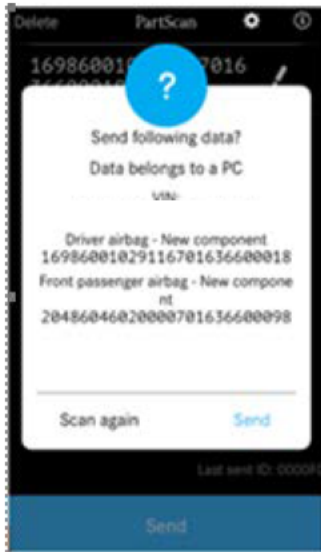
Figure 15

- i** All required data can also be read off and entered manually.
18. Create a scan ID via the "Send" button (figure 15).
 - i** The generated scan ID (figure 16) must be recorded in writing in the workshop order and then stored in a tamper-proof manner.

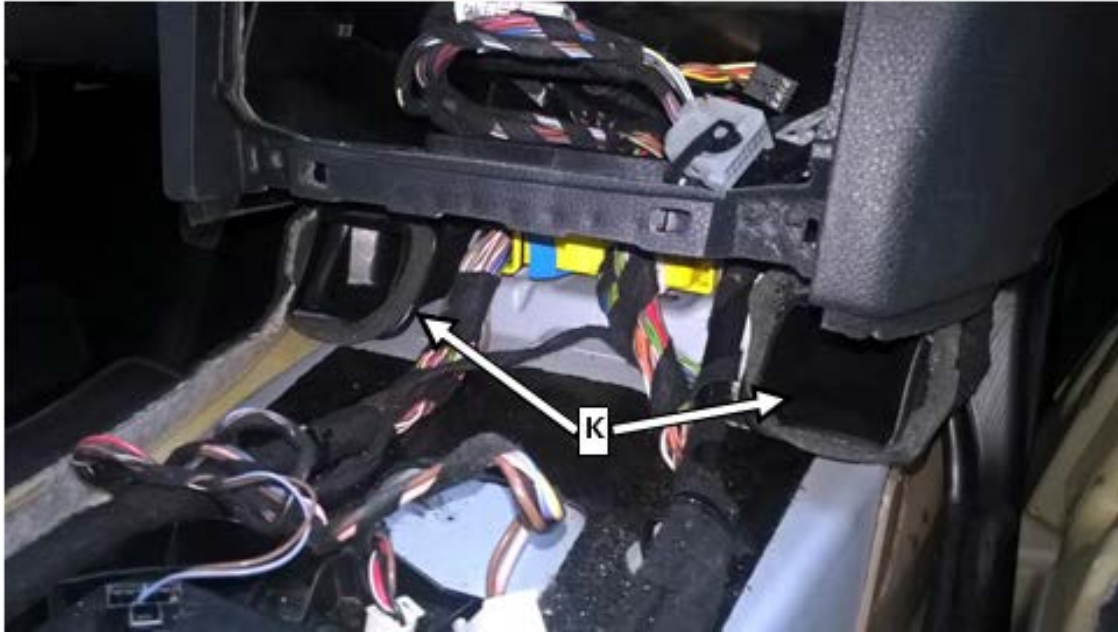
Figure 17

19. Carefully insert the new front passenger airbag authorized for the vehicle from below and fasten to the instrument panel with 4 nuts.
 - i** Contrary to the work instructions in WIS, it is **not** necessary to check the supplemental restraint system with XENTRY/DAS following front passenger airbag replacement.
 - Nm** Nut of front passenger airbag at instrument panel 5 Nm.
20. Place instrument panel back into position and install the air ducts (K, figure 17) correctly.
 - i** The air ducts are pulled out when the instrument panel is raised.

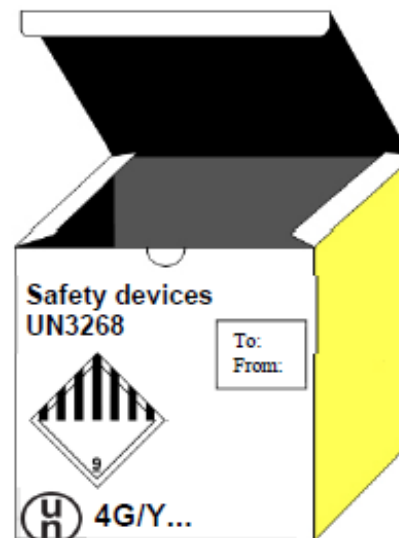
- Carefully open received box and remove new airbag. Keep box intact & save all contents!
- Place used airbag into replacement airbag box, re-using any packaging material (e.g., cardboard inserts) used for the new airbag. Package as the new airbag was packaged.
- Use plastic adhesive tape 50 mm wide to secure the box closed. Do not obscure labels or text on the box with the tape.
- Ensure that the 4G fiberboard box is not ripped or damaged.

- A Class 9 Miscellaneous label must be clearly visible on one side of the box.

- The following words ("marking") must also be clearly visible on the same side of the box as the Class 9 label:
Safety devices
UN3268 (font size must be $\geq \frac{1}{2}$ inch)
- Affix "To/From" address label to same or adjacent packaging face as the hazardous markings/labels.
- The UN 4G code preprinted near the bottom edge of the box must also be clearly visible.
