SUBJECT: Safety Recall 20S30

Certain 2011-2014 Fiesta, 2013-2014 Fusion and MKZ, 2013-2015 C-MAX and Escape, 2012-2015 Focus, 2015 MKC and Mustang, and 2014-2016 Transit Connect Vehicles
Side Door Latch Previously Repaired Under 15S16 or 16S30

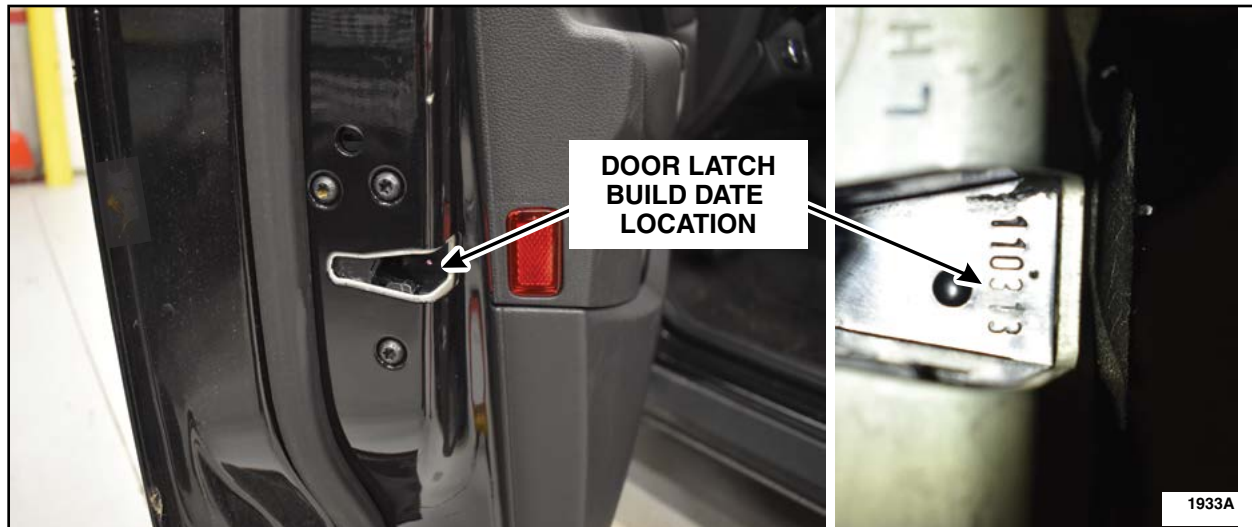
FIGURE 1

NOTE: If there is grease or debris covering the door latch build date, use a shop rag to wipe away the grease prior to taking the picture.

NOTE: Date code style and orientation may vary. Date codes can be from 4 to 7 alphanumeric characters.

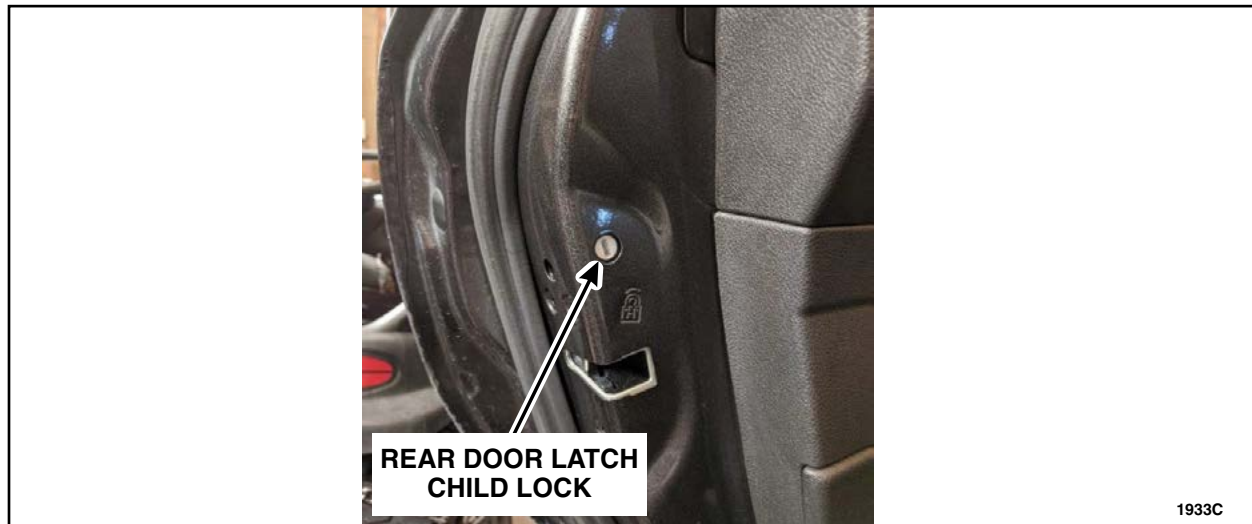
FIGURE 2

3. Inspect and record if the rear door latch has the presence of a child lock as evidenced by a white slotted circle. See Figure 2

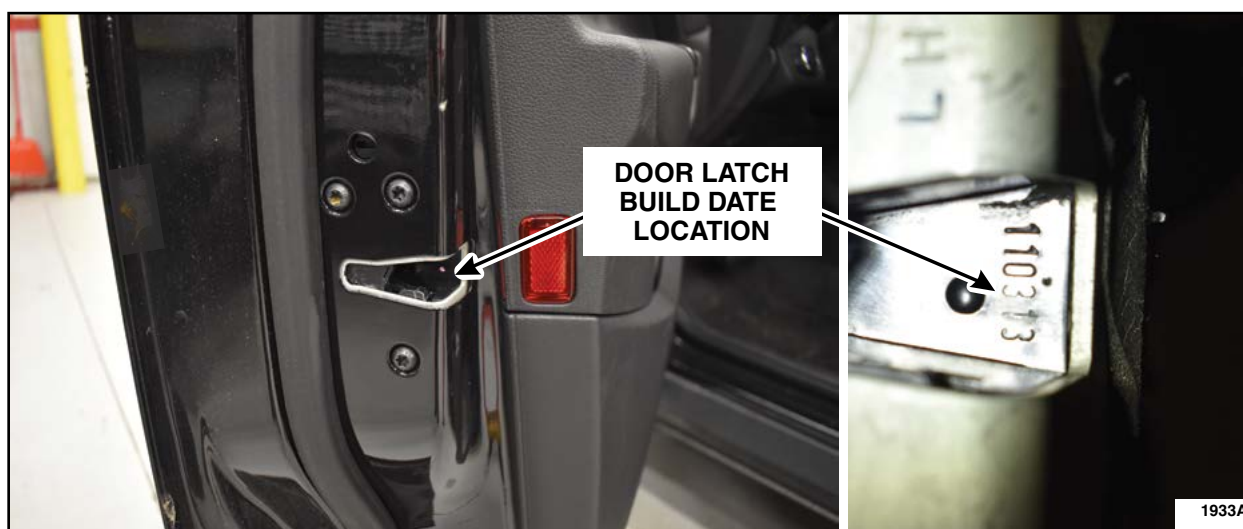
FIGURE 1

NOTE: Latch date code can be comprised of numbers or letters 4-7 characters in length.

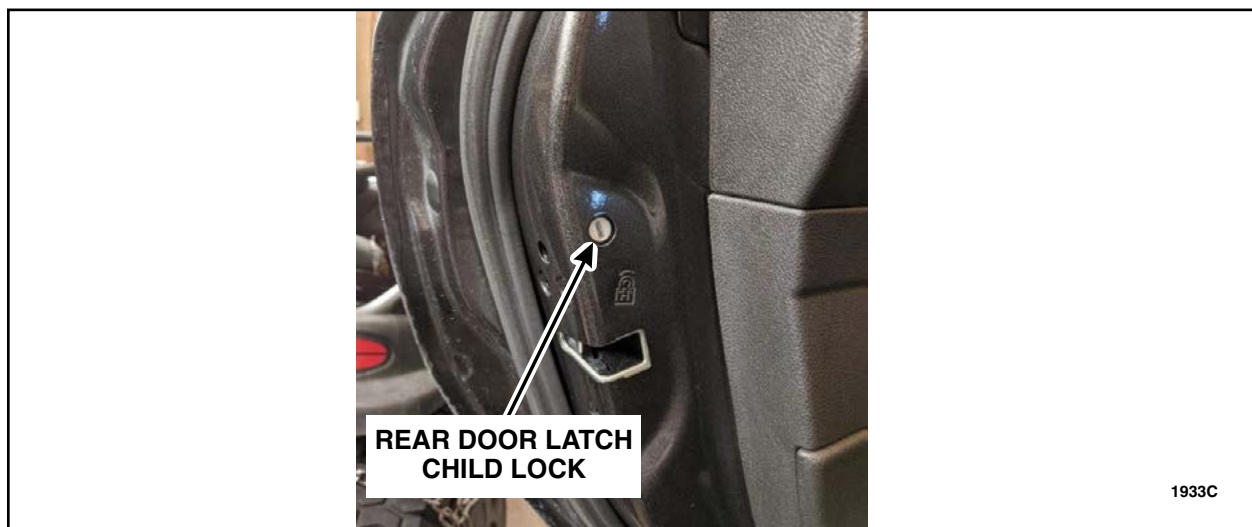
FIGURE 2

1. Replace all four door latches. For additional information, refer to Workshop Manual (WSM) Section 501-14.
2. As each old door latch is removed, perform the Door Latch Functionality Bench Test on page 4.
3. When repairs are complete, verify the presence of a child lock in each of the rear door latches. See Figure 2.

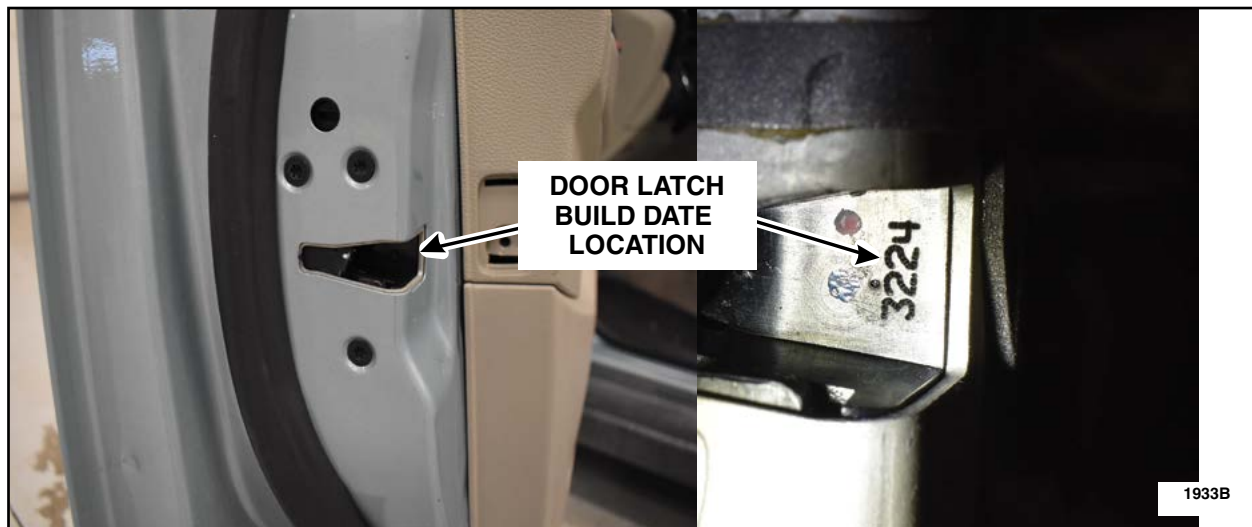
FIGURE 3

4. Once the **new** latches have been installed in the vehicle, record all four date codes of the new latches. Additionally, capture a picture of the date code of each new door latch (four pictures total) showing them installed in the vehicle. These pictures will need to be submitted in the SSSC web questionnaire. See Figure 3.

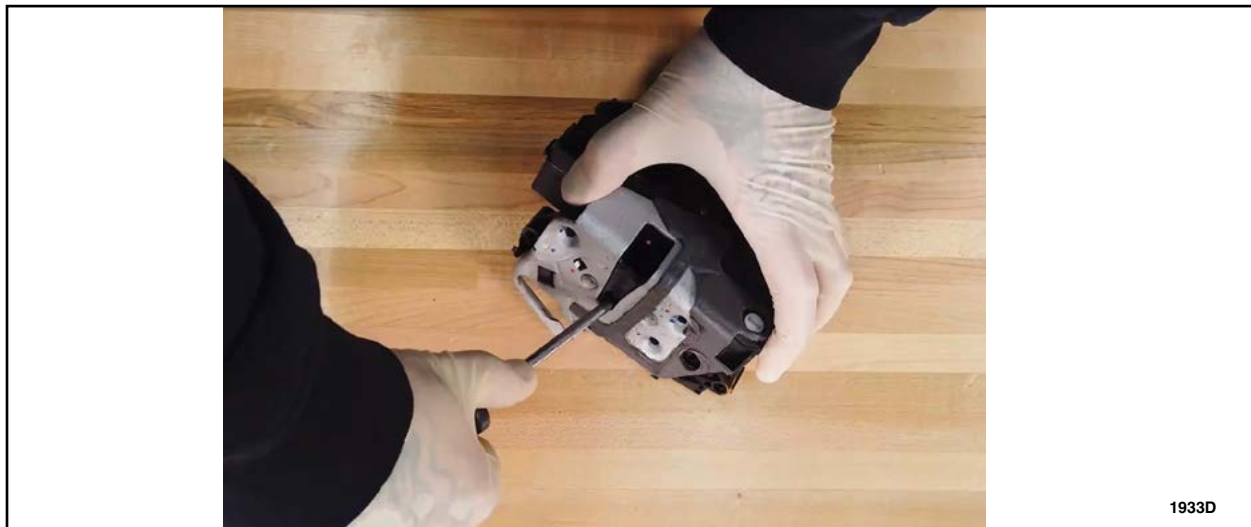
FIGURE 4

1. Using a suitable screwdriver, insert and engage the door latch mechanism. See Figure 4.

NOTE: Rear door latch shown, Front door latch similar.

4. Re-engage the latch with the screwdriver. See Figure 4.

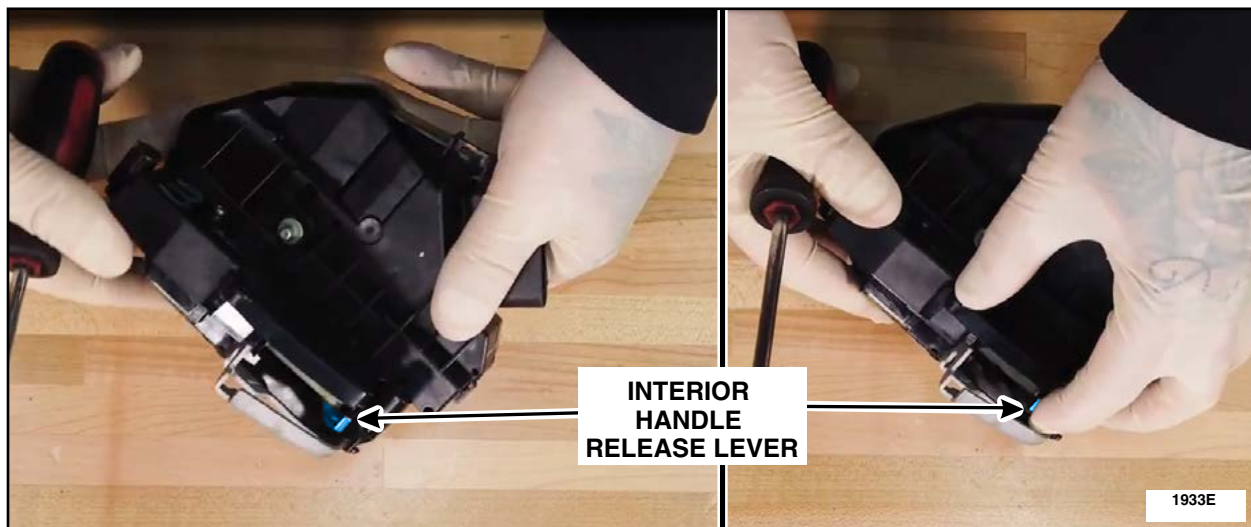
FIGURE 5

2. Turn the door latch on its side, and slide the interior handle release lever to release the latching mechanism. See Figure 5.

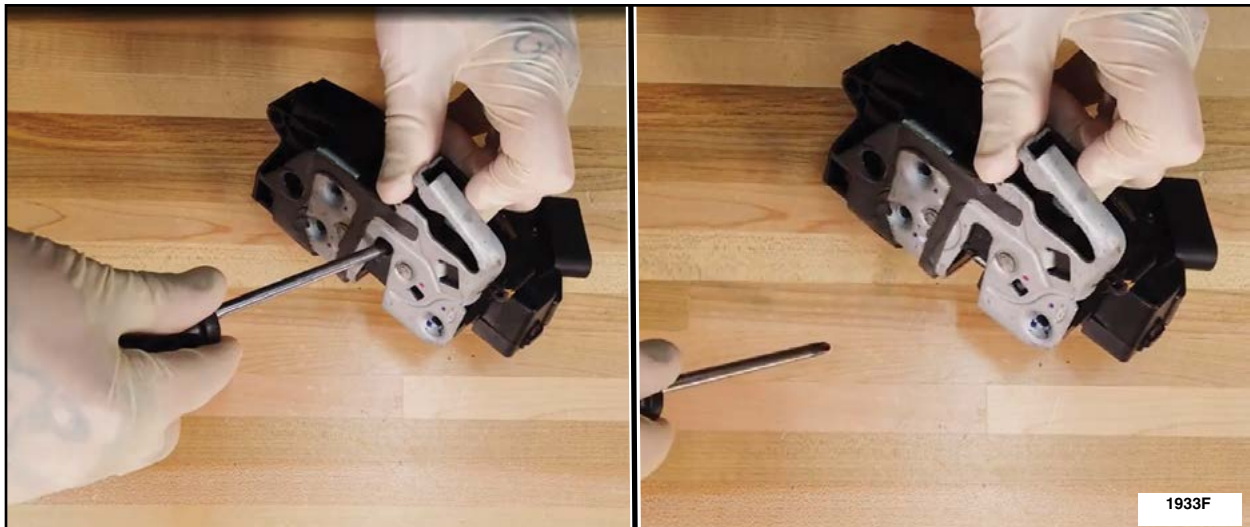
FIGURE 6

3. With the interior handle release lever engaged, place screwdriver back in the latch and verify that the latch releases. See Figure 6.

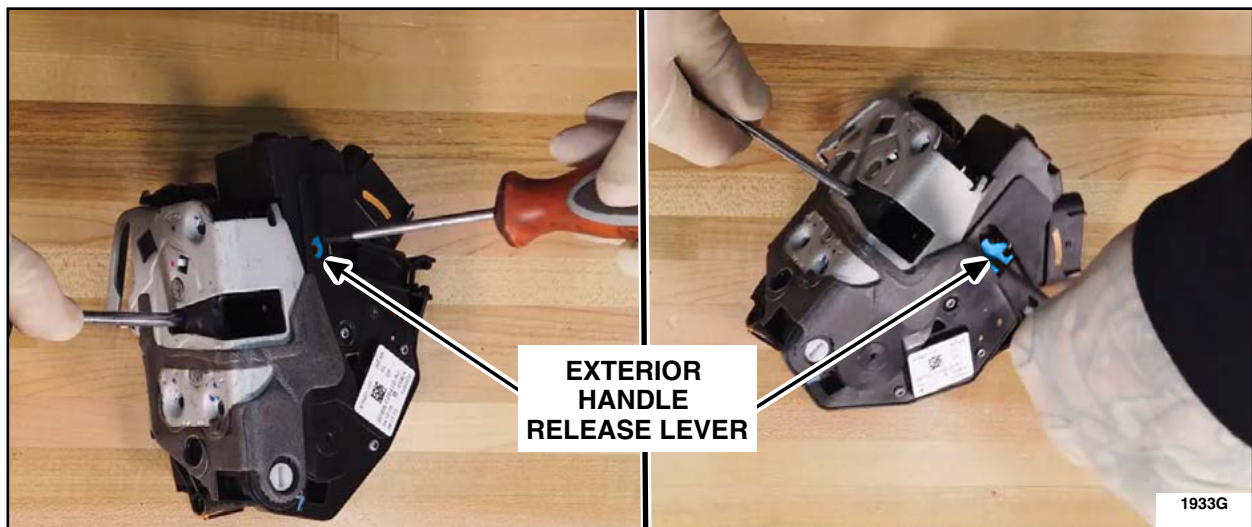
FIGURE 7

5. After the latch has been placed in the latched position, take a second screwdriver and actuate the exterior handle release lever. See Figure 7.

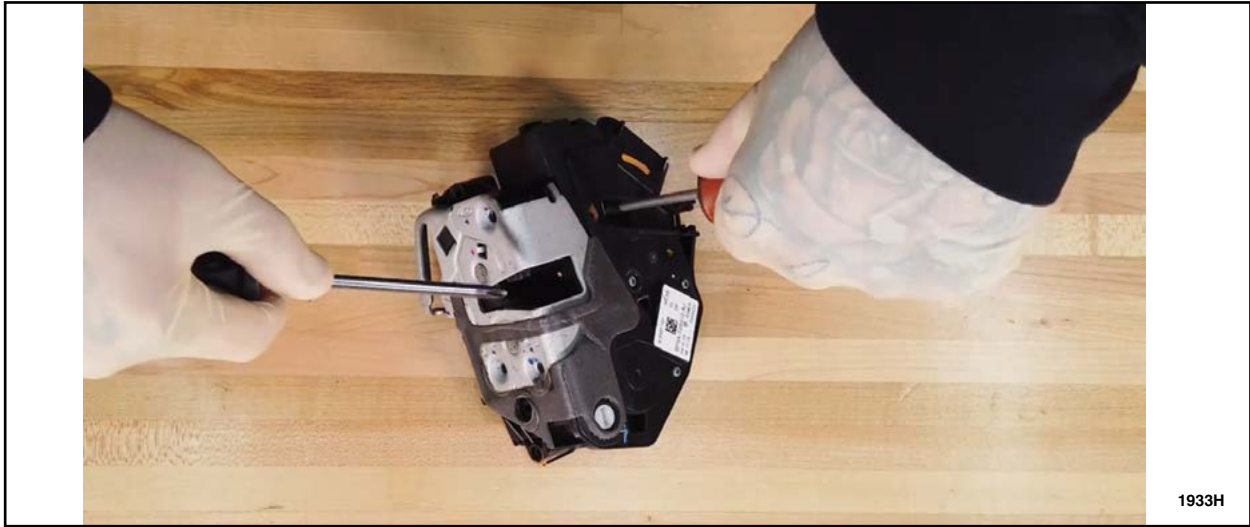
FIGURE 8

6. With the exterior handle release lever engaged, verify that the latch releases. See Figure 8.

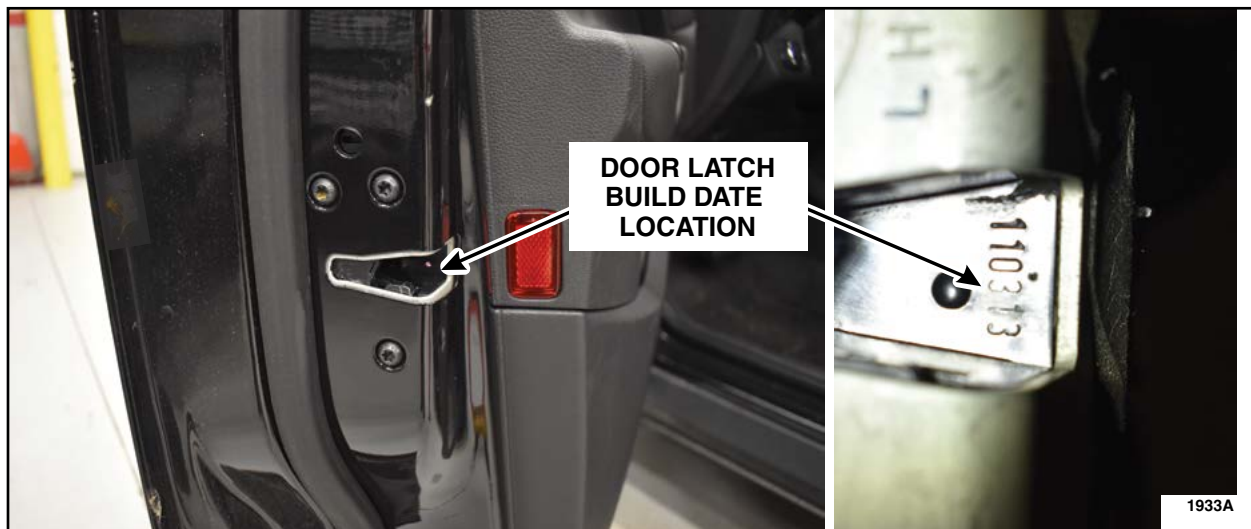
FIGURE 1

NOTE: Latch date codes can be comprised of numbers or letters 4-7 characters in length.

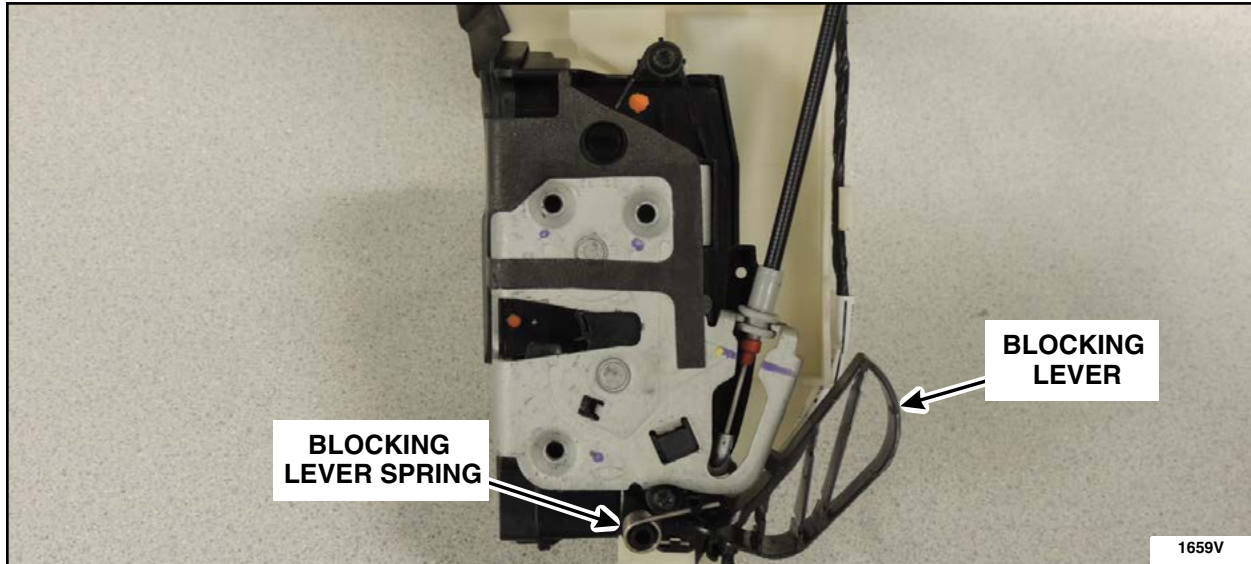
FIGURE 2

IMPORTANT: If equipped, ensure that the blocking lever and blocking lever spring are transferred to the *new* door latch, along with all other components removed from the old door latch.
See Figure 2.

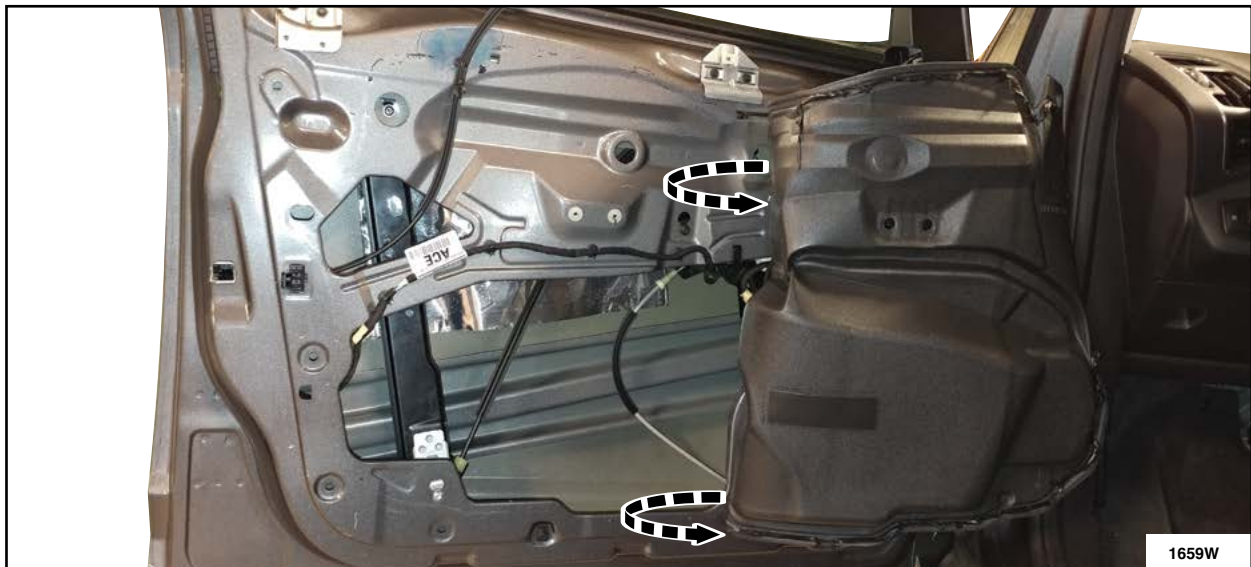
FIGURE 3

NOTE: For front door latch replacement, it is not necessary to remove the door modules, speakers, or water shield. To access components for removal, position aside the water shield as needed. See Figure 3.

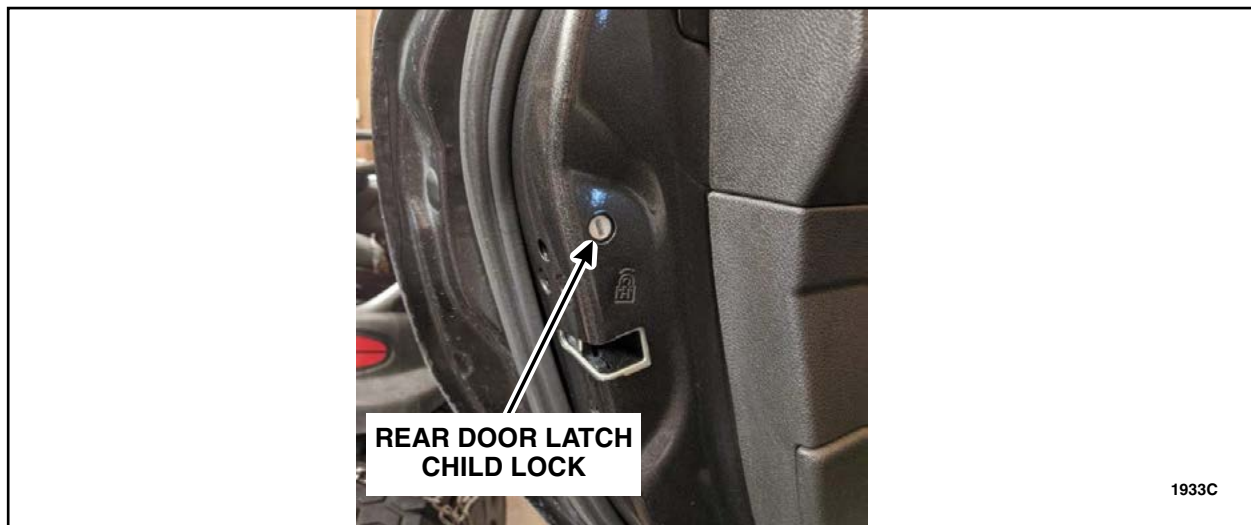
FIGURE 4

3. Verify the presence of a child lock in both rear doors. See Figure 4.

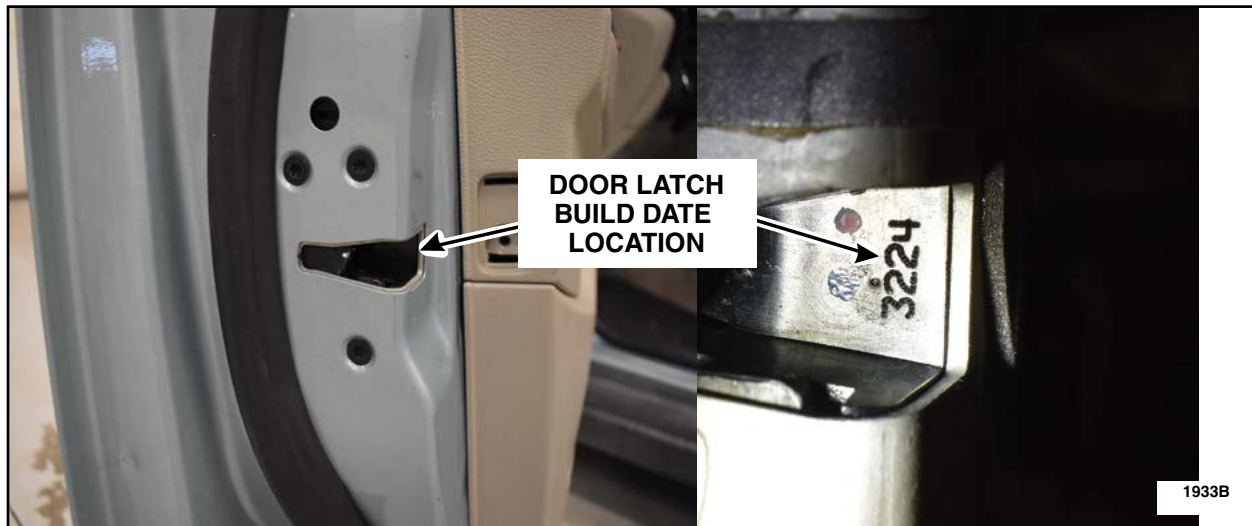
FIGURE 5

4. Once the new latches have been installed in the vehicle, record all four date codes of the new latches. Additionally, capture a picture of the date code of each new door latch (four pictures total) showing them installed in the vehicle. These pictures will need to be submitted on the SSSC web questionnaire. See Figure 5.

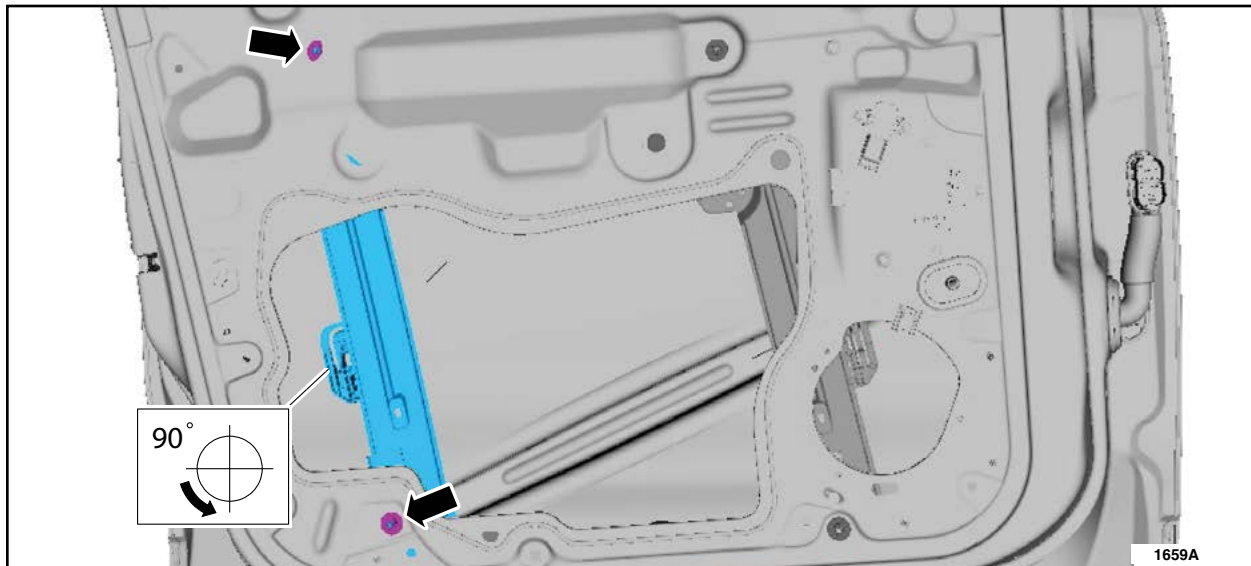
FIGURE 6

NOTE: For front door latch replacement, it is not necessary to completely remove the window regulator. Remove the two bolts and position aside the outer portion of the window regulator. See Figure 6.

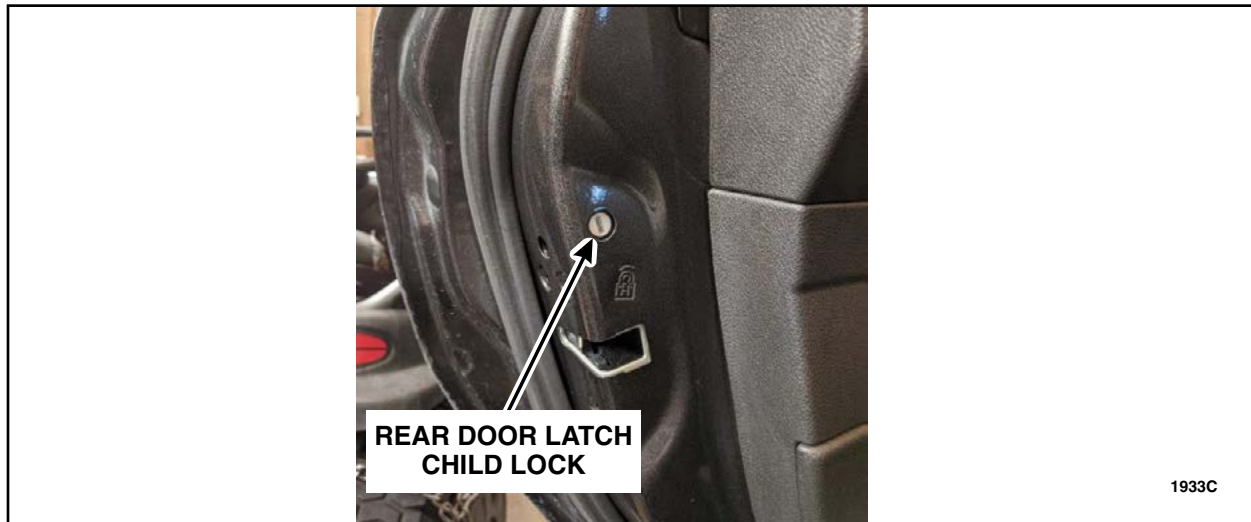
FIGURE 7

3. Verify the presence of a child lock in both rear doors. See Figure 7.

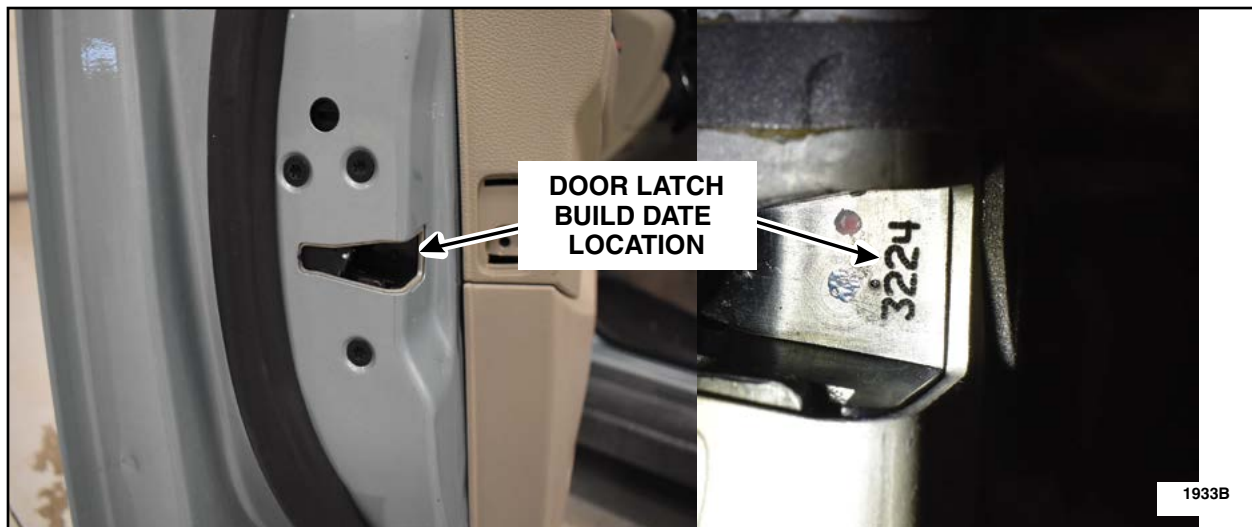
FIGURE 8

4. Once the **new** latches have been installed in the vehicle, record all four date codes of the new latches. Additionally, capture a picture of the date code of each new door latch (four pictures total) showing them installed in the vehicle. These pictures will need to be submitted on the SSSC web questionnaire. See Figure 8.

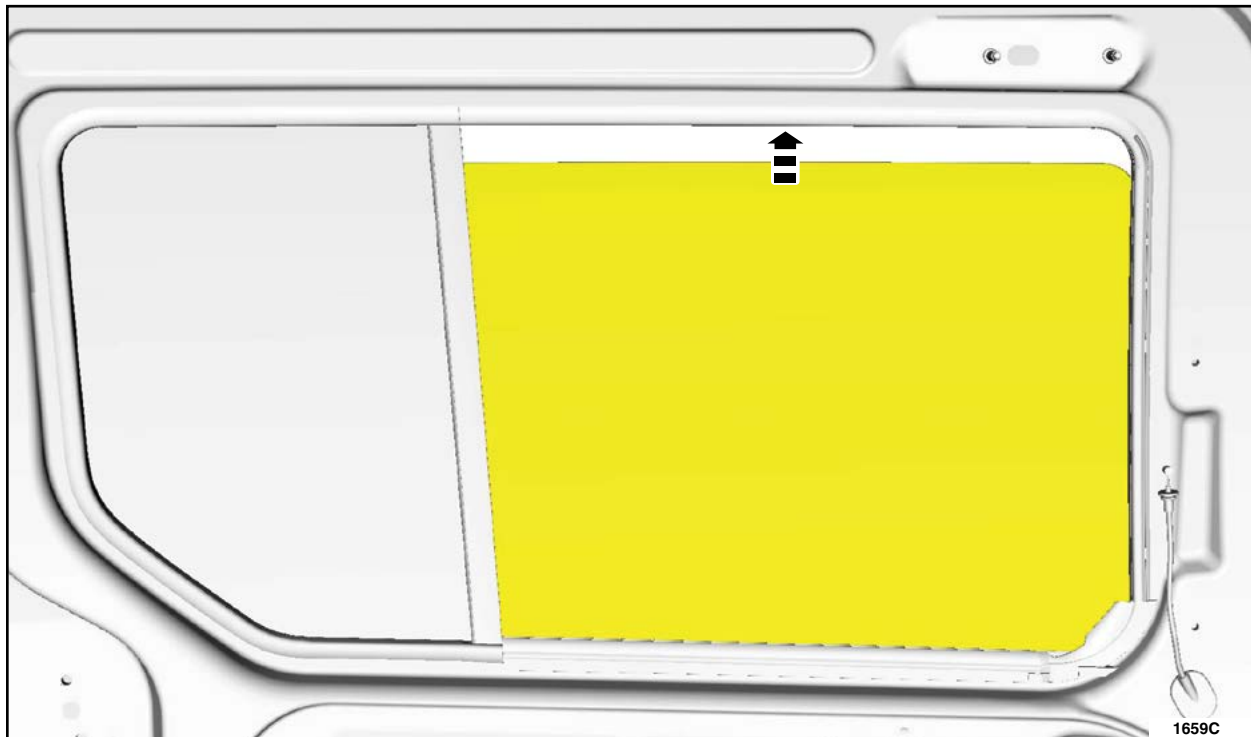
FIGURE 9

1. Remove the sliding door trim panel. Please follow the WSM procedures in Section 501-05.
2. Raise the sliding door glass to the full up position. See Figure 9.

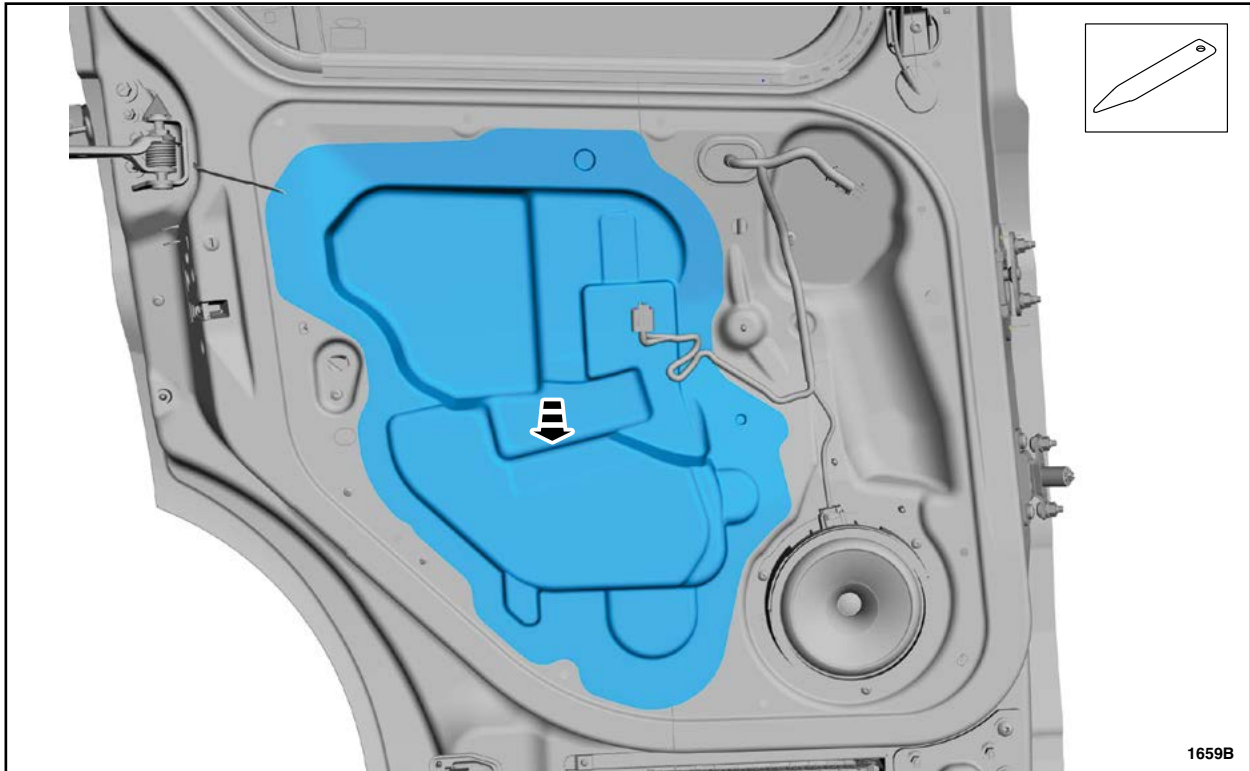
FIGURE 10

3. Remove the sliding door watershield using an interior trim remover tool. See Figure 10.

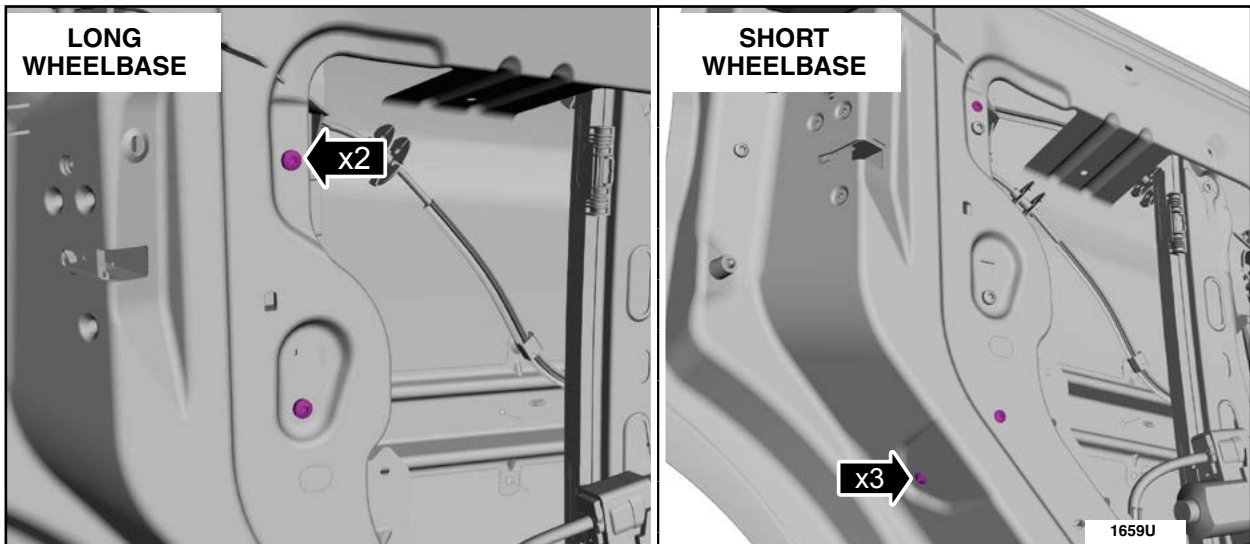
FIGURE 11

4. Remove the sliding door latch bolts. See Figure 11.

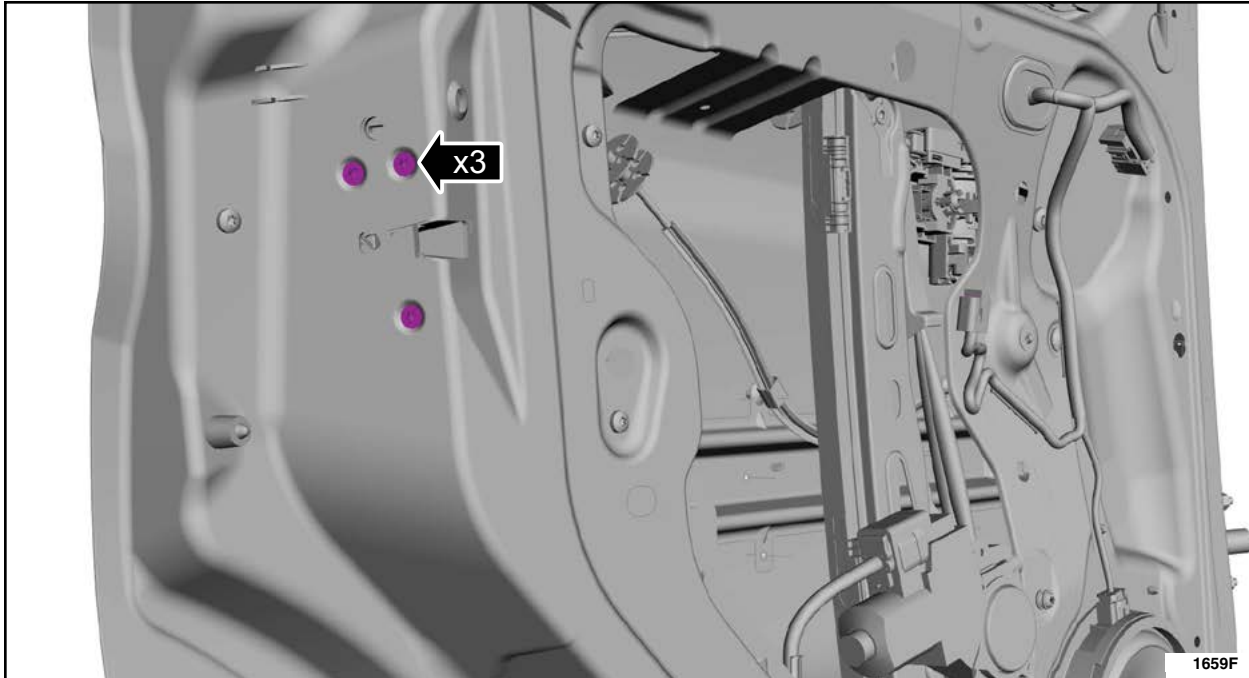
FIGURE 12

5. Remove the sliding door latch bolts. See Figure 12.

- Torque: 106 lb.in (12 Nm).

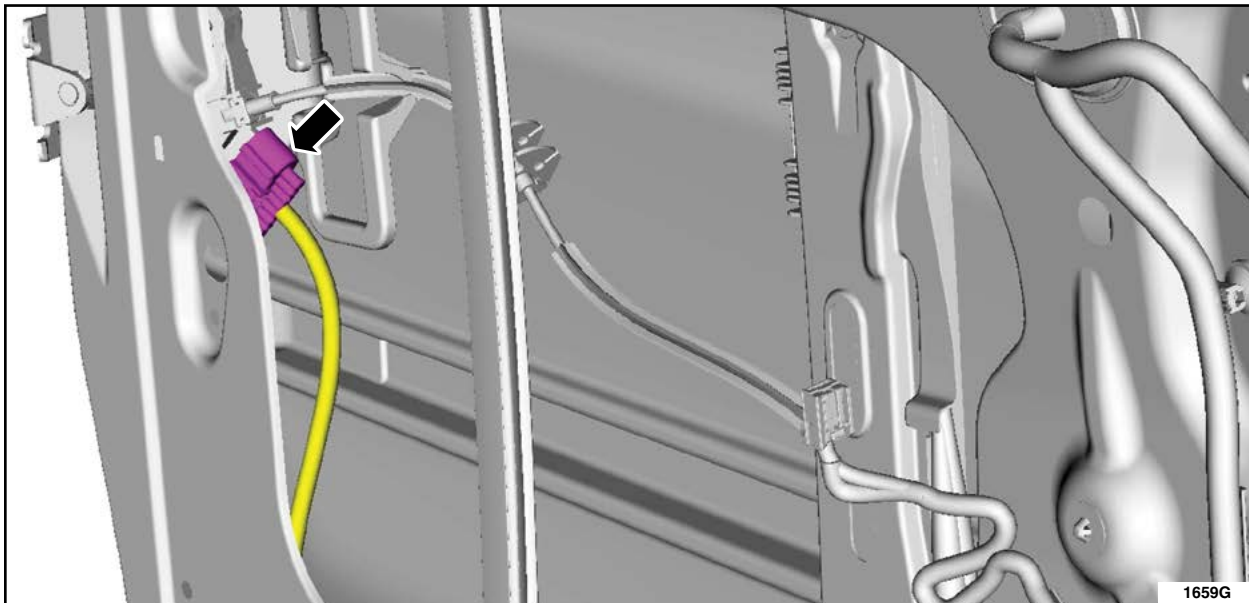
FIGURE 13

6. Disconnect the electrical connector from the sliding door latch. See Figure 13.

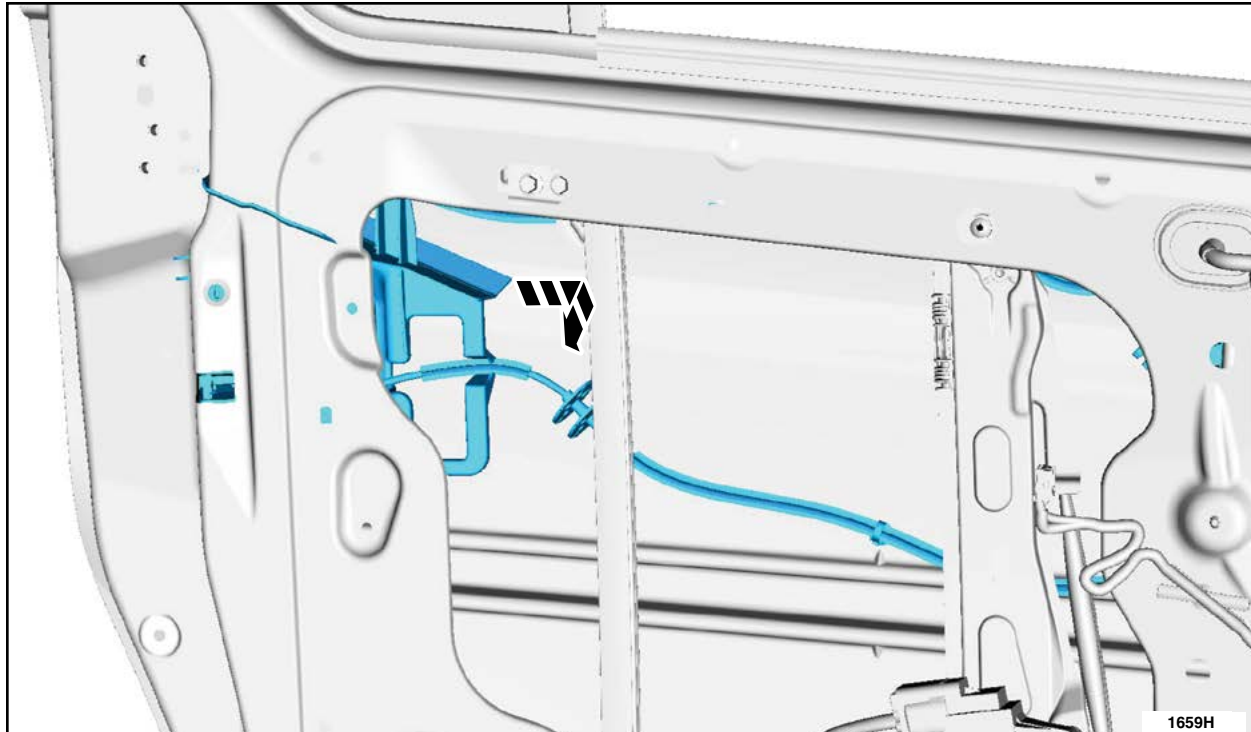
FIGURE 14

7. Position the sliding door latch out of the sliding door. See Figure 14.

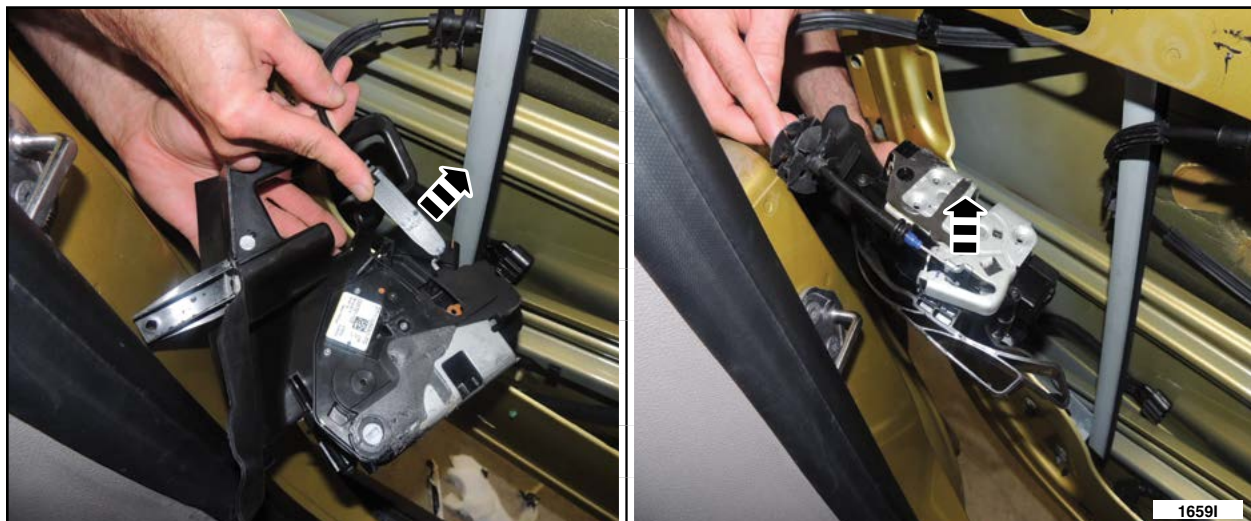
FIGURE 15

8. Disconnect the interior and exterior sliding door latch cables. Remove and discard the sliding door latch. See Figure 15.

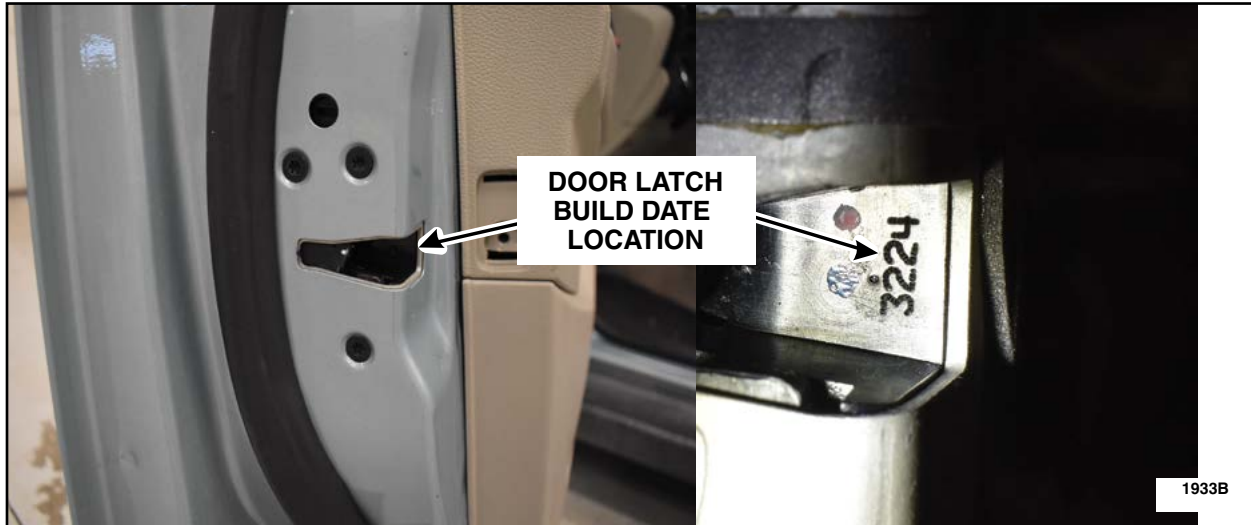
FIGURE 16

10. As each old door latch is removed, perform the Door Latch Functionality Bench Test. See Page 14.
11. Once the **new** latches have been installed in the vehicle, record both date codes of the new latches. Additionally, capture a picture of the date code of each new door latch (two pictures total) showing them installed in the vehicle. These pictures will need to be submitted on the SSSC web questionnaire. See Figure 16.

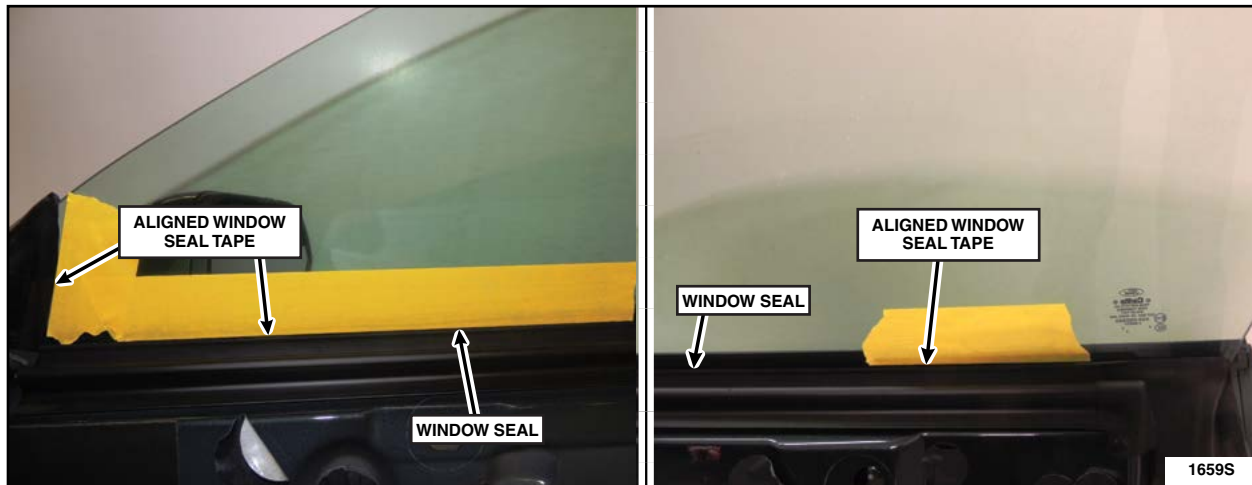
FIGURE 17

1. Remove the front door trim panel. Please follow the WSM procedures in Section 501-05.
2. Align and apply masking tape or equivalent to window glass fore and aft along window seals as reference points for alignment during re-installation of the window glass. See Figure 17.

NOTE: When reinstalling the window glass, align the tape with the window seal to ensure proper fit before tightening the fasteners. Door window glass adjustment is not necessary when following this procedure. See Figure 17.

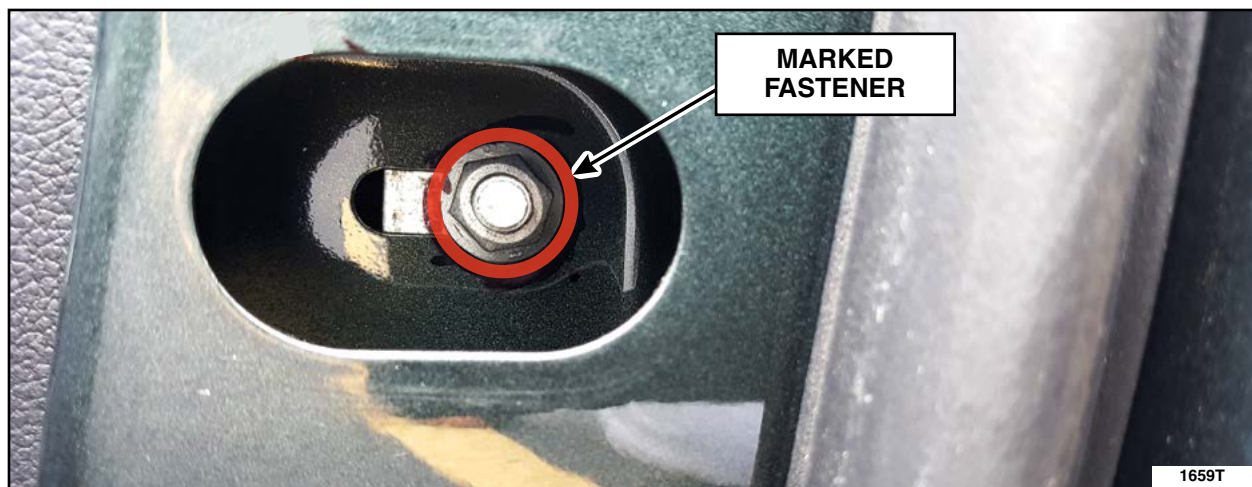
FIGURE 18

NOTE: BEFORE removing the fasteners, mark all of the fasteners for the aft front door glass run and front door window regulator with a paint pen or permanent marker. See Figure 18.

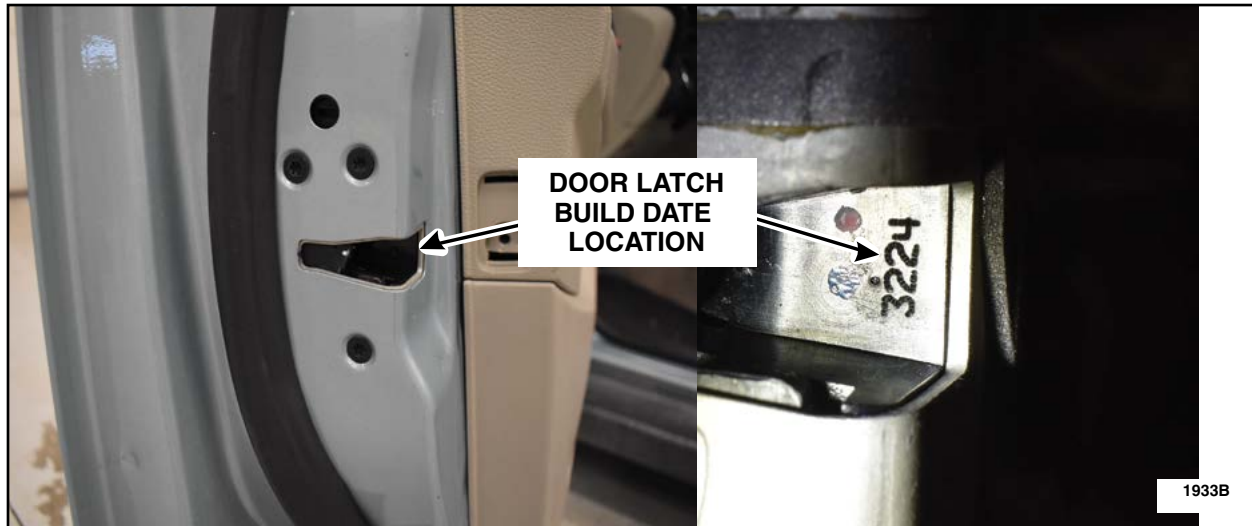
FIGURE 19

5. Once the **new** latches have been installed in the vehicle, record both date codes of the new latches. Additionally, capture a picture of the date code of each new door latch (two pictures total) showing them installed in the vehicle. These pictures will need to be submitted on the SSSC web questionnaire. See Figure 19.

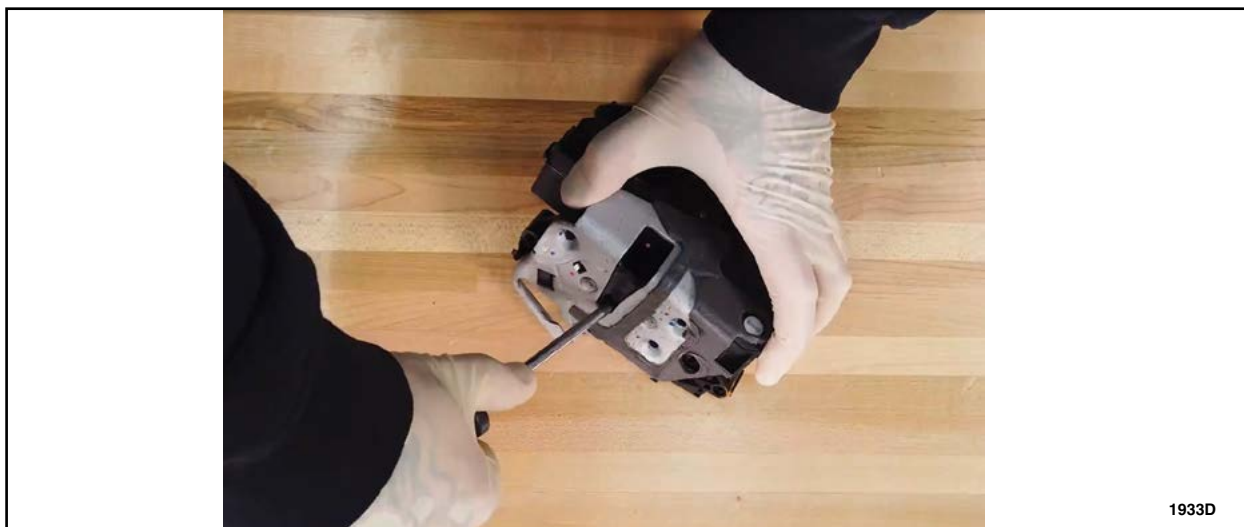
FIGURE 20

1. Using a suitable screwdriver, insert and engage the door latch mechanism. See Figure 20.

NOTE: Rear door latch shown, Front door latch similar.
