SUBJECT: Safety Recall 20S30

Certain 2011-2014 Fiesta, 2013-2014 Fusion and MKZ, 2013-2015 C-MAX and Escape, 2012-2015 Focus, 2015 MKC and Mustang, and 2014-2016 Transit Connect Vehicles
Side Door Latch Previously Repaired Under 15S16 or 16S30

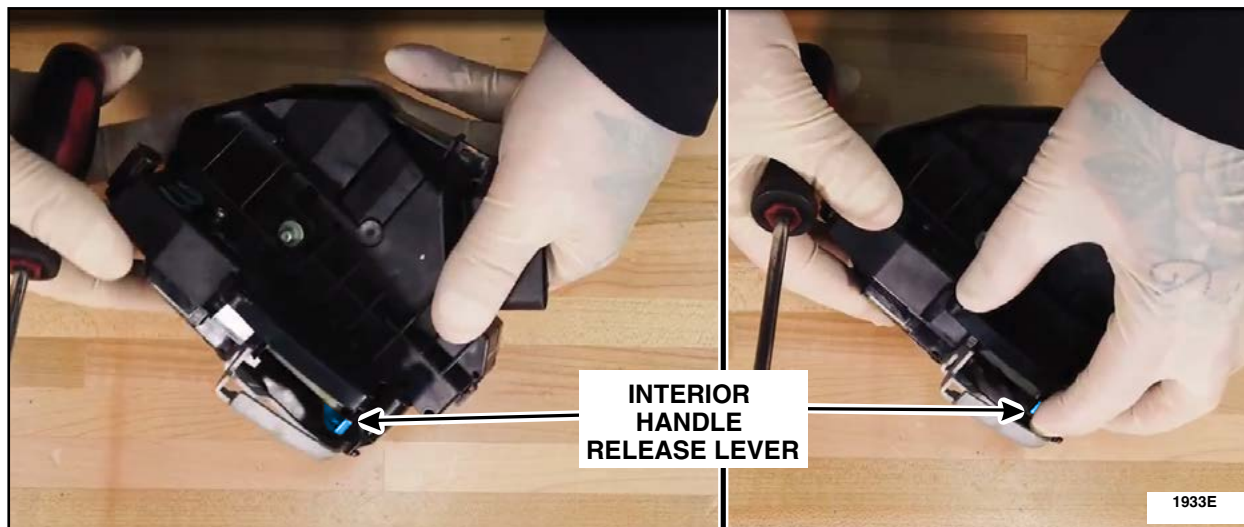
FIGURE 21

2. Turn the door latch on its side, and slide the interior handle release lever to release the latching mechanism. See Figure 21.

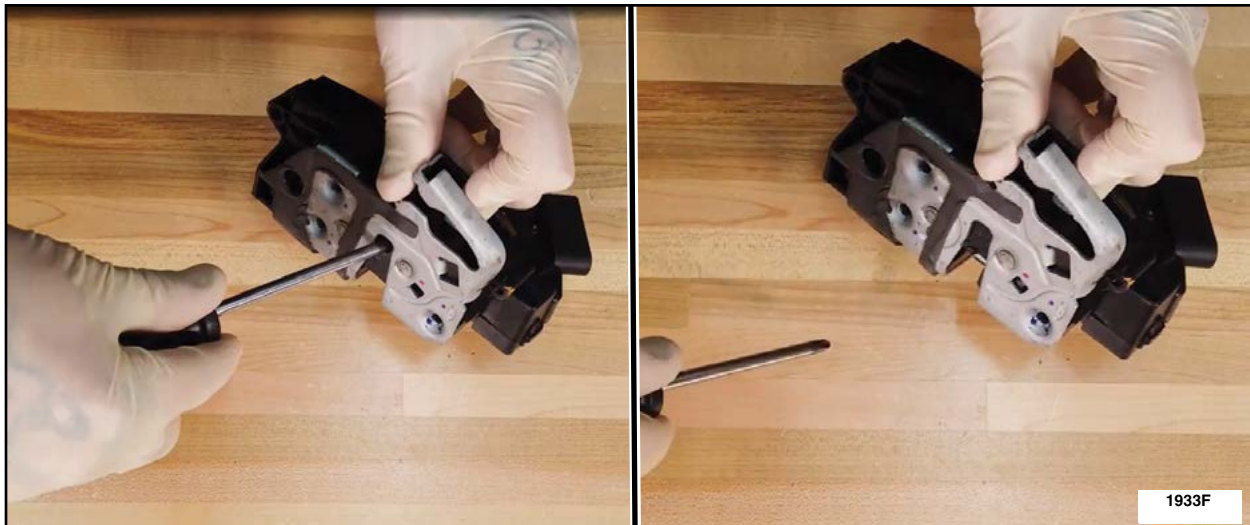
FIGURE 22

3. With the interior handle release lever engaged, place screwdriver back in the latch and verify that the latch releases. See Figure 22.

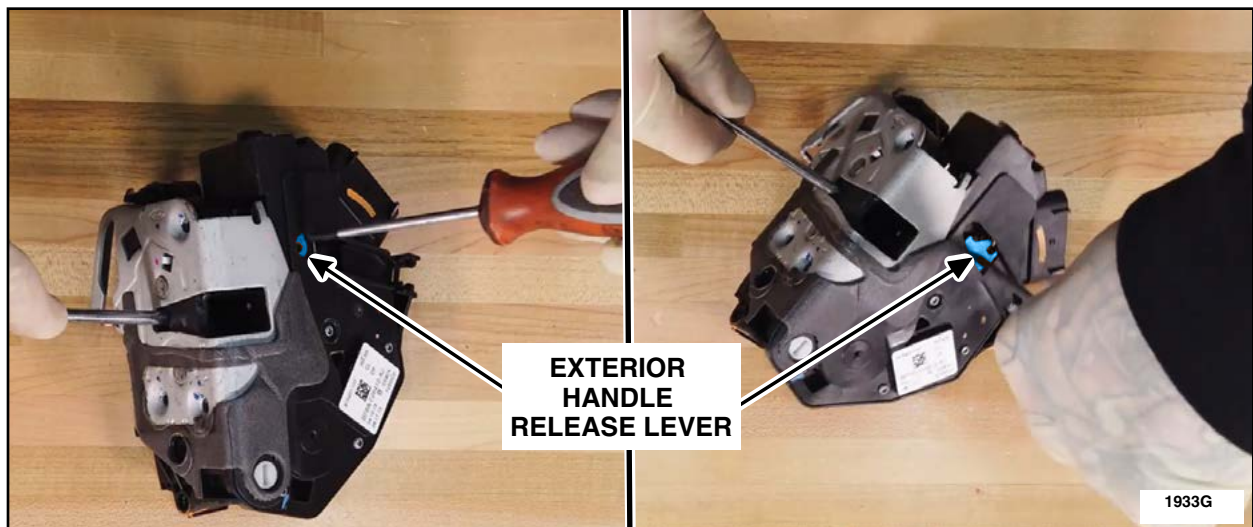
FIGURE 23

4. Re-engage the latch with the screwdriver. See Figure 20.
5. After the latch has been placed in the latched position, take a second screwdriver and actuate the exterior handle release lever. See Figure 23.

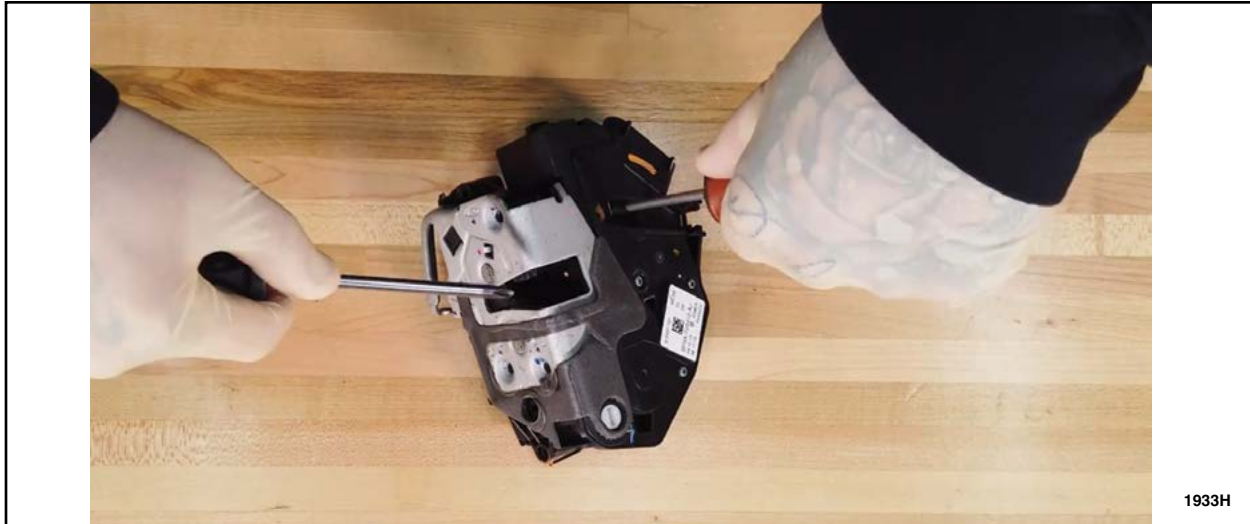
FIGURE 24

6. With the exterior handle release lever engaged, verify that the latch releases. See Figure 24.

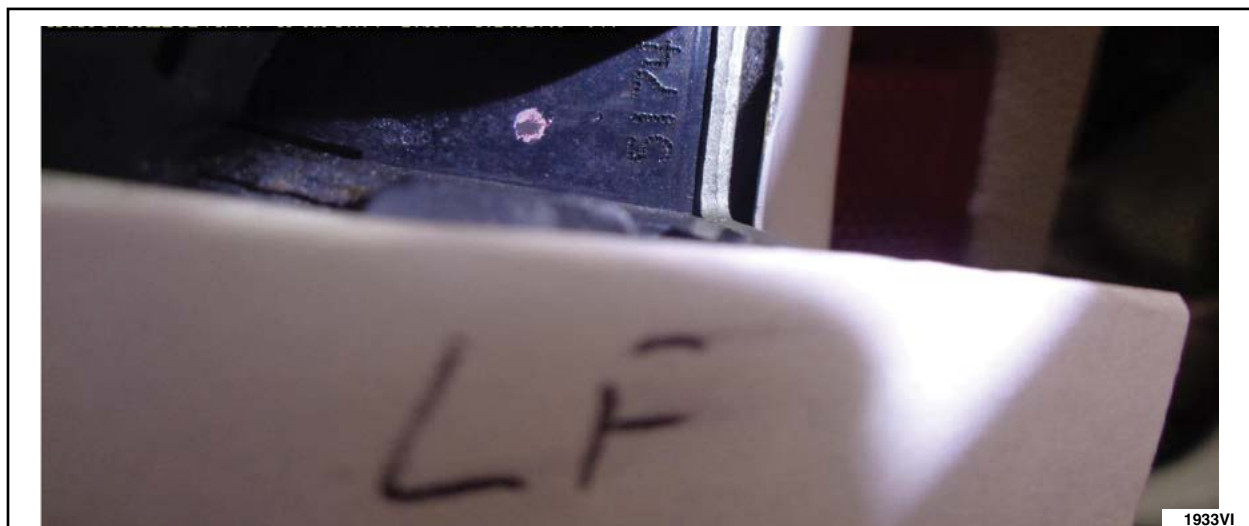
FIGURE 1

- If the Dealer Site indicates a Date Code Review or Failed Latch Review contact is needed:
 - o Ensure that the photos you supply clearly reflect the date codes of ALL affected latches. See Figure 1 for example clear photo. Any of the following can prevent an approval contact from being processed for approval the first time:
 - Latch code out of focus
 - Glare on latch code (use a constant light source and disable the camera's flash for best results)
 - Insufficient lighting
 - Latch code obstructed due to camera angle
 - o Clearly label each door latch using a sticky note (or similar notation). See Figure 1 for an example

NOTE: Photos that do not clearly reflect the location and date code of each affected door latch will prevent an SSSC approval request from being processed.
