Revision (3) August 2020

Dealer Service Instructions for:

Safety Recall W46 / NHTSA 20V-334 12-Volt Isolator Post Connection

2017-2020 (RU) Chrysler Pacifica PHEV

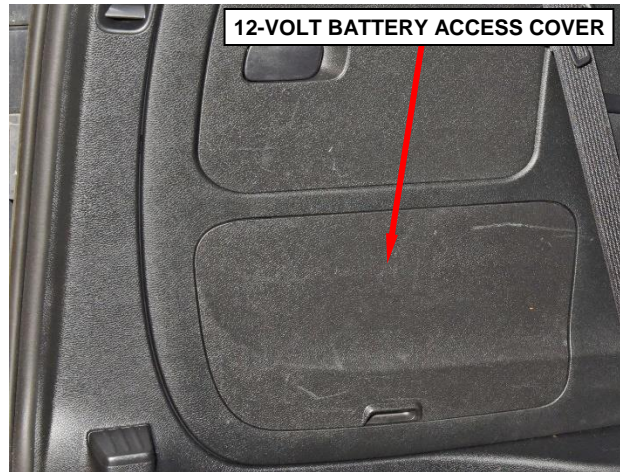
Figure 3 – Battery Access Cover

7. Remove the 12-volt battery access cover from the left rear quarter trim panel (Figure 3).

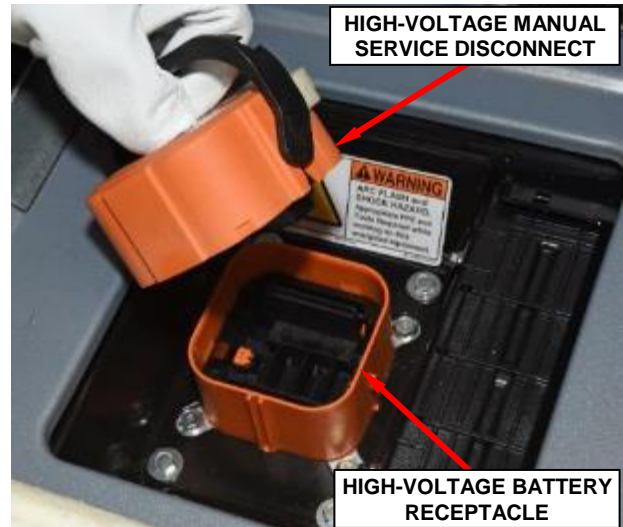
Figure 12 – High-Voltage Manual Service Disconnect and Receptacle

19. Pull straight up on the service disconnect lever to disengage and remove the high-voltage manual service disconnect from the receptacle (Figure 12).

NOTE: Make sure the location of the high-voltage manual service disconnect is always known after removal. It is best practice to place the high-voltage manual service disconnect in a highly visible location when removed.

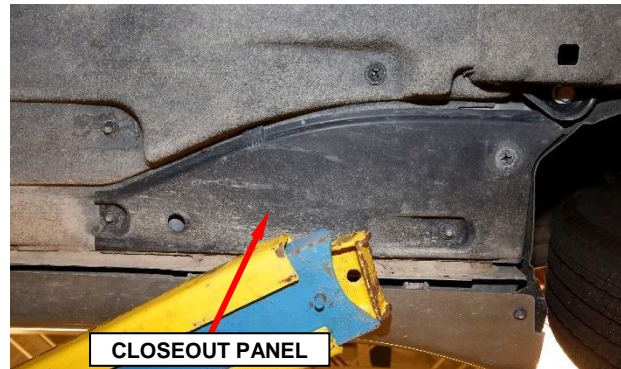
Figure 14 – Belly Pan Closeout Panel

2. Remove the fasteners then remove the left side closeout panel overlapping the charger belly pan (Figure 14).

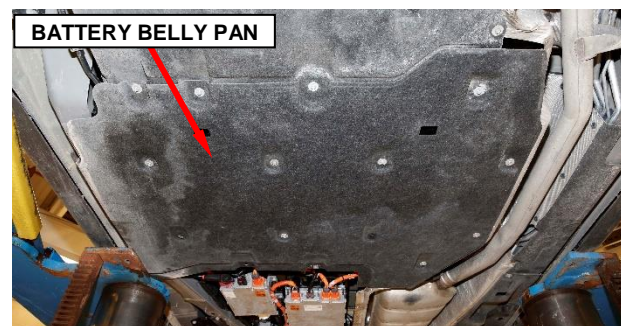
Figure 16 – Battery Belly Pan

4. Remove the fasteners then remove the battery belly pan (Figure 16).

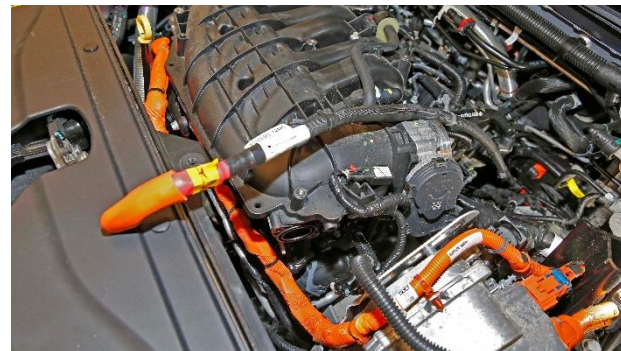
Figure 30 – 12-Volt Cable

12. Thread the 12-volt cable clear of all components and lay out straight so that it can be pulled through the engine compartment from underneath the vehicle (Figure 30).

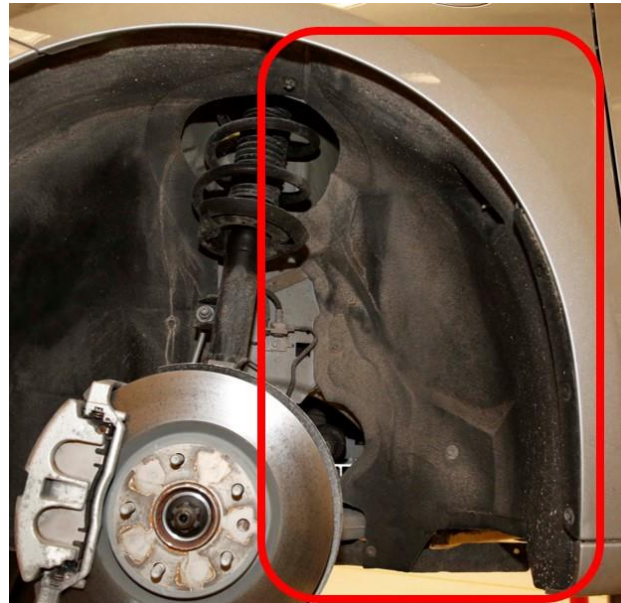
Figure 31 – Wheel House Splash Shield

13. Raise and support the vehicle for tire and wheel removal.
14. Remove the left front tire and wheel.
15. Remove the fasteners securing the rear half of the left front splash shield. Then position the rear half of the splash shield out of the way for cable access (Figure 31).

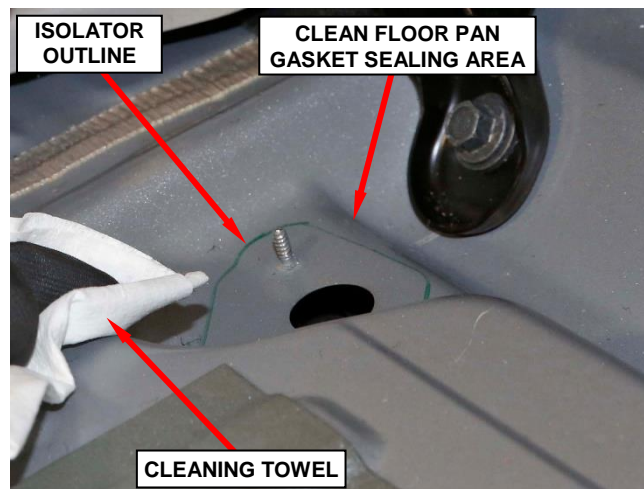
Figure 49 – Clean Gasket Sealing Area

NOTE: Do NOT wash away the isolator outline while cleaning the floor pan. The outline will be needed for isolator installation.
