Revised July 2020

Dealer Service Instructions for:

Safety Recall W46 / NHTSA 20V-334 12-Volt Isolator Post Connection

2017-2020 (RU) Chrysler Pacifica PHEV

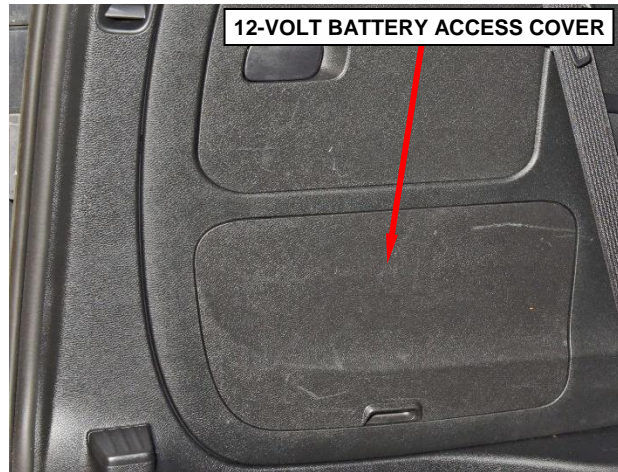
Figure 3 – Battery Access Cover

7. Remove the 12-volt battery access cover from the left rear quarter trim panel (Figure 3).

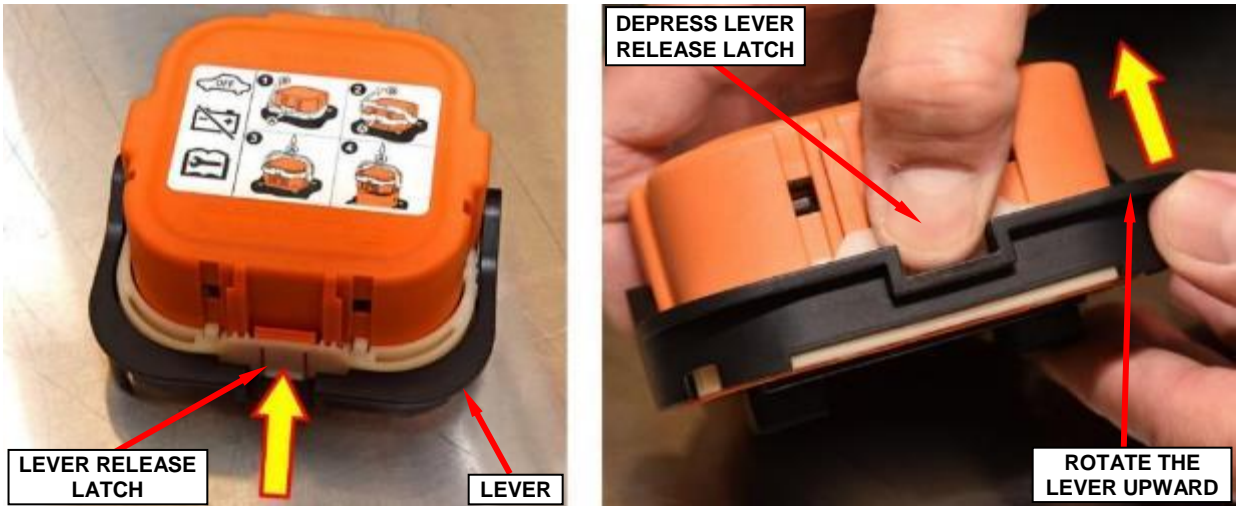
Figure 10 – High-Voltage Manual Service Disconnect First Stage Latch Release (High-Voltage Manual Service Disconnect Removed from Vehicle for Visual Clarity)

- 17. Depress the lever release latch firmly. With the latch fully depressed, rotate the lever upward. The lever will stop at the 45° position (Figure 10).

NOTE: At this stage, the High Voltage Inter-Lock (HVIL) connection has been broken and the circuit is de-energized.

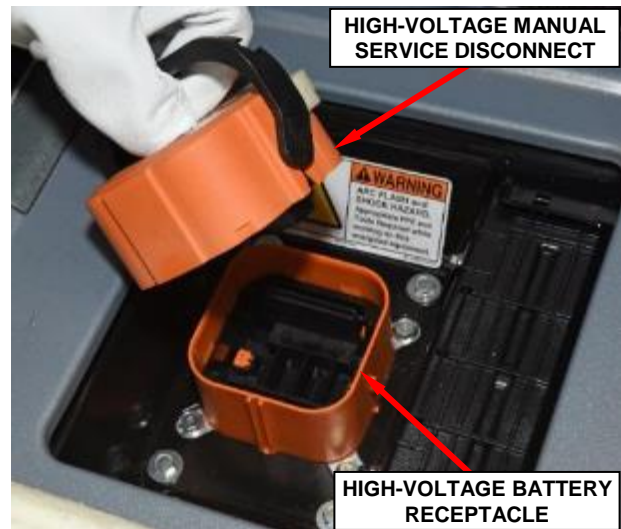
Figure 12 – High-Voltage Manual Service Disconnect and Receptacle

19. Pull straight up on the service disconnect lever to disengage and remove the high-voltage manual service disconnect from the receptacle (Figure 12).

NOTE: Make sure the location of the high-voltage manual service disconnect is always known after removal. It is best practice to place the high-voltage manual service disconnect in a highly visible location when removed.

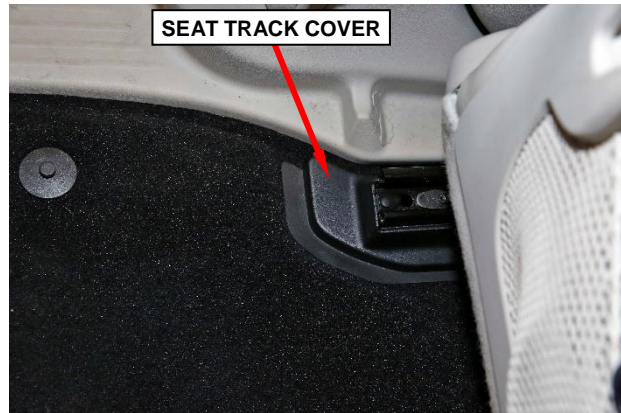
Figure 21 – Seat Track Cover

10. Remove the left side rear seat track cover from the driver seat (Figure 21)

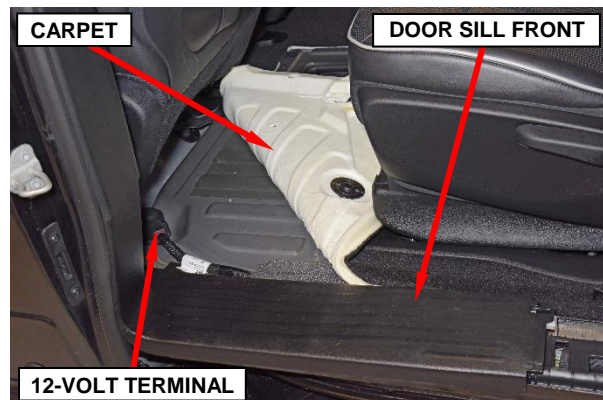
Figure 23 – Door Sill Front and Carpet

12. Release from the floor but do not fully remove the front door sill from left side rear door opening (Figure 23).

13. Pull back the carpet from behind the front driver seat (Figure 23).

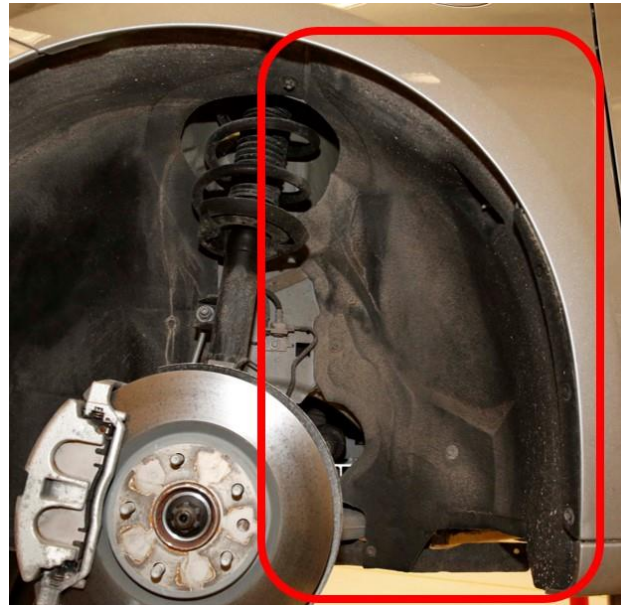
Figure 31 – Wheel House Splash Shield

13. Raise and support the vehicle for tire and wheel removal.
14. Remove the left front tire and wheel.
15. Remove the fasteners securing the rear half of the left front splash shield. Then position the rear half of the splash shield out of the way for cable access (Figure 31).

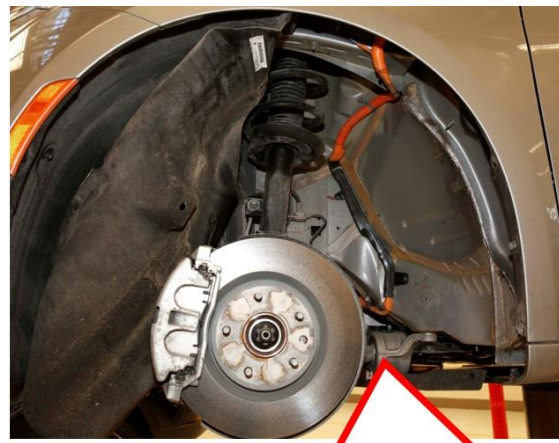
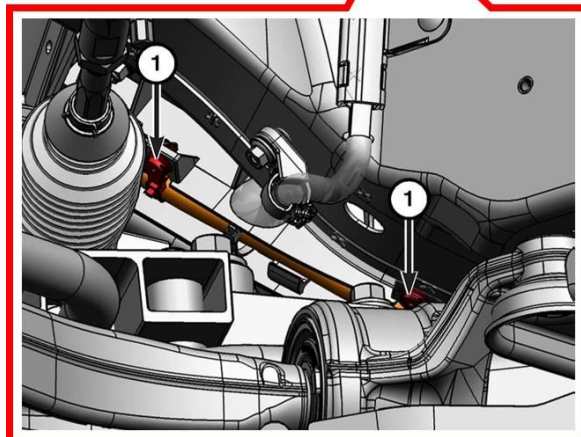
Figure 32 – 12-Volt Cable

16. Working through the wheel opening, release the clips (1) securing the 12-volt cable to the high voltage cable carrier (Figure 32).

17. Cut any cable ties retaining the 12-volt cable to the high voltage cable carrier.

33. Working through the wheel opening, attach the clips (1) securing the 12-volt cable to the high voltage cable carrier (Figure 32).

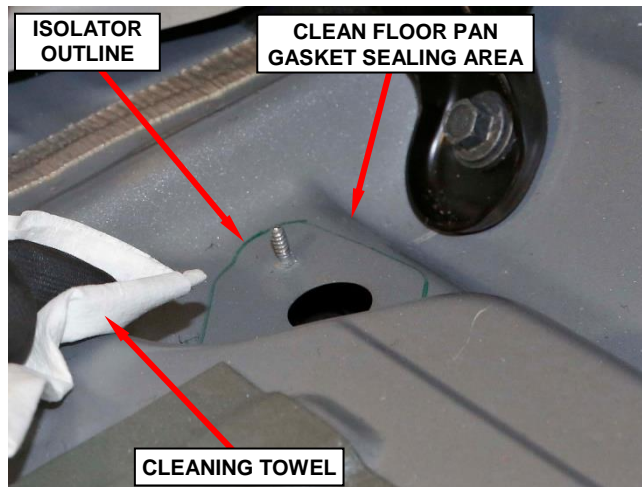
Figure 49 – Clean Gasket Sealing Area

NOTE: Do NOT wash away the isolator outline while cleaning the floor pan. The outline will be needed for isolator installation.
