Revision (4) December 2020

Dealer Service Instructions for:

## **Safety Recall W46 / NHTSA 20V-334 12-Volt Isolator Post Connection**

#### **2017-2020 (RU) Chrysler Pacifica PHEV**

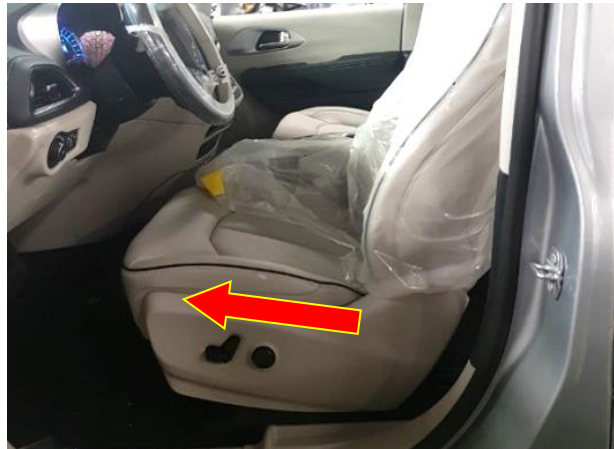
**Figure 1 – Position Driver Seat Forward**

1. Position the vehicle on a suitable hoist which will allow access to the belly pan for removal later in this procedure.
2. Position the driver seat fully forward for improved access to the 12-volt isolator post connection (Figure 1).

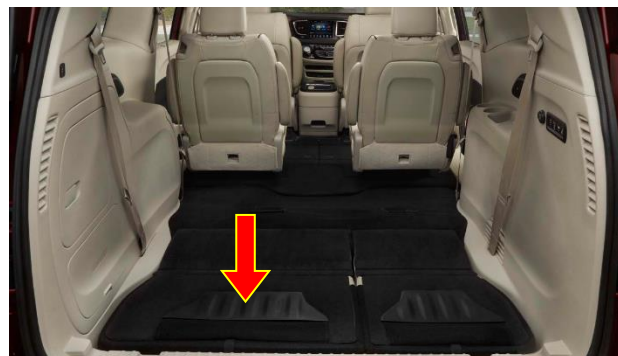
**Figure 2 – Stow Left Third Row Seat**

5. Stow the left third row seat down into the floor as shown (Figure 2).

**NOTE: Vehicles equipped with power third row Stow 'n Go seats must have left third row seat stowed in the floor as described in Step 5 (Figure 2). Depending on repair direction later in this procedure, it may be necessary to access the left rear quarter trim panel while the electrical system is powered down.**

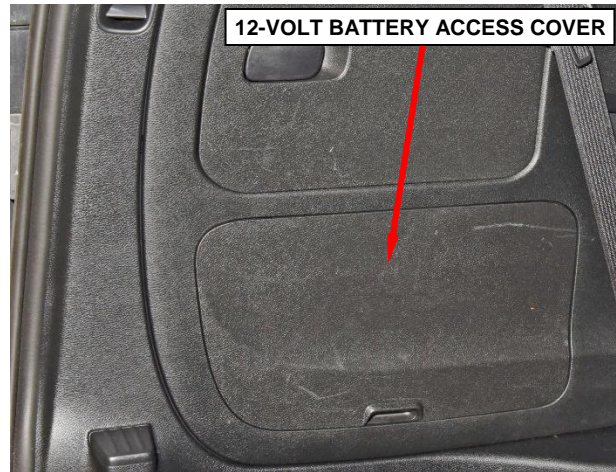
**Figure 3 – Battery Access Cover**

7. Remove the 12-volt battery access cover from the left rear quarter trim panel (Figure 3).

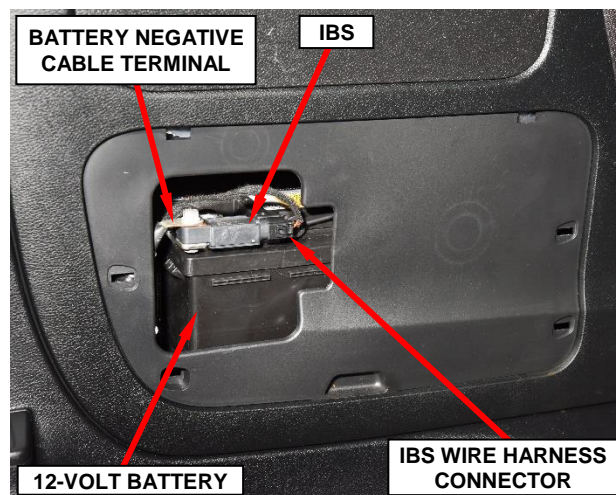
**Figure 4 – Battery Negative Cable**

8. Disconnect the wire harness connector from the Intelligent Battery Sensor (IBS) (Figure 4).

9. Remove the nut securing the battery negative cable terminal to the IBS (Figure 4).

10. Disconnect and isolate the battery negative cable terminal from the IBS (Figure 4).

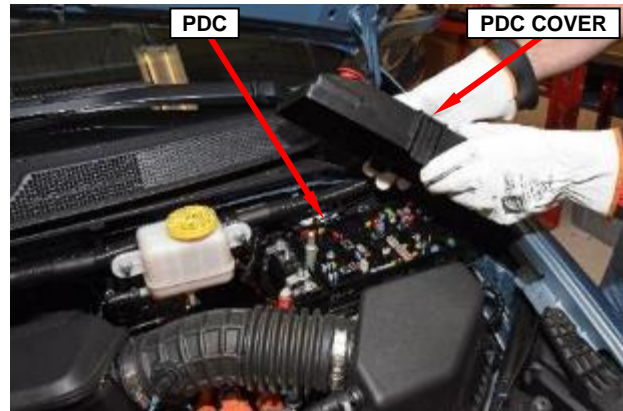
**Figure 5 – Power Distribution Center**

12. Remove the 12-volt Power PDC cover (Figure 5).

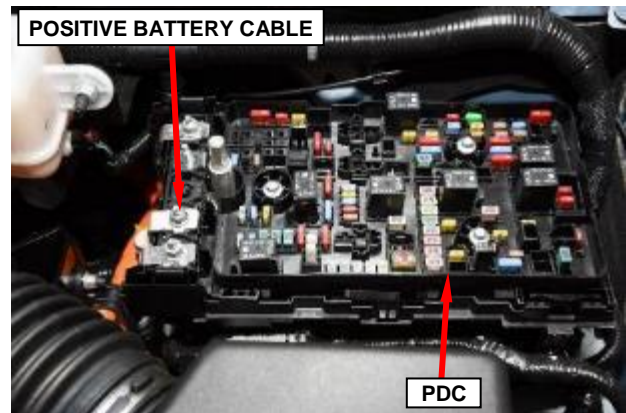
**Figure 6 – Positive Battery Cable**

13. Remove the nut securing the positive battery cable, then disconnect the positive battery cable from the 12-volt PDC (Figure 6).

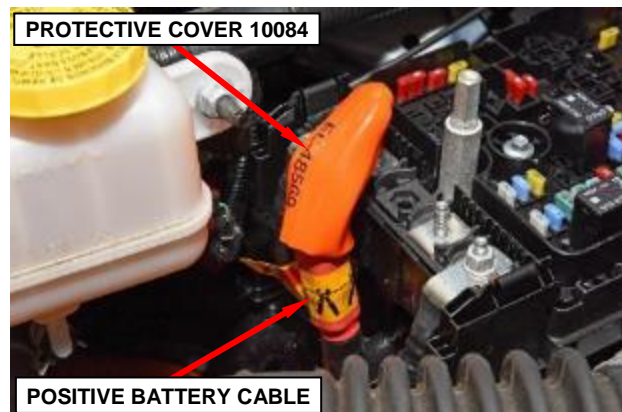
**Figure 7 – Cover Cable Terminal**

14. Isolate the positive battery cable terminal with protective cover 10084 (2035110082 equivalent) (Figure 7).

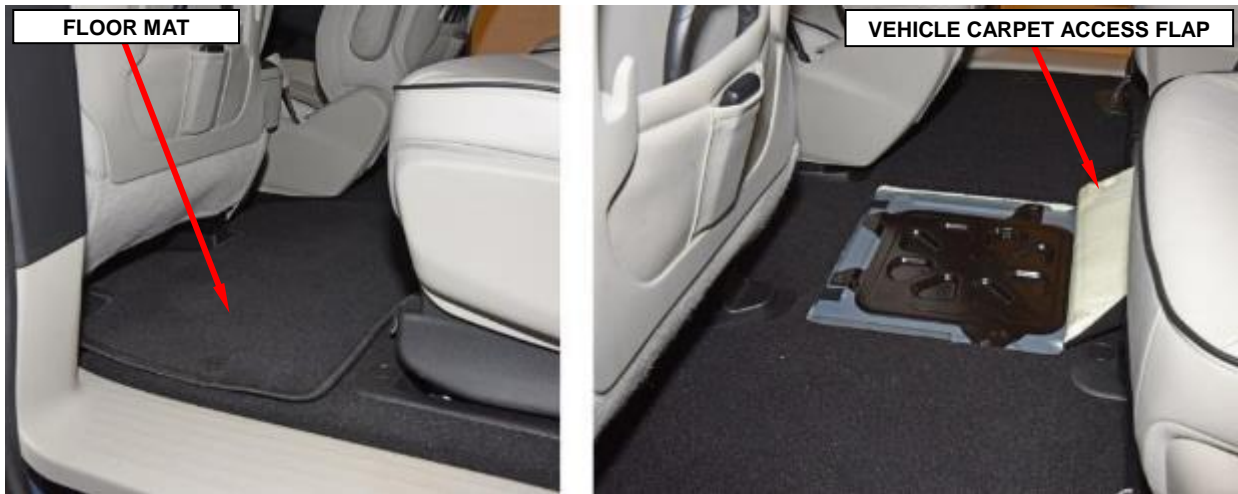
**Figure 8 – Vehicle Carpet**

- 15. Lift the carpet away from the high-voltage manual service disconnect access cover (Figure 8).

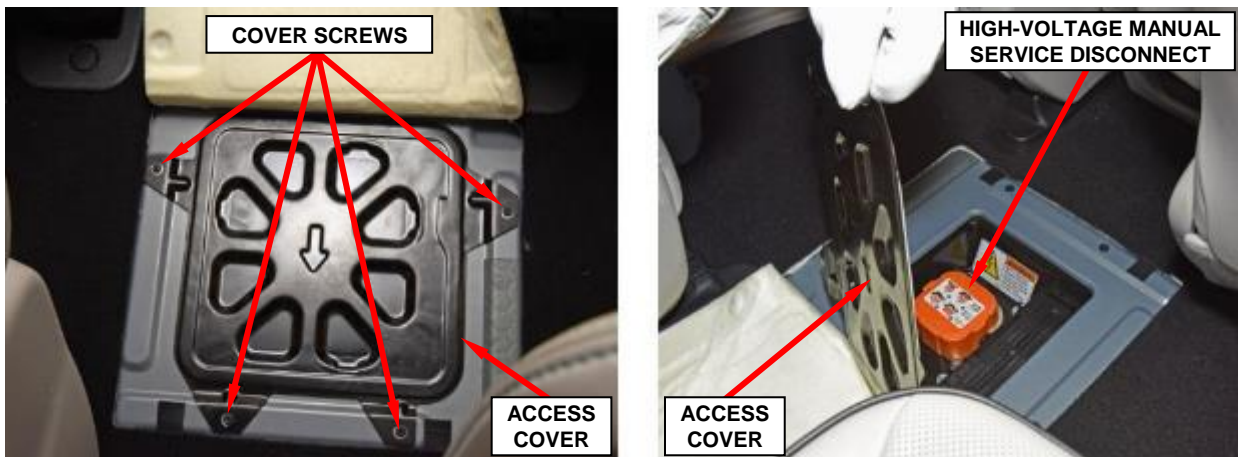
**Figure 9 – High-Voltage Manual Service Disconnect Access Cover**

- 16. Remove the four screws securing the high-voltage manual service disconnect access cover to the floor then remove the cover (Figure 9).

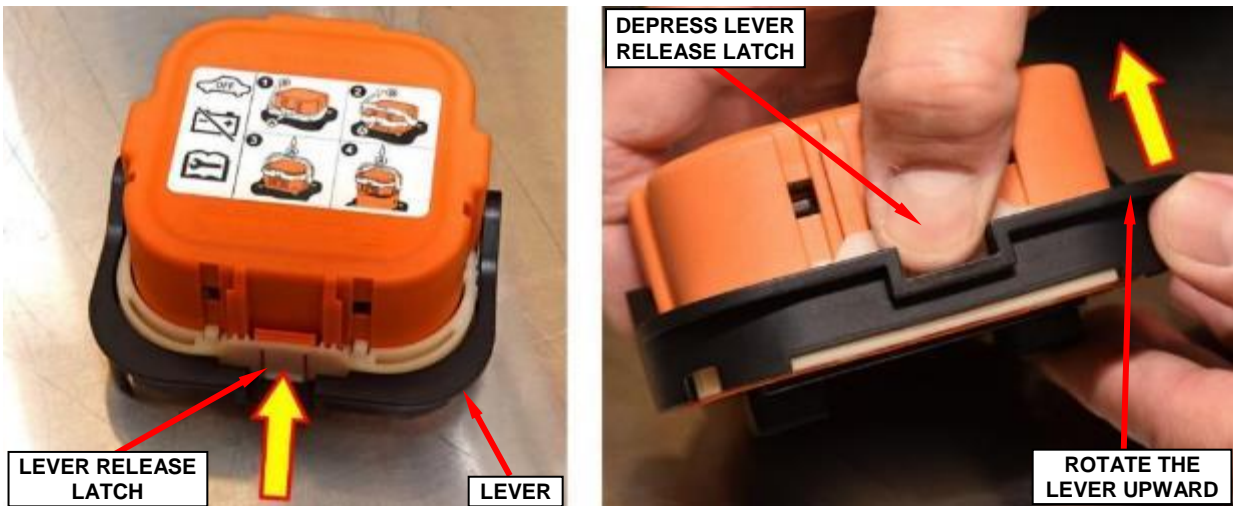
**Figure 10 – High-Voltage Manual Service Disconnect First Stage Latch Release (High-Voltage Manual Service Disconnect Removed from Vehicle for Visual Clarity)**

- Depress the lever release latch firmly. With the latch fully depressed, rotate the lever upward. The lever will stop at the 45° position (Figure 10).

**NOTE: At this stage, the High Voltage Inter-Lock (HVIL) connection has been broken and the circuit is de-energized.**

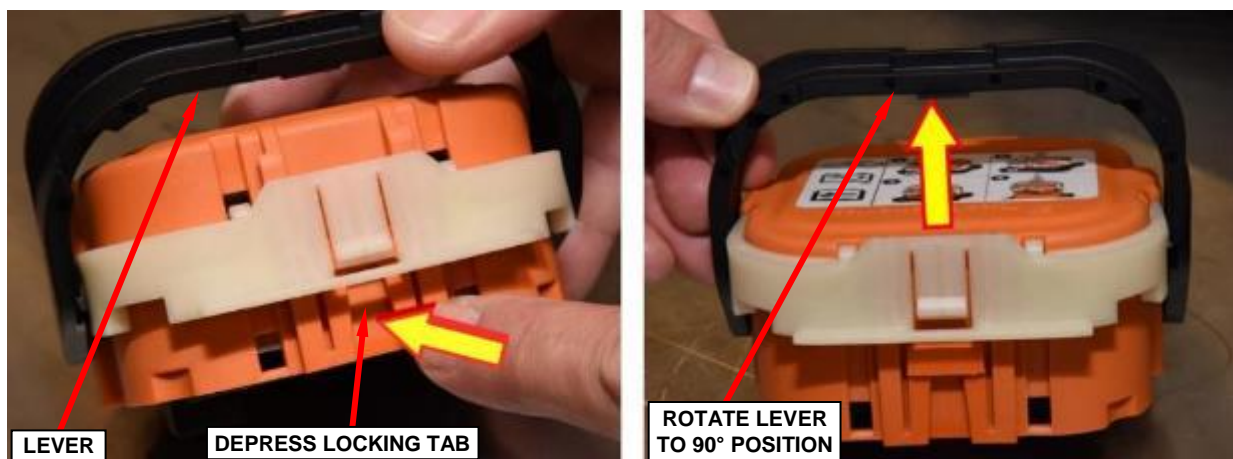
**Figure 11 – High-Voltage Manual Service Disconnect Second Stage Latch Release (High-Voltage Manual Service Disconnect Removed from Vehicle for Visual Clarity)**

- Depress the locking tab and continue to rotate the lever to the end of travel, 90° position (Figure 11).

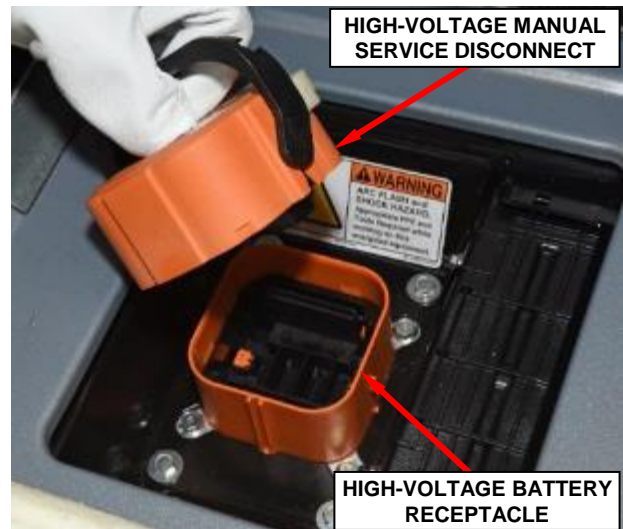
**Figure 12 – High-Voltage Manual Service Disconnect and Receptacle**

19. Pull straight up on the service disconnect lever to disengage and remove the high-voltage manual service disconnect from the receptacle (Figure 12).

**NOTE:** Make sure the location of the high-voltage manual service disconnect is always known after removal. It is best practice to place the high-voltage manual service disconnect in a highly visible location when removed.

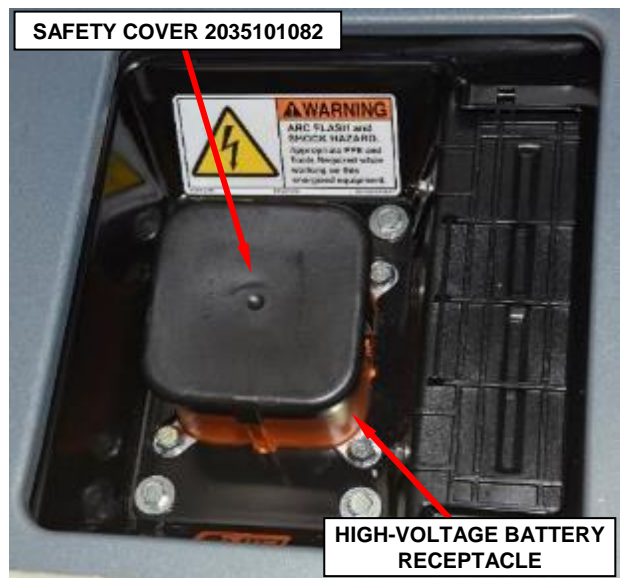
**Figure 13 – High-Voltage Battery Receptacle Safety Cover**

20. Cap the receptacle on the high-voltage battery with safety cover 2035101082 to prevent foreign objects from entering the receptacle (Figure 13).

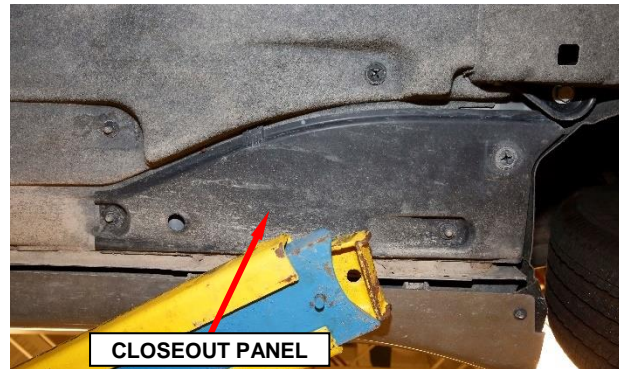
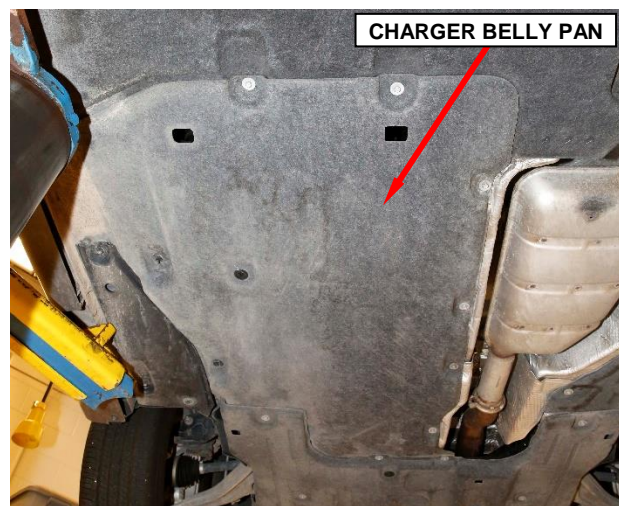
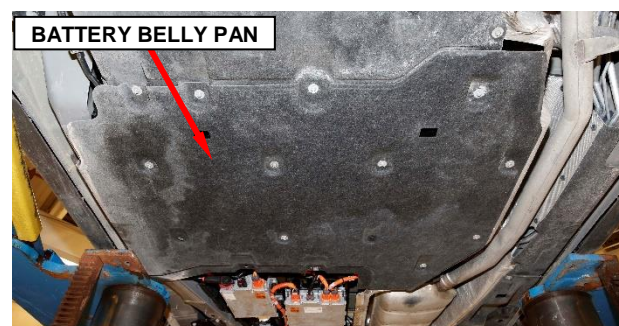
1. Raise and support the vehicle.
2. Remove the fasteners then remove the left side closeout panel overlapping the charger belly pan (Figure 14).
3. Remove the fasteners then remove the charger belly pan (Figure 15).
4. Remove the fasteners then remove the battery belly pan (Figure 16).

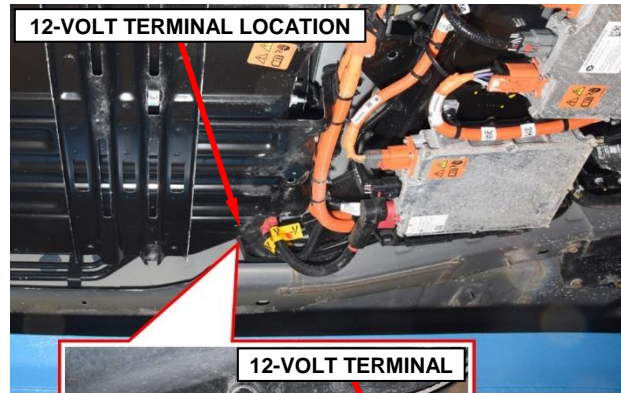
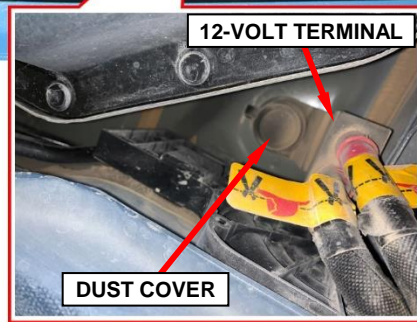
**Figure 17 – 12-Volt Cable Underbody Connector Location**

5. 12-volt cable underbody connector location (Figure 17).

6. Release the dust cover from the 12-volt cable terminal (Figure 17).

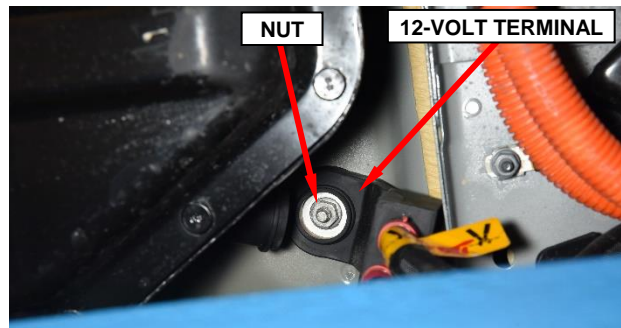
**Figure 18 – 12-Volt Cable Terminal**

7. Loosen the nut and remove the 12-volt terminal and nut assembly from the isolator post (Figure 18).

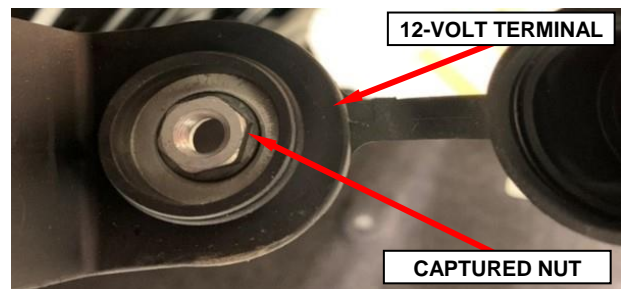
**Figure 19 – Captured Nut**

**NOTE: Nut is captured to the terminal (Figure 19).**

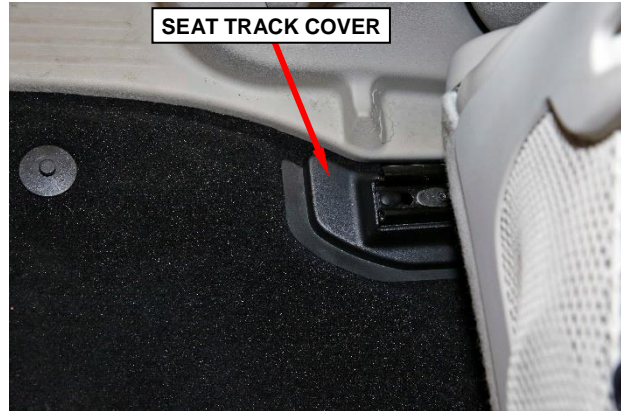
**Figure 21 – Seat Track Cover**

10. Remove the left side rear seat track cover from the driver seat (Figure 21)

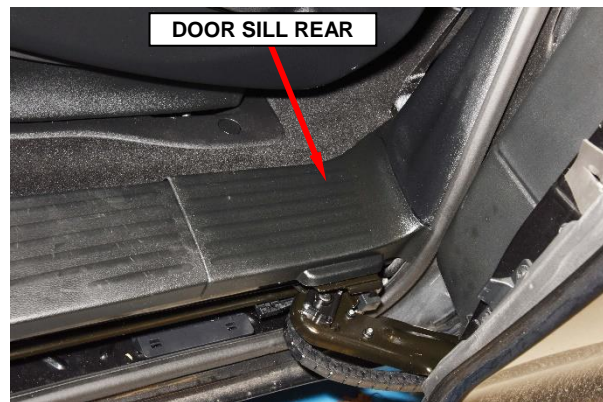
**Figure 22 – Door Sill Rear**

11. Remove the rear door sill from the left side rear door opening (Figure 22).

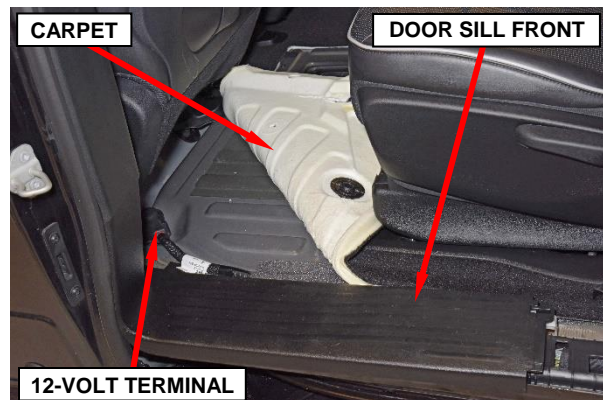
**Figure 23 – Door Sill Front and Carpet**

12. Release from the floor but do not fully remove the front door sill from left side rear door opening (Figure 23).

13. Pull back the carpet from behind the front driver seat (Figure 23).

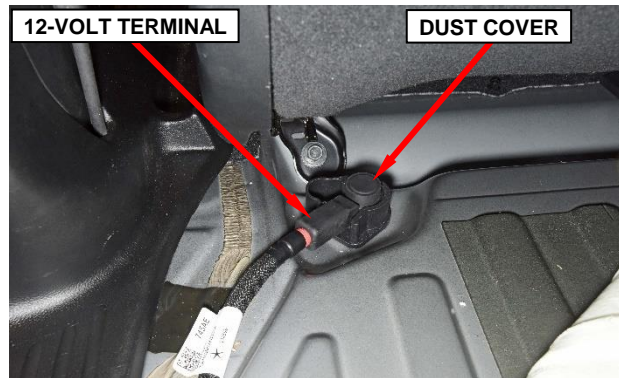
Figure 24 – 12-Volt Terminal Dust Cover

14. Release the dust cover from the 12-volt cable terminal (Figure 24).

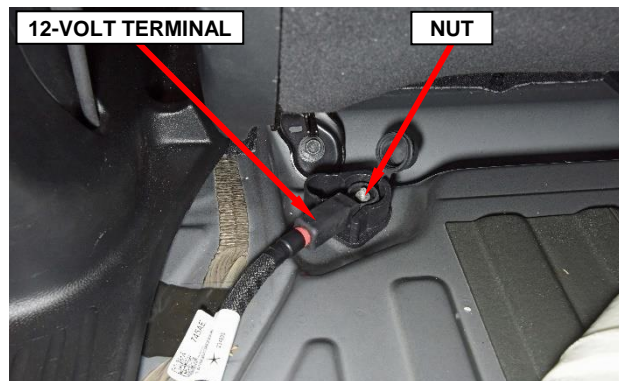
Figure 25 – 12-Volt Cable Terminal

15. Remove the nut from the 12-volt terminal isolator post (Figure 25).

16. Remove the 12-volt terminal from the isolator post (Figure 25).

13. Install the 12-volt cable terminal to the isolator post (Figure 25).
14. Install the nut to the 12-volt isolator post terminal and tighten the nut to 23 N·m (17 ft. lbs.) (Figure 25).
15. Install the dust cover to the 12-volt cable terminal (Figure 24).
16. Install the carpet behind the front driver seat (Figure 23).
17. Install the front door sill to left side rear door opening (Figure 23).
18. Install the rear door sill to the left side rear door opening (Figure 22).
19. Install the left side rear seat track cover to the driver seat (Figure 21).
20. Raise the vehicle.
21. Inspect that the 12-volt isolator post is centered in the vehicle floor pan hole (Figure 53).

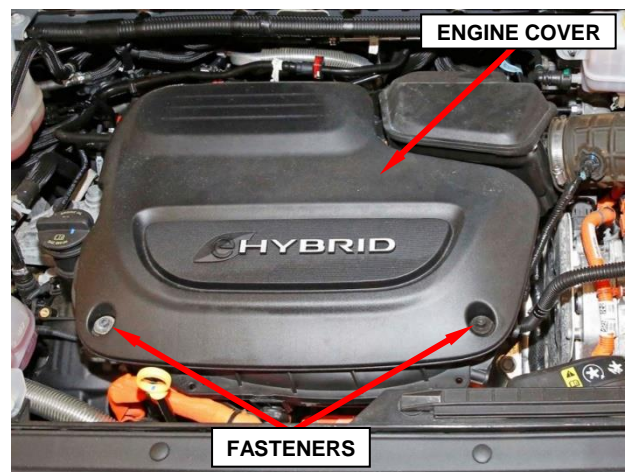
**Figure 26 – Engine Cover**

2. Remove the engine cover fasteners then release the engine cover rubber mount sockets from the locating pins and remove the engine cover from the engine compartment (Figure 26).

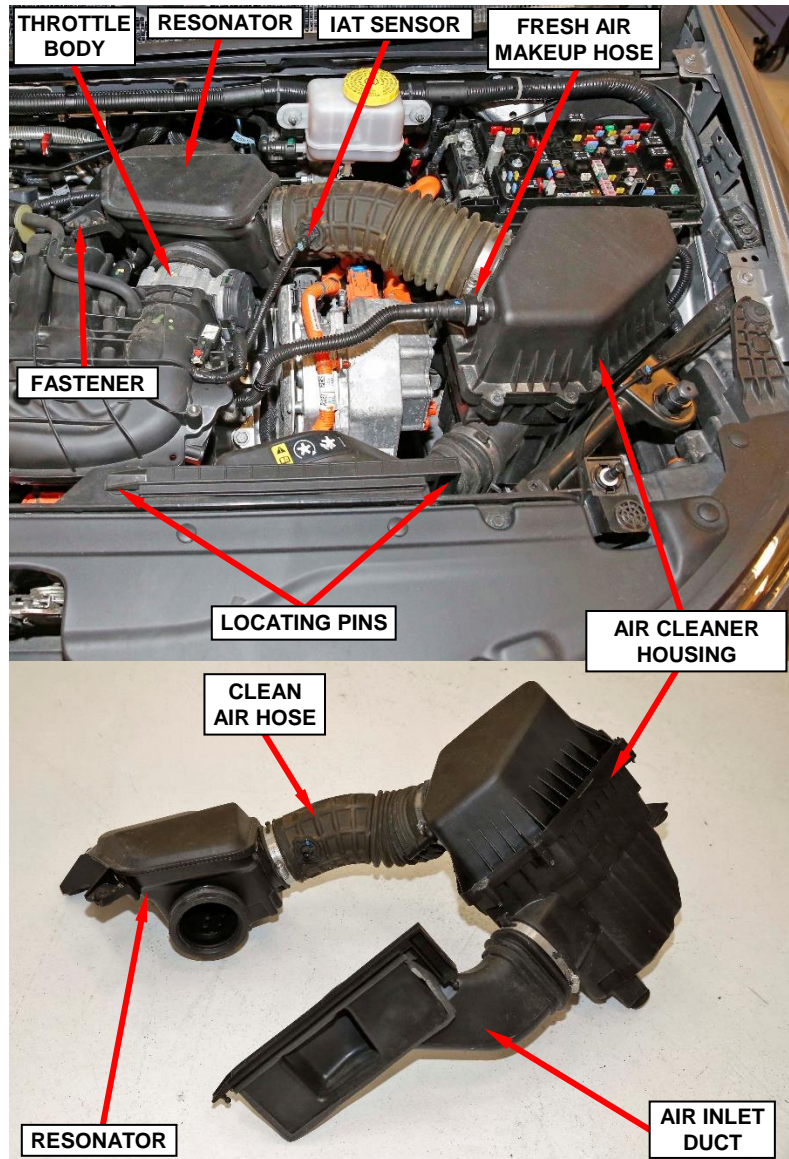
**Figure 27 – Air Intake Assembly**

3. Remove the fastener from the resonator (Figure 27).
4. Disconnect the wire harness connector from the Inlet Air Temperature (IAT) sensor (Figure 27).
5. Disconnect the fresh air makeup hose from the air cleaner housing (Figure 27).
6. Disengage the resonator from the throttle body and the locating pins from the rubber mount sockets (Figure 27).
7. Disengage the clean air housing locating pins from the rubber mount sockets (Figure 27).

8. Disengage the air inlet duct locating pins from the rubber mount sockets (Figure 27).
9. Remove the resonator, air cleaner housing, and air inlet duct as an assembly from the engine compartment for 12-volt cable access (Figure 27).

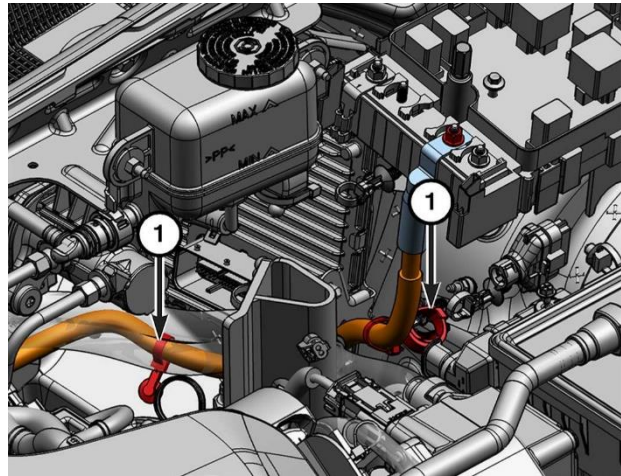
**Figure 28 – 12-Volt Cable Clips**

**NOTE:** Pay very close attention to original cable clip locations and cable routing during the removal of the 12-volt cable so that original cable placement can be duplicated properly. It may be helpful to mark the clip locations and cable routing with a paint pen prior to removal.

10. Release the clips (1) that secure the 12-volt cable (Figure 28).

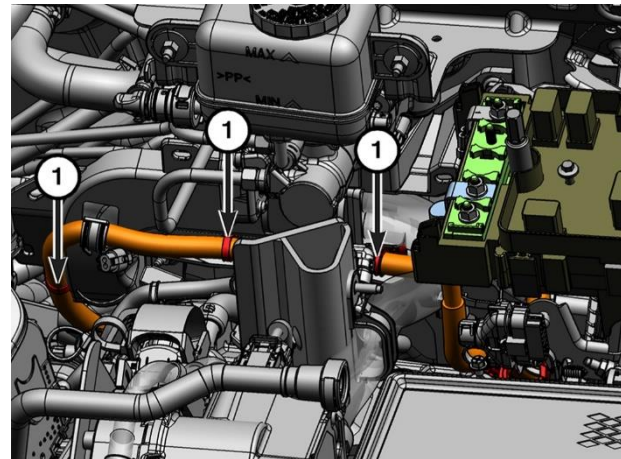
**Figure 29 – 12-Volt Cable Clips**

11. Release the clips (1) that secure the 12-volt cable to the high voltage cable carrier and extend the harness to prepare for removal from below (Figure 29).

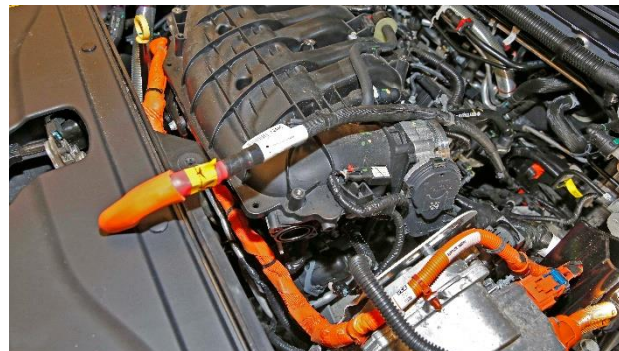
**Figure 30 – 12-Volt Cable**

12. Thread the 12-volt cable clear of all components and lay out straight so that it can be pulled through the engine compartment from underneath the vehicle (Figure 30).

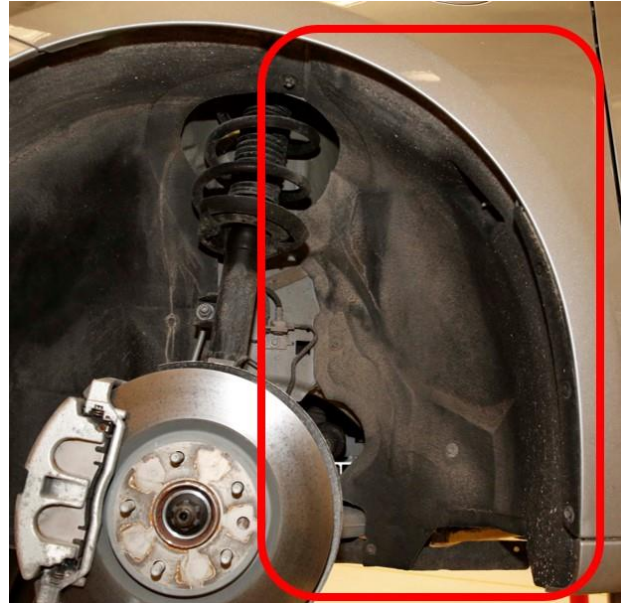
**Figure 31 – Wheel House Splash Shield**

13. Raise and support the vehicle for tire and wheel removal.
14. Remove the left front tire and wheel.
15. Remove the fasteners securing the rear half of the left front splash shield. Then position the rear half of the splash shield out of the way for cable access (Figure 31).

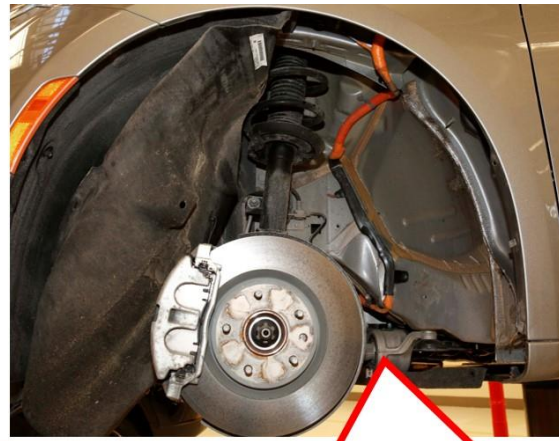
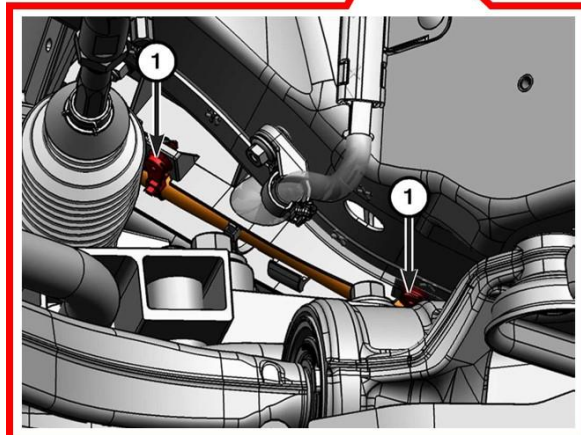
**Figure 32 – 12-Volt Cable**

16. Working through the wheel opening, release the clips (1) securing the 12-volt cable to the high voltage cable carrier (Figure 32).

17. Cut any cable ties retaining the 12-volt cable to the high voltage cable carrier.

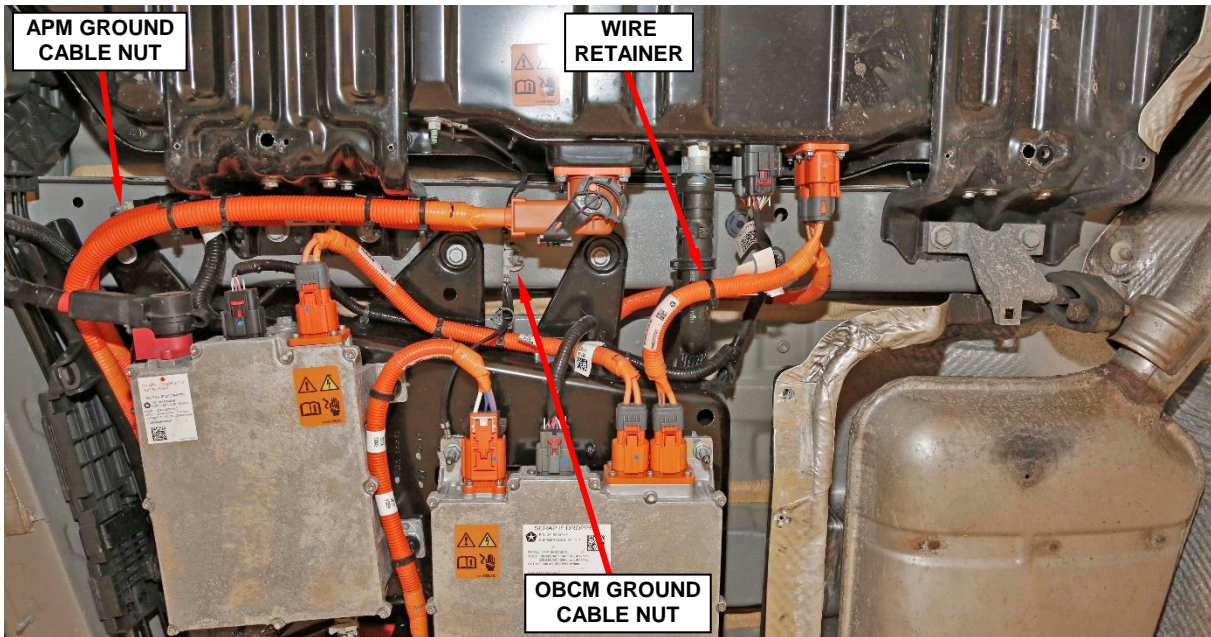
**Figure 33 – Wire Retainer and Ground Cable nuts**

- 18. Release the wire retainer from the coolant hose (Figure 33).
- 19. Remove the On-Board Charging Module (OBCM) chassis ground cable nut and Accessory Power Module (APM) chassis ground cable nut (Figure 33).

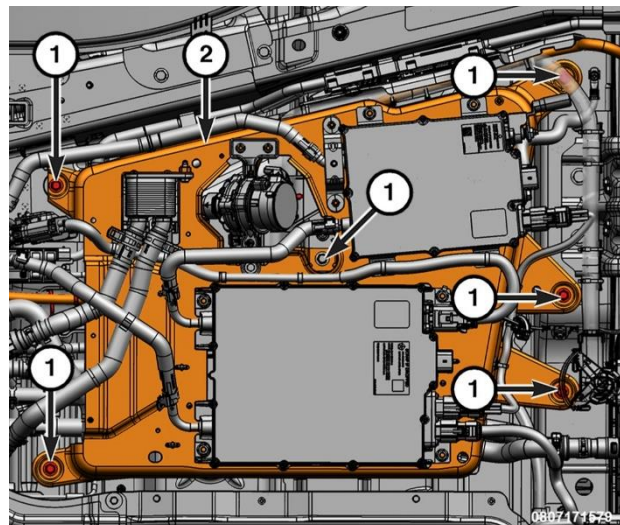
**Figure 34 – Battery Charger Bracket**

- 20. Position a suitable stand to support the battery charger bracket (2) and remove the fasteners (1) (Figure 34).

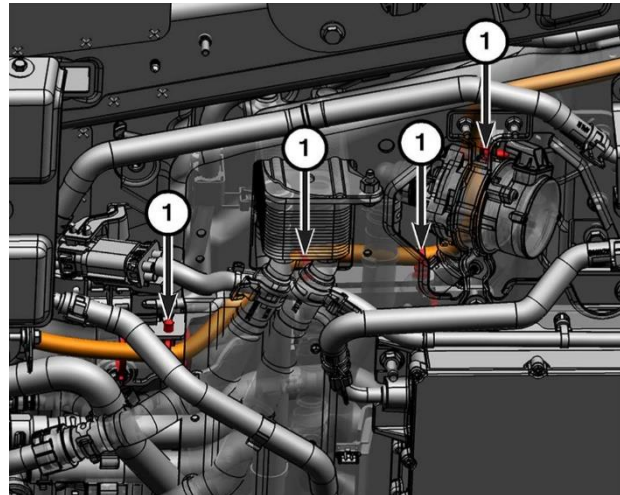
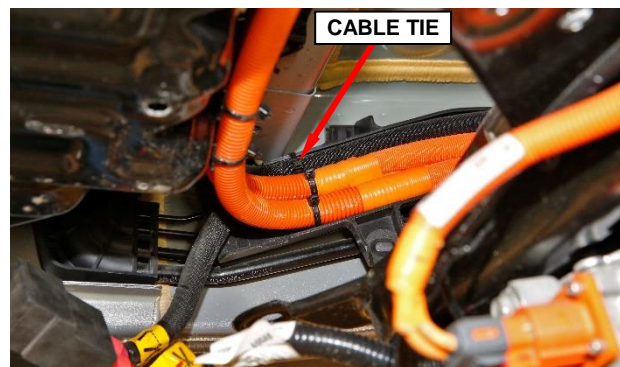
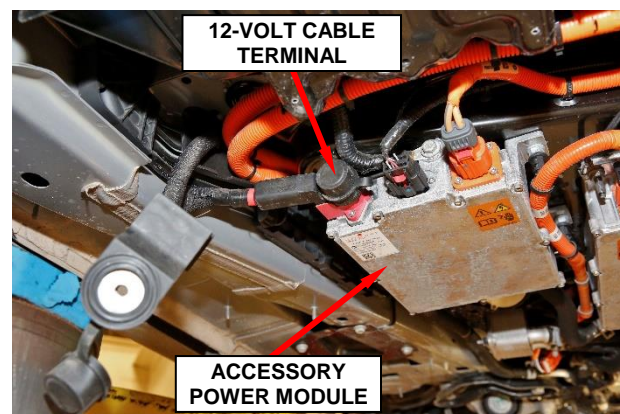
21. Carefully lower the battery charger bracket to release the remaining 12-volt Cable clips (1) (Figure 35).
22. Cut the cable tie retaining the 12-volt cable to the cable carrier. It is not necessary to replace this cable tie during reassembly (Figure 36).
23. Release the protective cover and remove the fasteners that secures the 12-volt cable terminal to the Accessory Power Module (APM) (Figure 37).

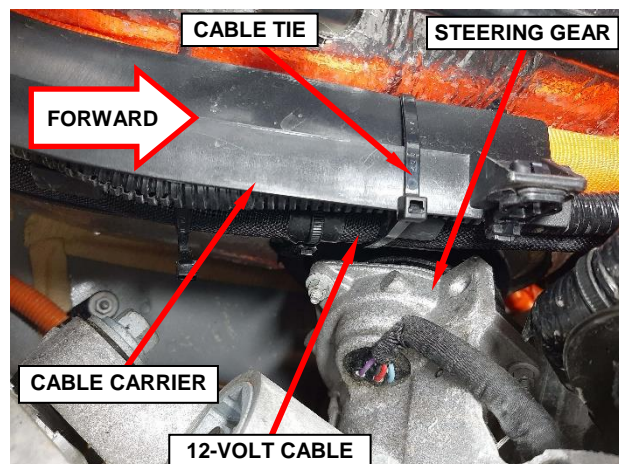
**Figure 38 – Cable Tie at Steering Gear**

34. Using the cable tie provided in the campaign kit, secure the 12-volt cable to the high voltage cable carrier to prevent cable contact to the steering gear (Figure 38).

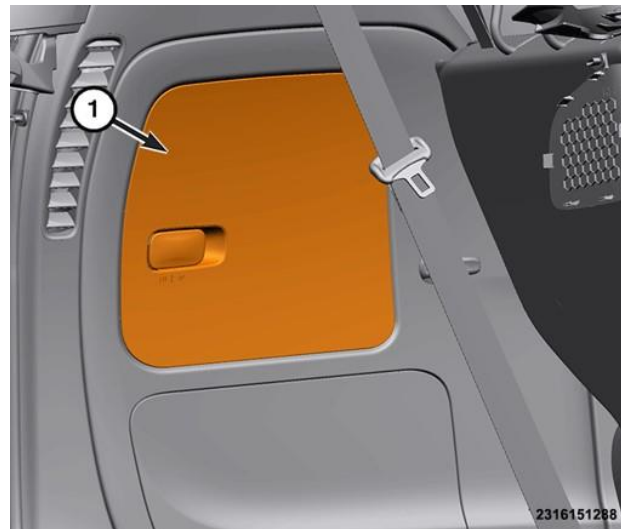
**Figure 39 – Quarter Panel Insert**

- 48. Open the access door (1) from the quarter trim panel (Figure 39).

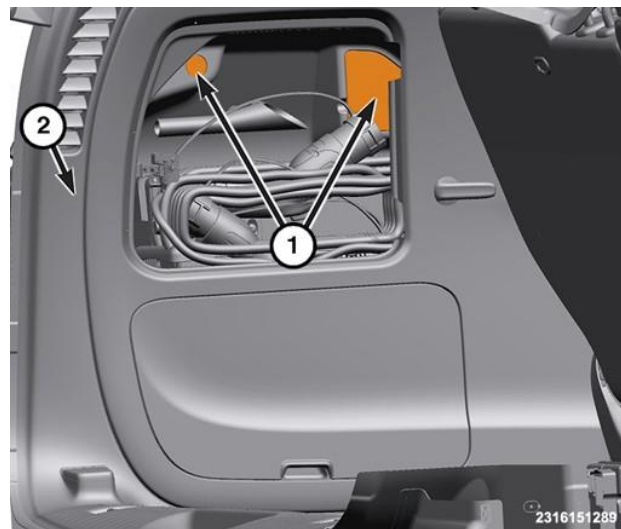
**Figure 40 – Quarter Panel Insert**

- 49. Remove the fastener covers (1) (Figure 40).

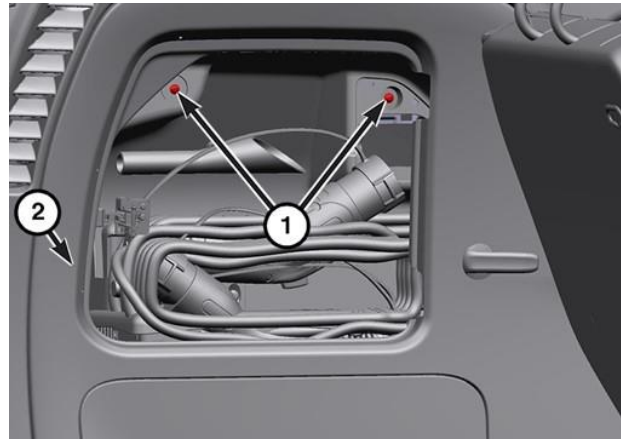
**Figure 41 – Quarter Panel Insert**

50. Remove the fasteners (1) from the quarter panel trim (2) (Figure 41).

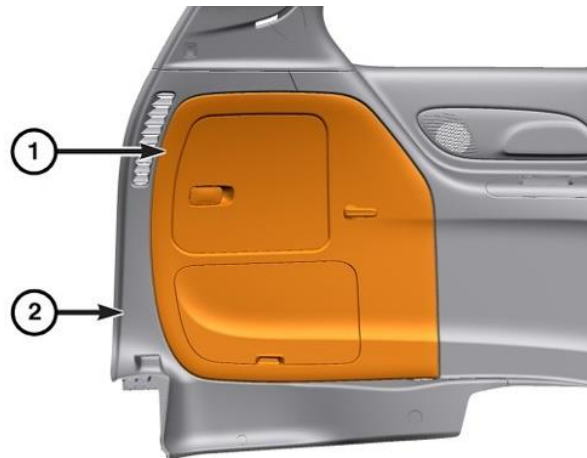
**Figure 42 – Quarter Panel Insert**

51. Using a trim stick or equivalent, release the quarter panel trim insert (1) from the quarter panel trim panel (2) (Figure 42).

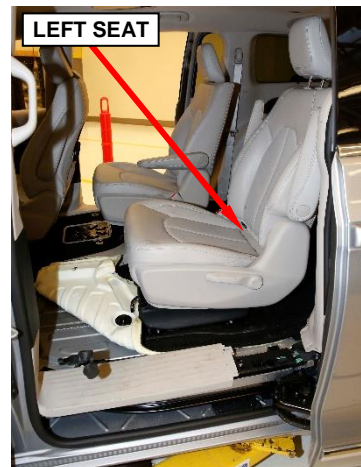
**Figure 43 – Second Row Seat Left Side**

52. Remove the left side second row seat for improved access to rear quarter trim and 12-volt cable (Figure 43).

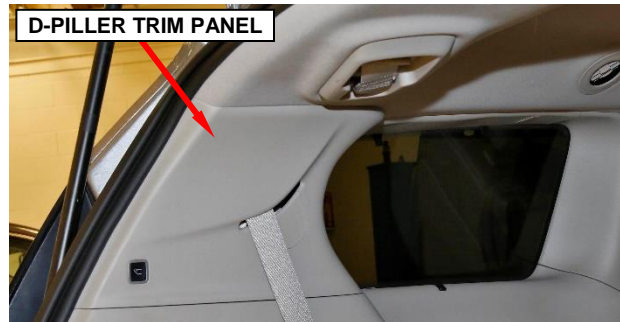
**Figure 44 – D-Pillar Trim Panel**

53. Release the D-pillar trim panel retaining clips and disconnect any electrical connectors then position aside. It is not necessary to release the D-pillar trim panel from the seat belt or remove it from the vehicle (Figure 44).

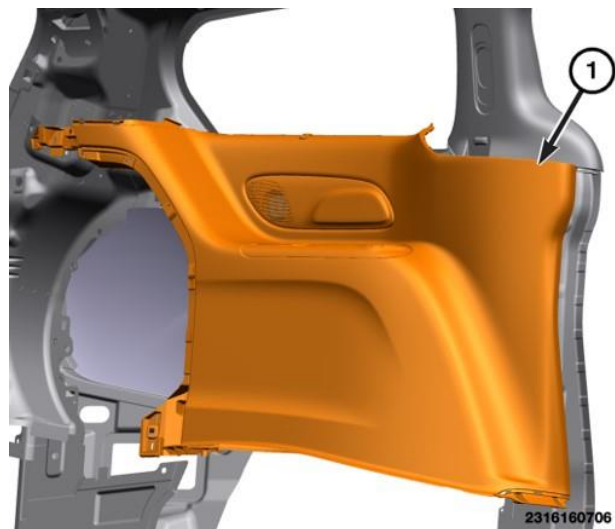
**Figure 45 – Quarter Trim Panel**

54. Using a trim stick or equivalent, starting at the top and release the fasteners at the front edge the quarter trim panel (1) carefully release the top of the quarter trim panel from the C-pillar trim panel (Figure 45).

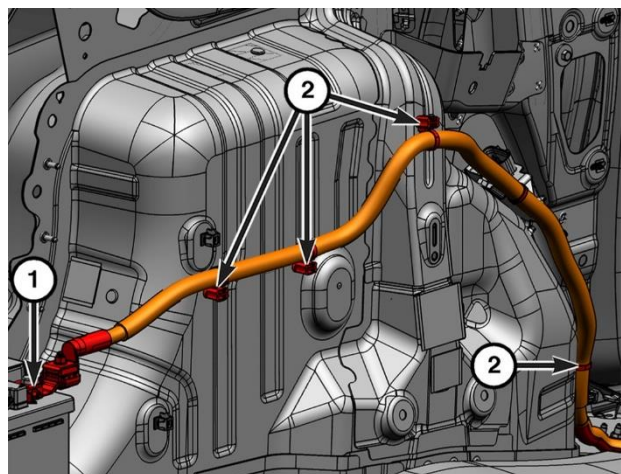
**Figure 46 – 12-Volt Cable**

55. Disconnect the 12-volt cable battery positive clamp (1) from the battery (Figure 46).

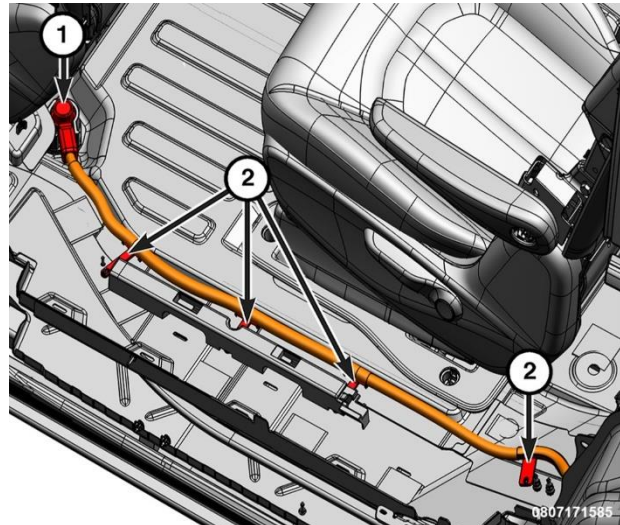
**Figure 47 – Quarter Trim Panel**

57. Pull back the floor covering to gain access to the 12-volt cable, remove the clips (2) and remove the cable from the vehicle. Render the cable unusable and discard (Figure 47).

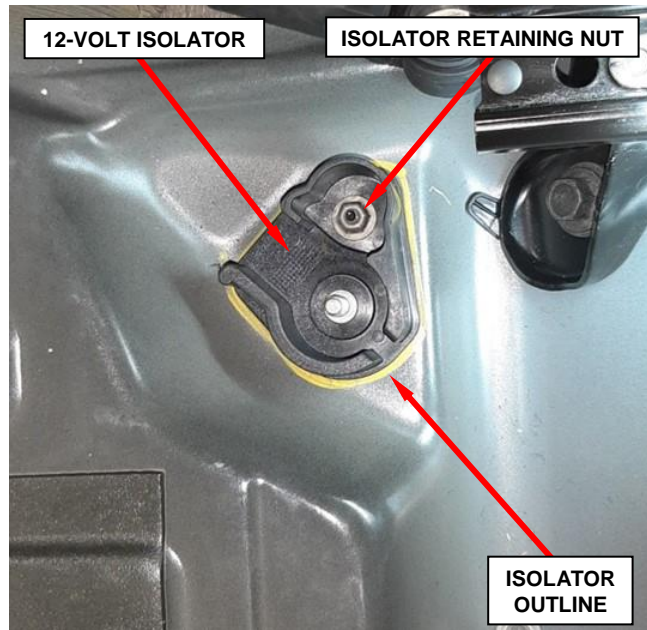
**Figure 48 – 12-Volt Isolator**

2. Remove the 12-volt isolator retaining nut then remove the isolator (Figure 48).

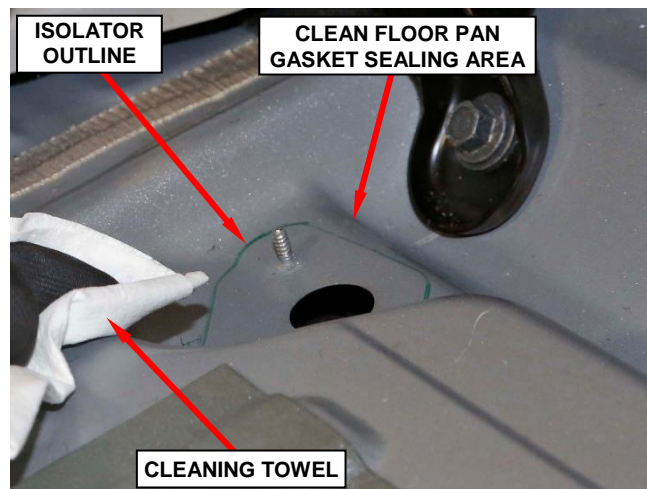
**Figure 49 – Clean Gasket Sealing Area**

**NOTE: Do NOT wash away the isolator outline while cleaning the floor pan. The outline will be needed for isolator installation.**

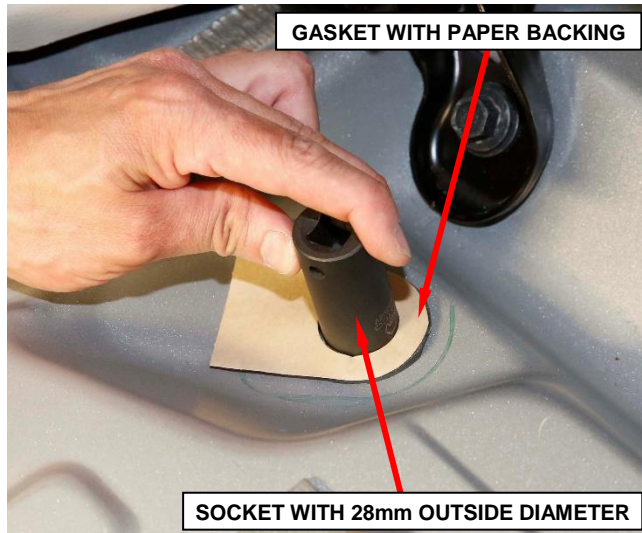
**Figure 50 – 12-Volt Isolator Gasket**

5. Use the socket as an alignment tool in order to center the isolator gasket (Figure 50).

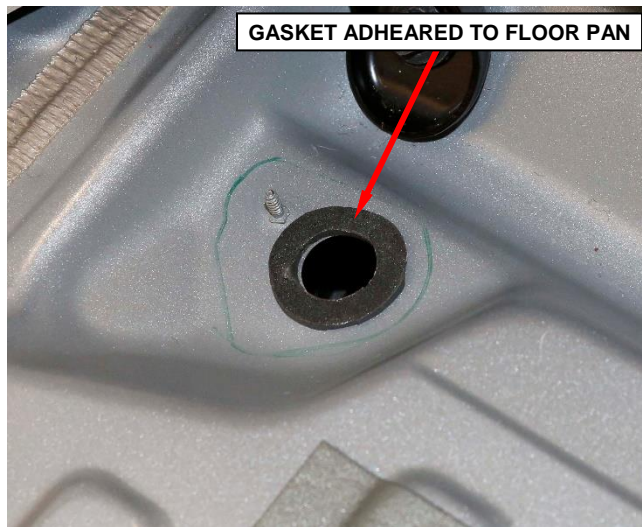
**Figure 51 – 12-Volt Isolator Gasket**

7. Remove the socket used for centering the gasket (Figure 51).

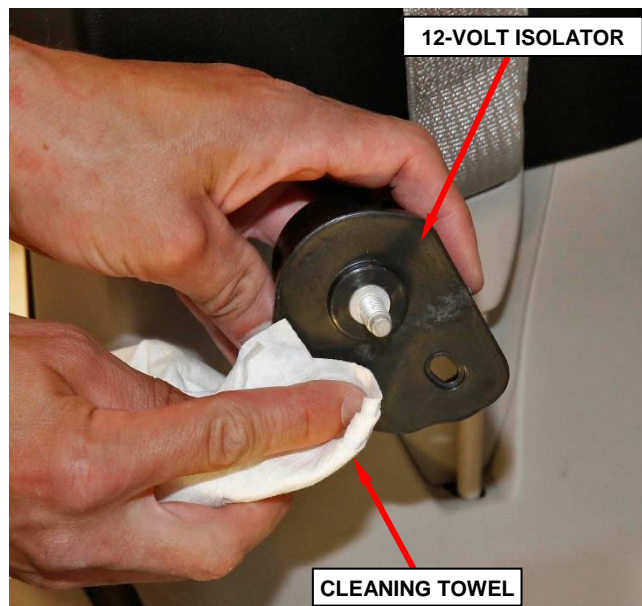
Figure 52 – Clean Gasket Sealing Area

9. Were the 12-volt cables replaced on this vehicle?
- **YES:** Use the **NEW** 12-volt isolator that came with the electrical cable campaign kit. Render the **OLD** 12-volt isolator unusable and discard.
  - **NO:** Cables were not replaced. **REUSE** the existing 12-volt isolator. It will **NOT** require replacement.
10. Using isopropyl alcohol or Mopar glass cleaner, clean the floor gasket sealing surface side of the 12-volt isolator to ensure proper bonding of the isolator gasket (Figure 52).

**CAUTION:** It will not be possible to reposition the 12-volt isolator once it contacts the gasket adhesive without causing damage to the gasket. If the gasket becomes damaged, another **NEW** gasket must be obtained.

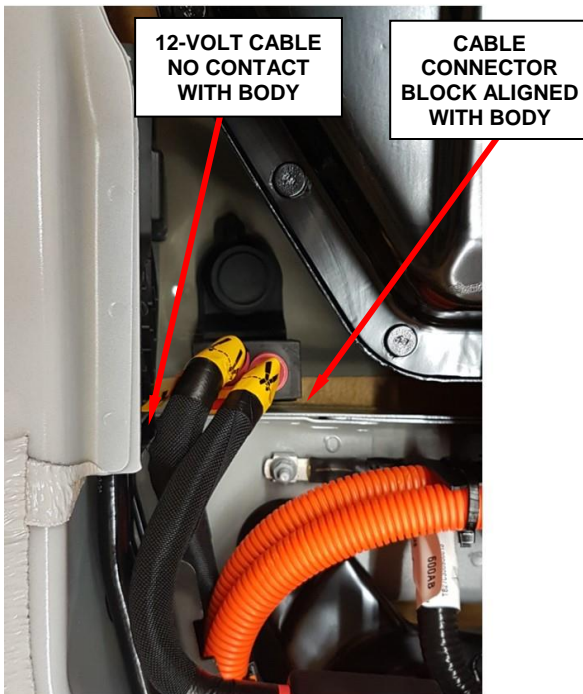
**Acceptable**

- 12-volt cable is NOT contacting the body
- Cable connector block is aligned with body NOT rotated or contacting the body

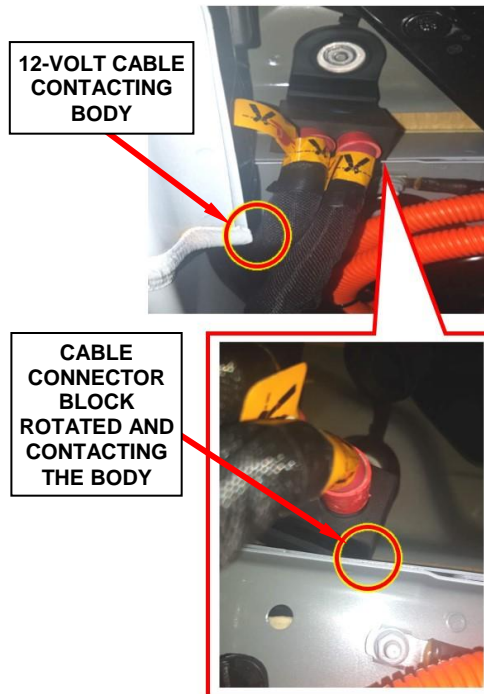
**Not Acceptable**

- 12-volt cable is contacting the body
- Cable connector block is rotated and contacting the body

**Figure 54 – Inspect 12-Volt Cable for Proper Alignment after Tightening**

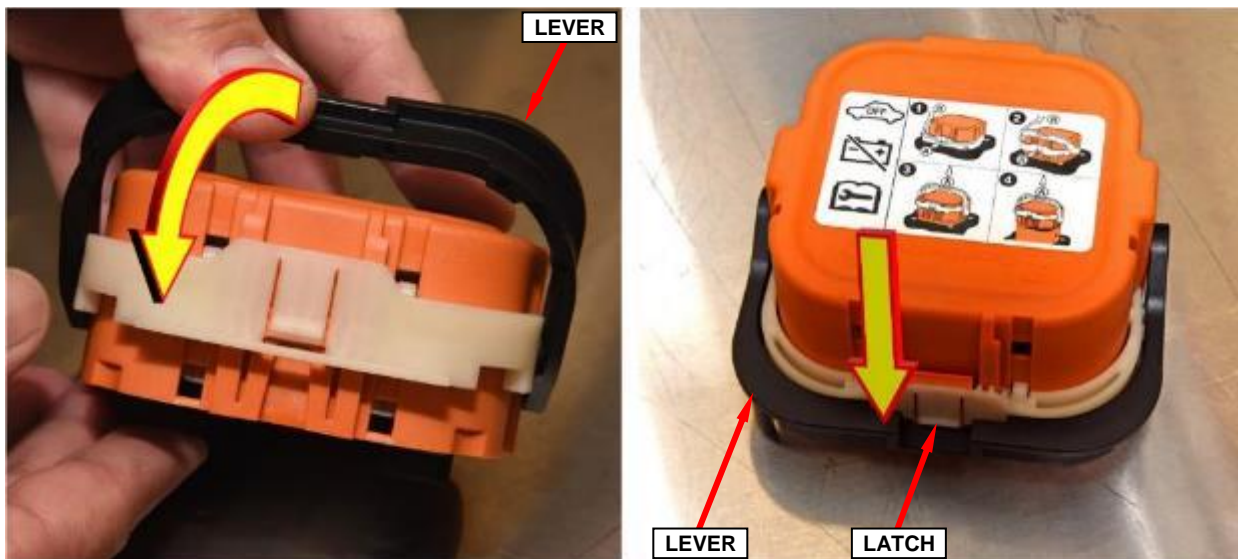
**Figure 55 – High-Voltage Manual Service Disconnect Latch Engagement  
(High-Voltage Manual Service Disconnect Removed from Vehicle for Visual Clarity)**

33. Rotate the lever downward while maintaining a slight downward force on the high-voltage manual service disconnect. The lever will engage the receptacle and draw the high-voltage manual service disconnect down onto the receptacle as the lever is rotated (Figure 55).
34. Rotate the lever downward until it is fully engaged and locked by the lever release latch. An audible “click” will be heard as the lever latches into position (Figure 55).
35. Gently pull the high-voltage manual service disconnect upward to ensure that it is fully seated in the receptacle and locked. If the manual service disconnect can be removed, repeat **steps 30 – 33**.
