A. VEHICLE INSPECTION PROCEDURE

Model	VIN range	Build date range
2020 CX-30 AWD Model Only	3MV DM**** LM 104188 – 137005	From November 13, 2019 through March 24, 2020

B. REPAIR PROCEDURE:

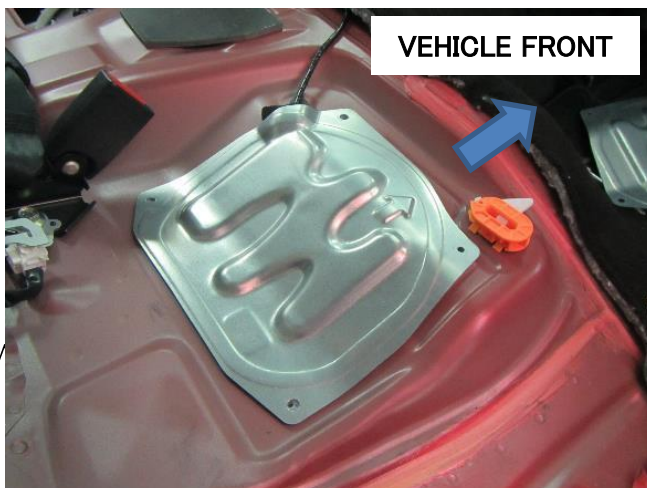
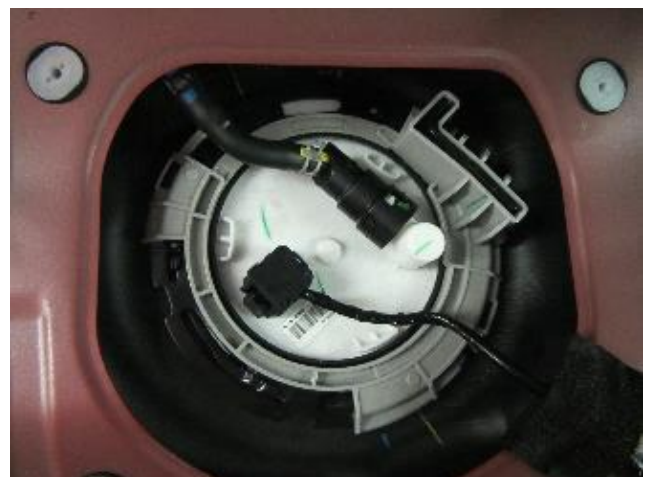
5. Remove the service hole cover at right rear (facing forward - passenger side).

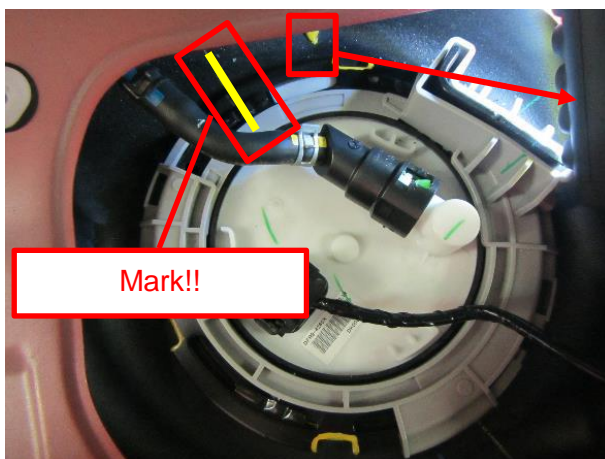
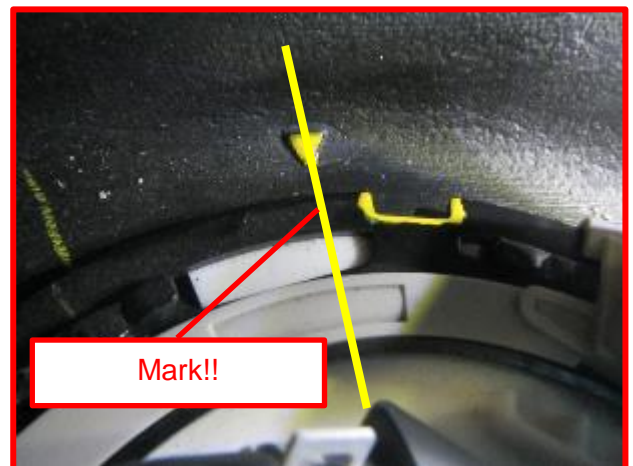
6. Draw a mark a on the fuel tank and set plate component.

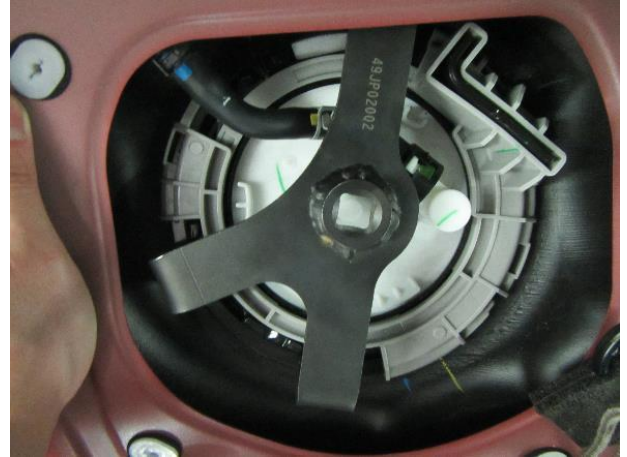
8. Remove the [FUEL GAUGE AT SUB FUEL TANK](#).
Using SST (PN:49JP02002) attach the 3 claws to the set plate component as shown in the picture below.

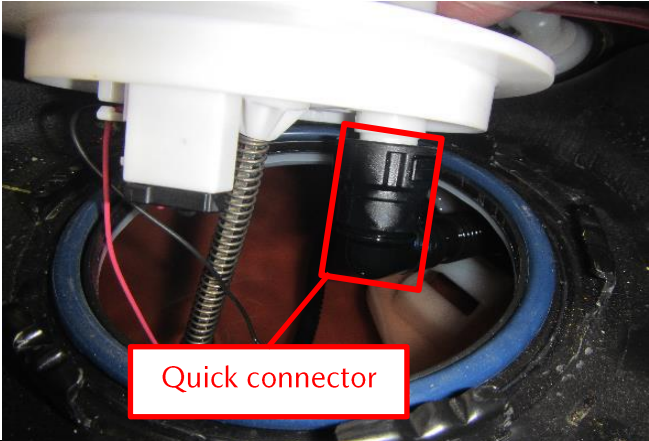
Status	Judgement
<p>The quick connector is connected and locked to the fitting correctly.</p>

<p>OK</p>

- Judgement of an OK quick connector. (The quick connector is connected and locked to the fitting correctly.) Go to Steps 13 through 16 and complete those steps. Then go to steps 19 through 24 which is the reverse order of removal and includes the required replacement parts (R part).
- **Judgement of a Not OK quick connector. (The quick connector is disconnected.) – see note above about photo requirements.**
- - **Dealer inventory vehicle***: Go to Steps 13 through 16 and complete those steps. Then go to steps 19 through 24 which is the reverse order of removal and includes the required replacement parts (R part).

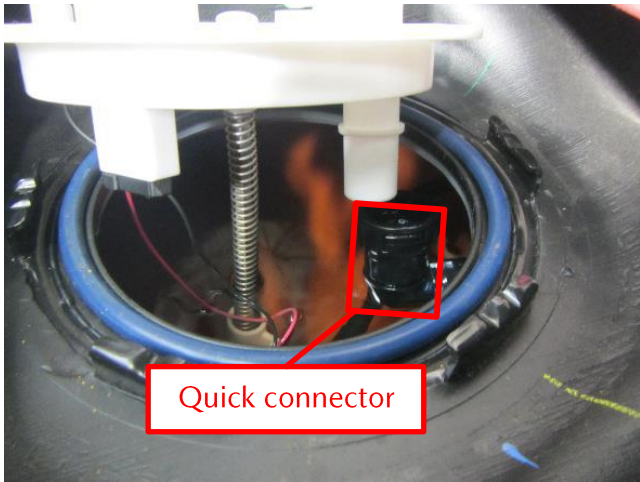
Status	Judgement
<p>The quick connector is disconnected. ** see note below</p>

<p>Not-OK</p>

**** Please take a photo of the hose with the RO in the background in all situations when the hose is disconnected. This photo is required to be submitted with the Warranty claim.**

_ - Customer vehicle: Go to and complete all Steps 11 through 24. Steps 17 and 18 require additional parts. Refer to MGSS Work shop manual below and is also the reverse order of removal and includes the required replacement parts (R part).

Because this judgement is expected to be very rare you must contact Dealer Recall Help for authorization. They will review and work with the DAG to order the necessary parts to complete. You will not be able to order the required parts to complete the repair for this concern.

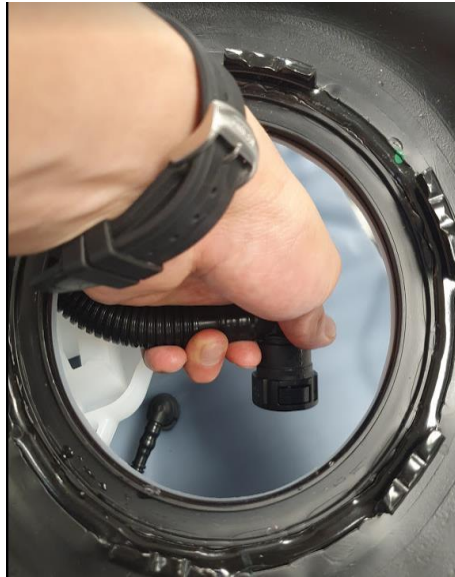
11. Twist the breather hose downward towards the bottom of the fuel tank to drain any fuel in the line. Refer to the VIDEO on MGSS under 4520F.

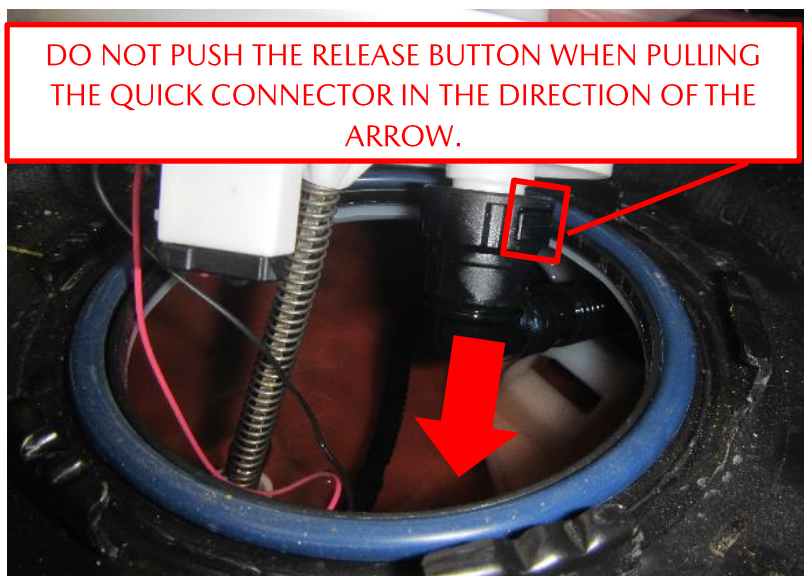
13. Double check the quick connector to be sure it has not disconnected, by pulling the quick connector in the direction of the arrow by hand shown below.

Caution: Do not push the release button when pulling the quick connector.

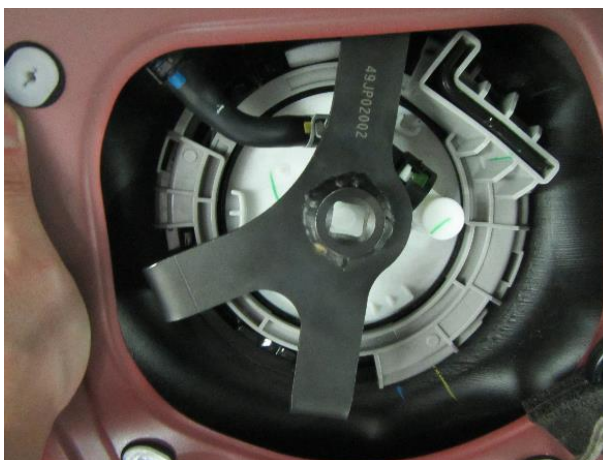
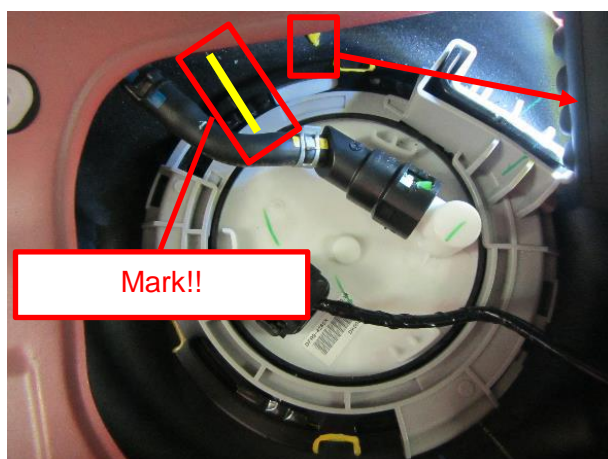
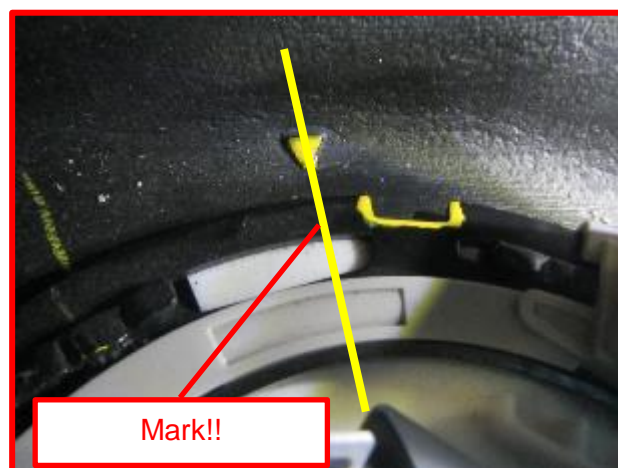
15. Install the [FUEL GAUGE AT SUB FUEL TANK](#). Make sure the alignment marks line back up. Using SST (PN:49 JP02 002) attach the 3 claws to the set plate component as shown below. Refer to the workshop manual on MGSS

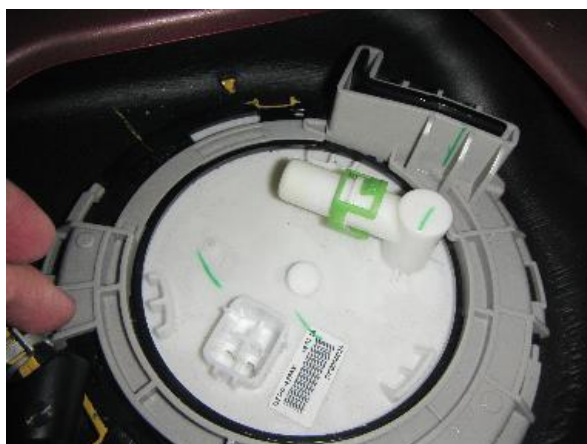
16. Install the [QUICK RELEASE CONNECTOR](#).

Caution: **NEW RETAINER** is necessary! It must be replaced when removing the **QUICK RELEASE CONNECTOR**.
