**SUBJECT: NEW VEHICLE DEMONSTRATION / DELIVERY HOLD -
Compliance Recall 20C12**

Certain 2020 Model Year Expedition and Navigator Vehicles
Second Row Left Hand Seat Frame Headrest Weld

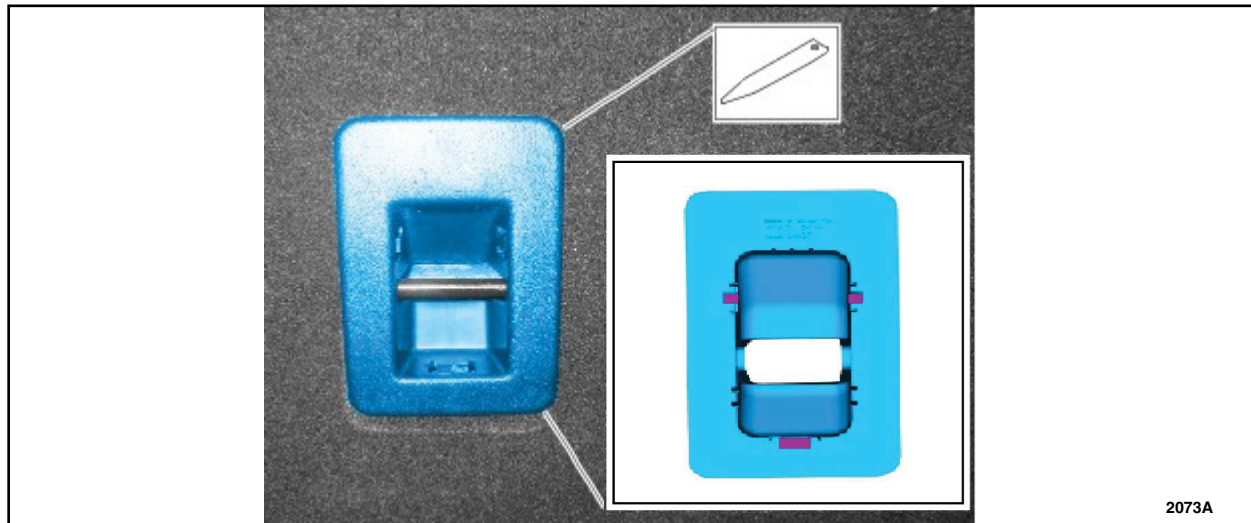
FIGURE 1

1. Remove the child safety seat tether anchor bezel. Use the General Equipment: Interior Trim Remover. See Figure 1.

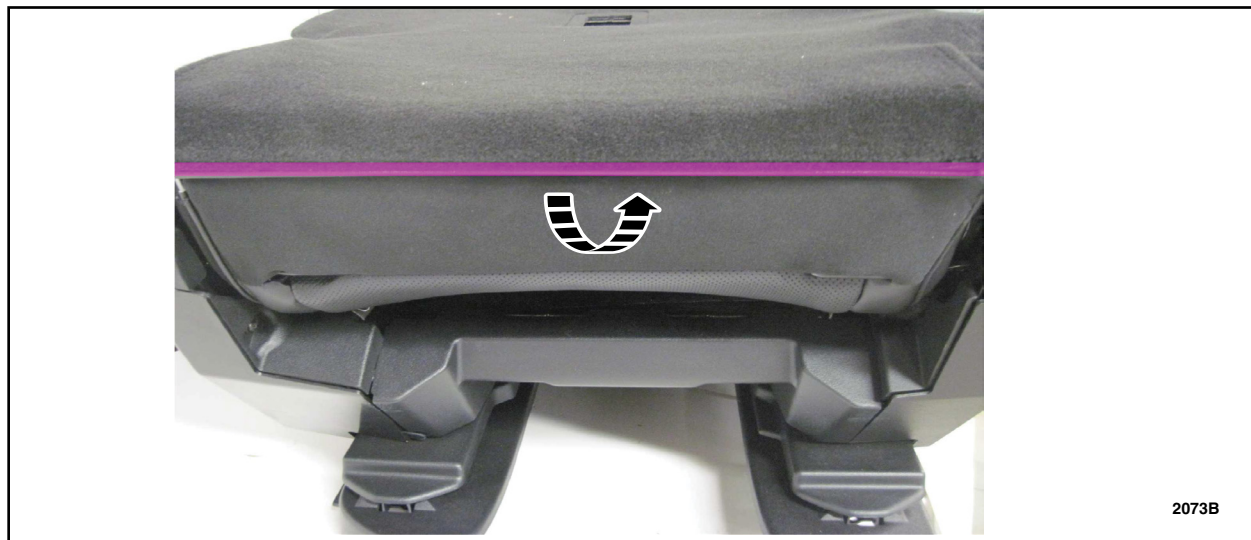
FIGURE 2

2. Release the backrest cover lower J-clip. See Figure 2.

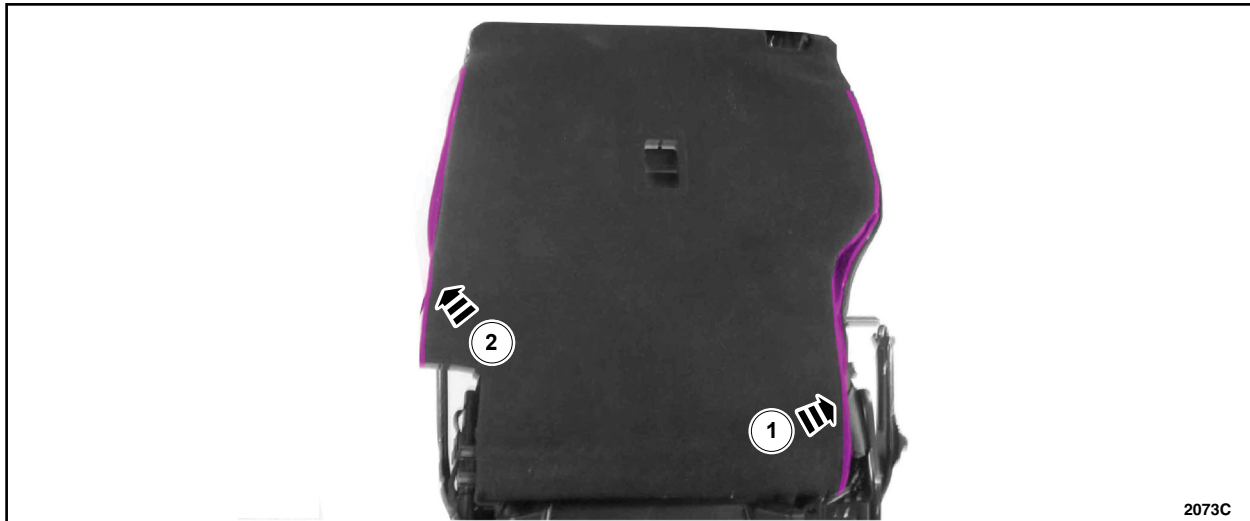
FIGURE 3

3. Unzip the RH side of the second row single seat backrest cover. If equipped, unzip the LH side of the second row single seat backrest cover. See Figure 3.

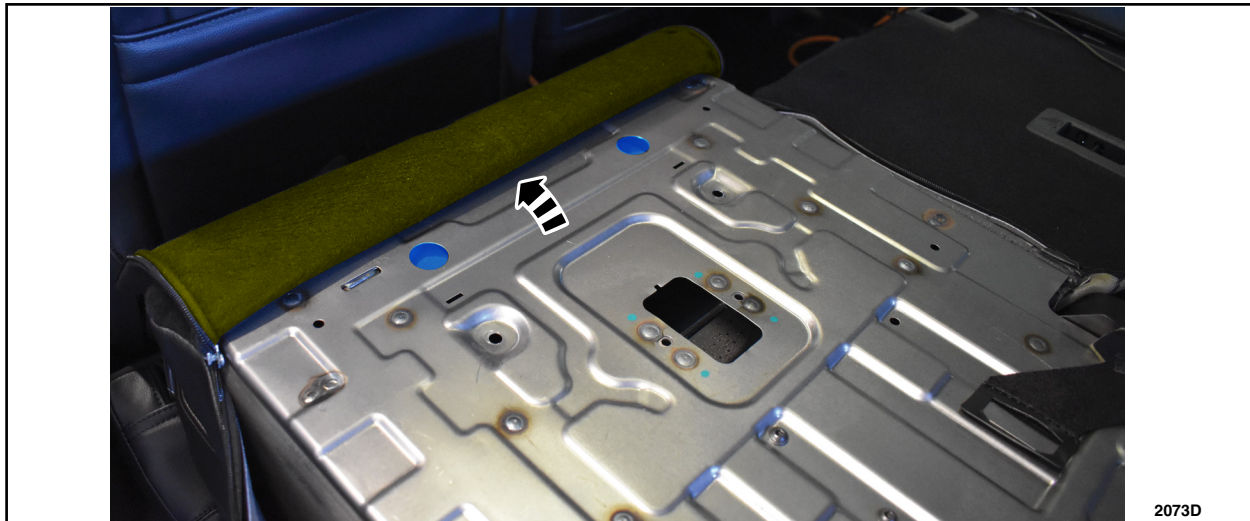
FIGURE 4

4. Position the backrest cover up to expose the two circular holes that are in-line with the headrest bracket welds. See Figure 4.

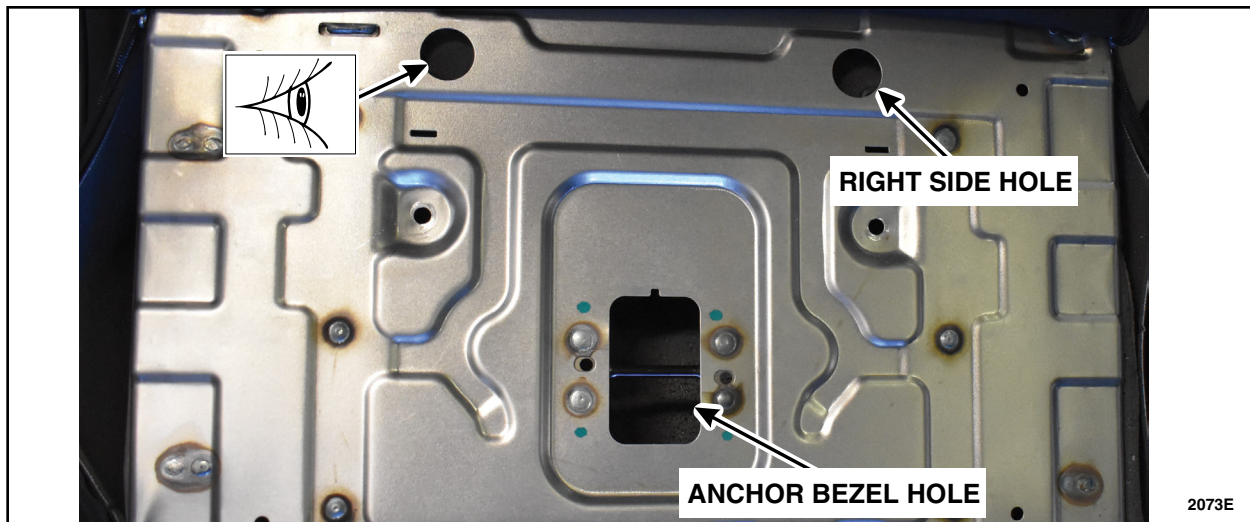
FIGURE 5

5. Shine a flashlight inside of the right side hole or the anchor bezel hole while viewing the two welds on the head rest bracket from the left side hole. See Figure 5.

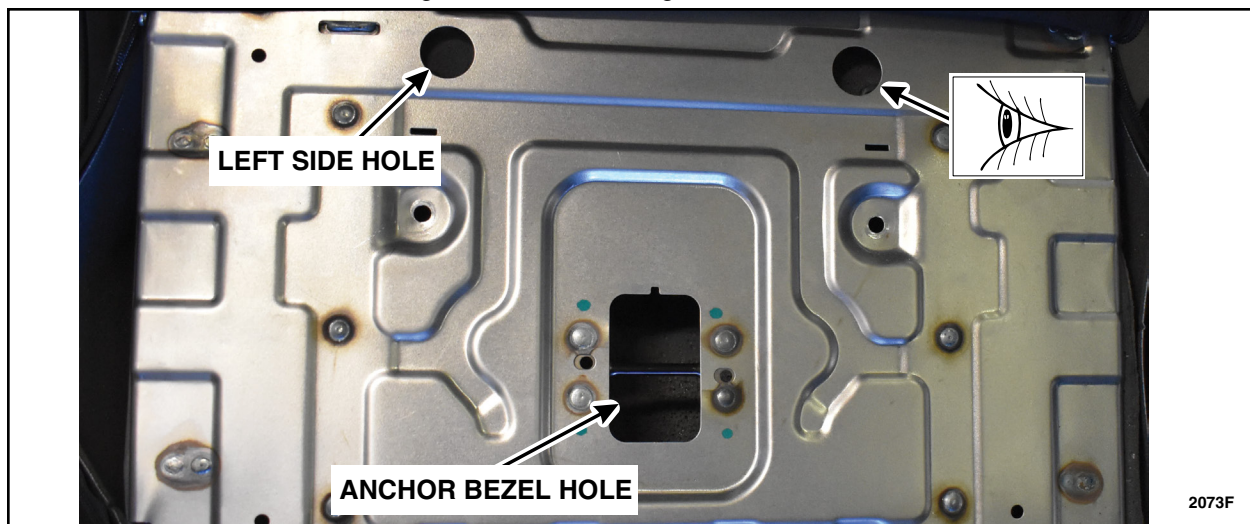
FIGURE 6

6. Shine a flashlight inside of the left side hole or the anchor bezel hole while viewing the two welds on the head rest bracket from the right side hole. See Figure 6.

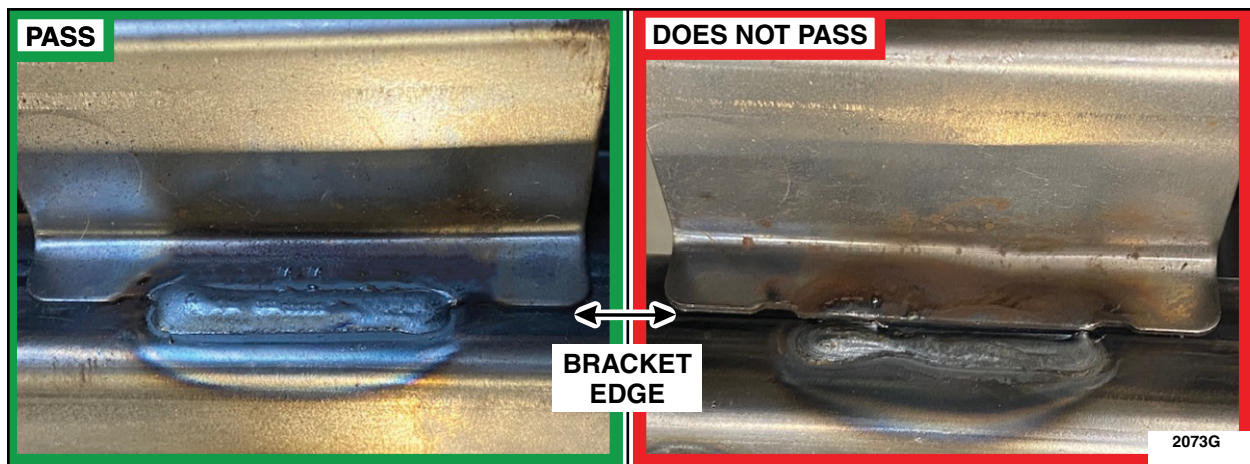
FIGURE 7

7. Are both welds covering the head rest bracket edge between the stamped notches? See Figure 7.

No – DOES NOT PASS inspection.

Yes – PASSES inspection.

- Take a clear photo of at least one suspect weld.
- Please submit a VIN-specific contact via the SSSC Web Contact Site.
- With SSSC approval, replace the entire seat frame and respective components following the Workshop Manual (WSM) procedures in Section 501-10B.

- Reinstall the backrest seat cover and clips by reversing steps 1 through 4.
- This inspection confirmation closes the program.
