SOP02673

QAAR 9711 Ensure Correct Torque Applied to CCP1 Electrical Connection

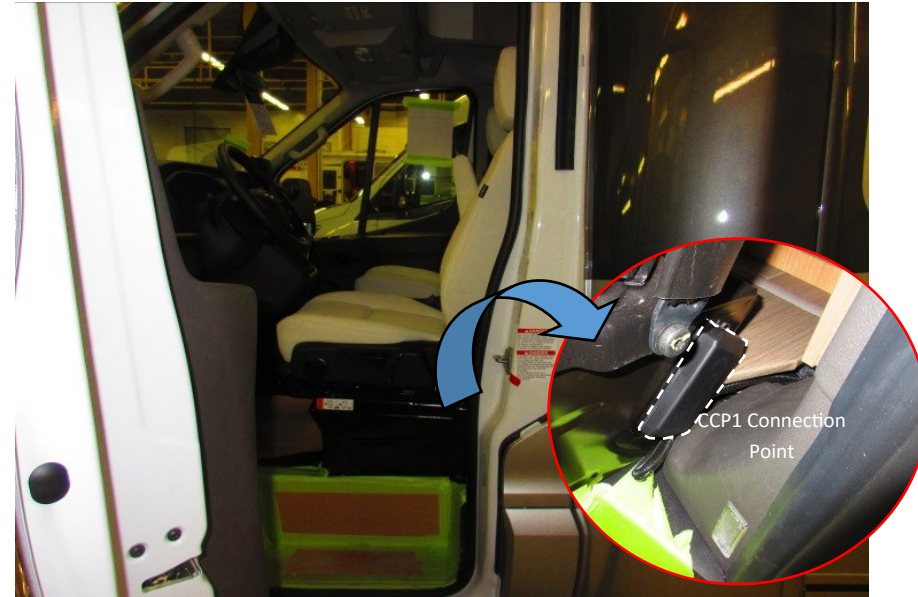
1

Open the driver's door and look at the base of the chair pedestal behind the rear of the cab door pillar for the CCP1 connection point.

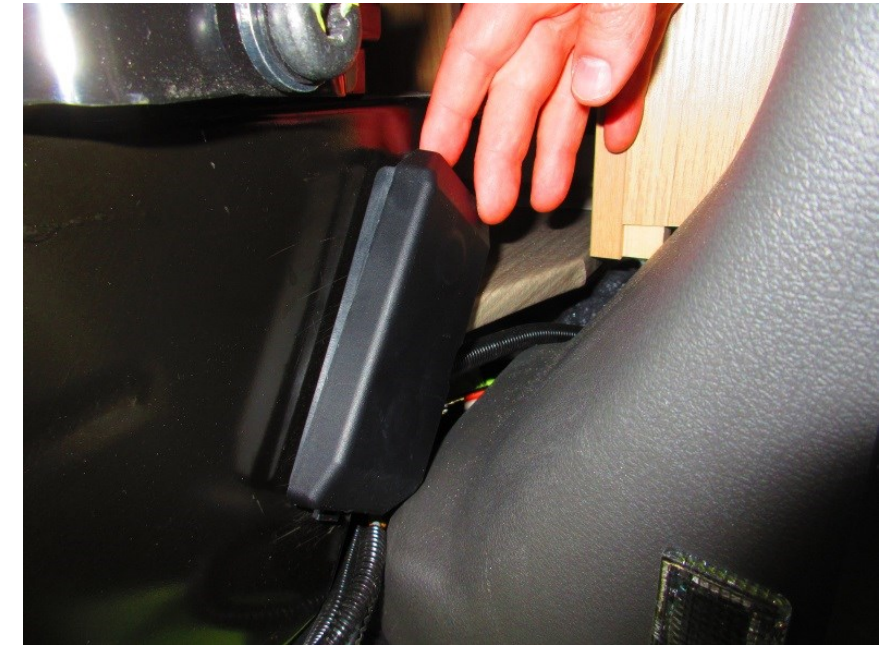
2

Remove the cover by gently pulling on the top tab away from the seat.

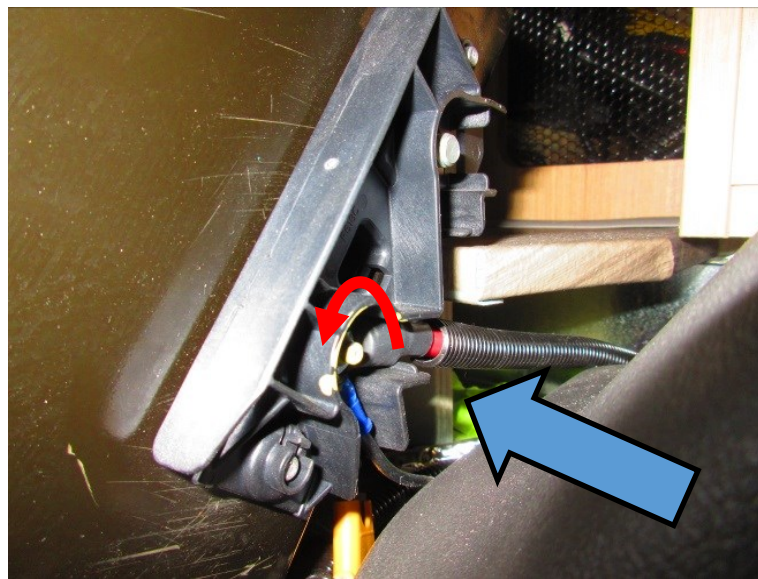
3

Using a 10mm (13/32") socket, back off the M5 nut until it spins freely.

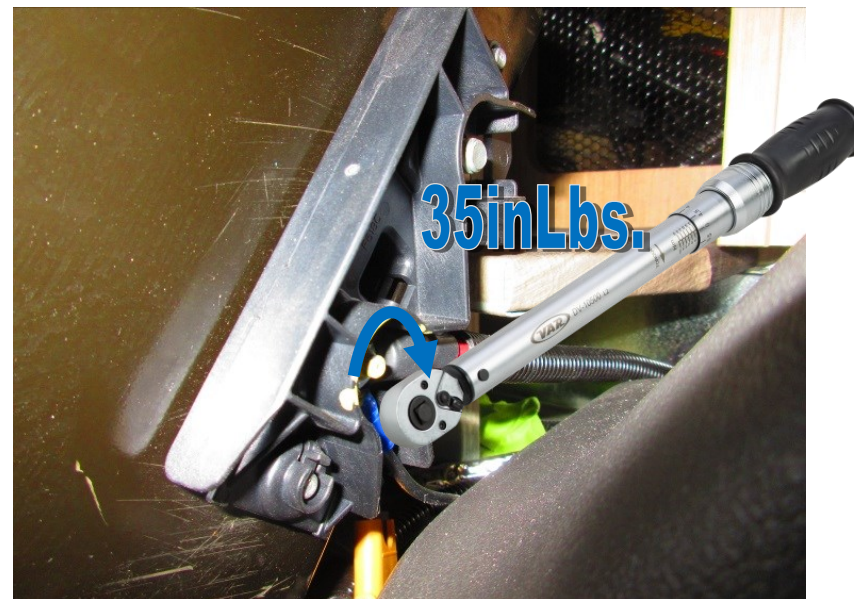
5

Use a torque wrench to apply **35in/lbs** to the nut.

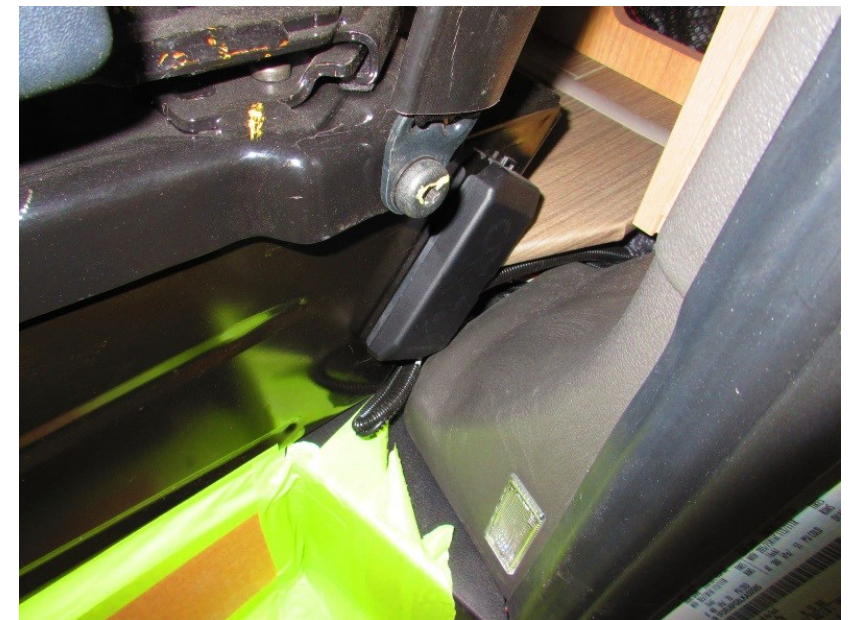
6

Snap cover back over connection point, make sure it clicks
