# Keystone RV Company

## SAFETY ADVISORY # 20-381

### Carbon, Cougar, Fuzion, Impact, and Raptor Fifth Wheel TV Antenna

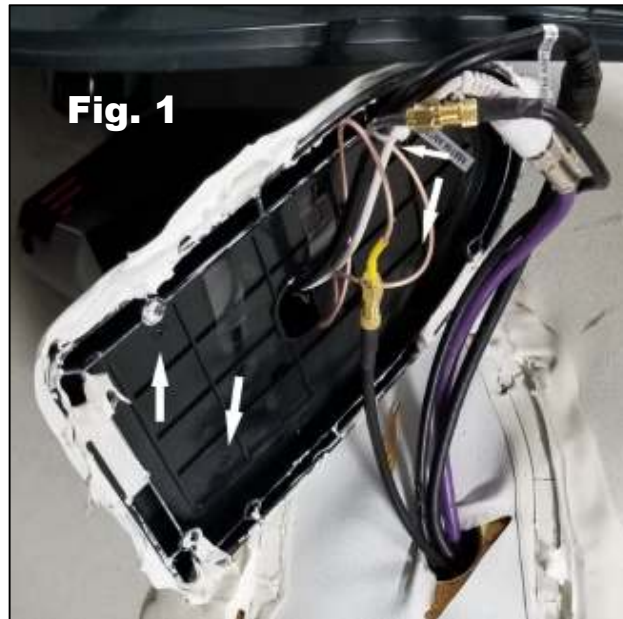
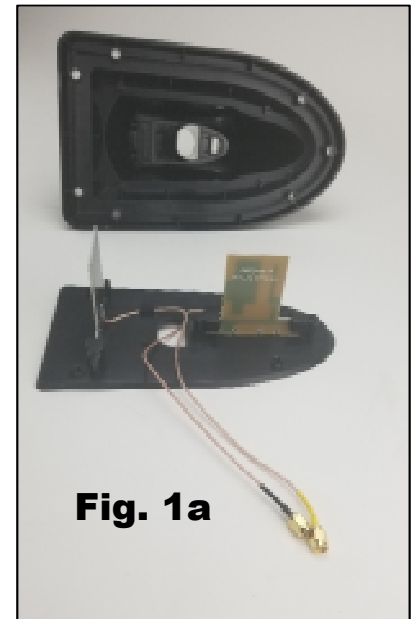
Locate the mounting base for the Furrion antenna and remove the exterior 7 screws to detach it from the roof. Remove the 4 screws out of the bottom of the base and pull the mount for the 4G antennas out of the base, Figures 1 and 1a. Discard the unused portion of the mounting base.

The remedy is to remove the 4G Wi-Fi base out of the Furrion antenna base and mount it to the roof, install the purple coax to the FM antenna, and connect the black coax to the Winegard 360 antenna. Mount the Winegard 360 antenna over the Furrion 4G Wi-Fi base and FM antenna, then properly seal the antenna.

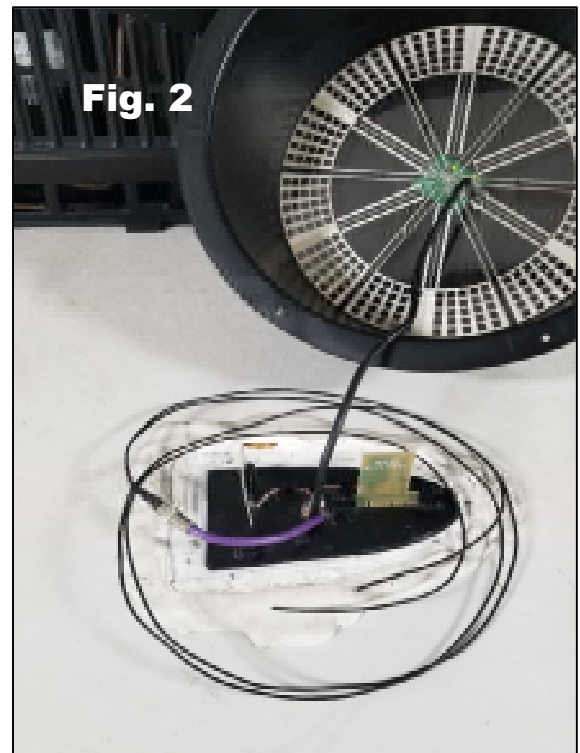
approximately 1" long (locally purchased/shop supplies). Be sure that the purple and black coax are routed through the center hole of the 4G antenna mount, Figure 2.

Attach the purple FM coax (where applicable as some FM antennas are behind the radio) to KRV # 558355 - Radio - Antenna Cord - Male To Female Connector. The FM antenna will lay on the roof around the 4G mounting base. Refer to Figure 2.

Attach the 4G antenna mount to the roof using 4 - #8 screws

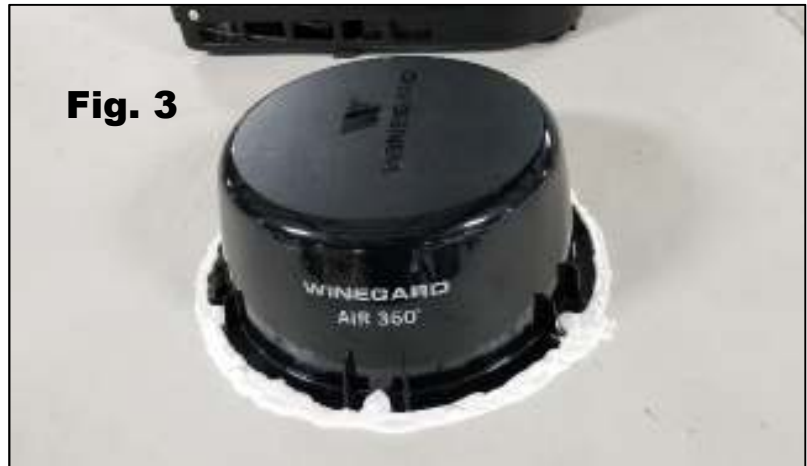
Prep the Winegard 360 by applying butyl tape to the bottom mounting flange of the antenna. Attach the black coax to the Winegard 360 and mount the antenna over the Furrion 4G Wi-Fi antenna using 6 - #8 x 1" screws (locally purchased/shop supplies). Seal the antenna mounting flange to the roof using the proper color of Alpha Superflex lap sealant. See Figure 3.
