RECALL

R20AX – FMVSS 210 Noncompliance – Instl. of Seats with 3-Point Belts

Models Affected: Certain 2018 through 2021 Model Year All American and Vision Buses

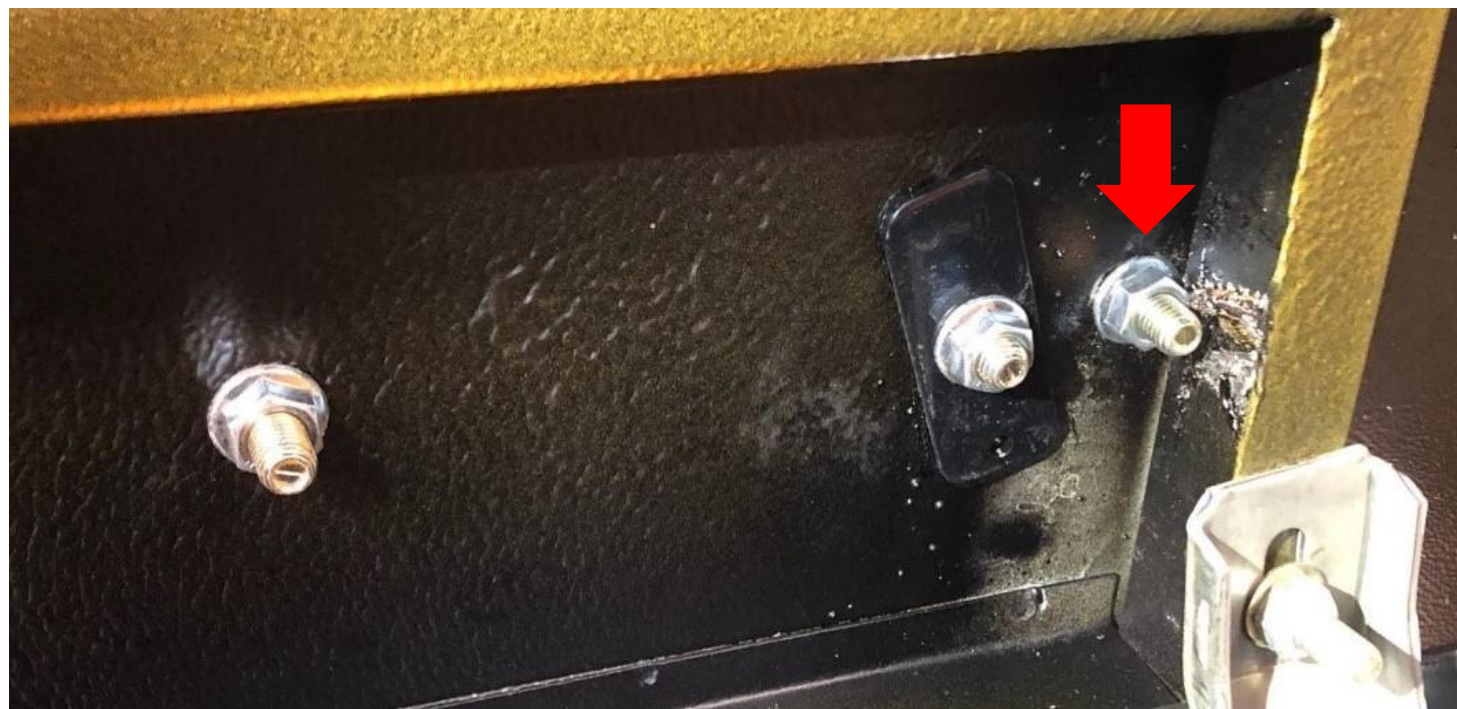
1. Inspect the Seat Fastener Installation to ensure the correct seat washers are installed. Do this by visually inspecting the underside of the seat fasteners. Each seat must have a washer installed on the rear two fasteners. No washer is required on the forward seat fastener.

Photo 1-Rear Washer Missing

1. Loosen the seat bolt that requires the washer addition.
2. Insert the notched washer (Photo 2) on to the fastener between the floor panel above the nut (Photo 3).
3. Torque the fastener to 26-30 ft lbs.

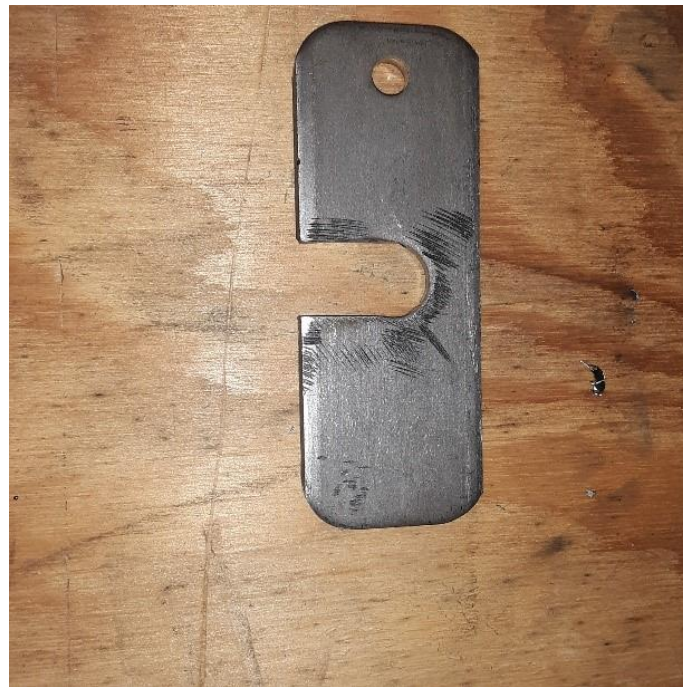
Photo 2-Notched Washer

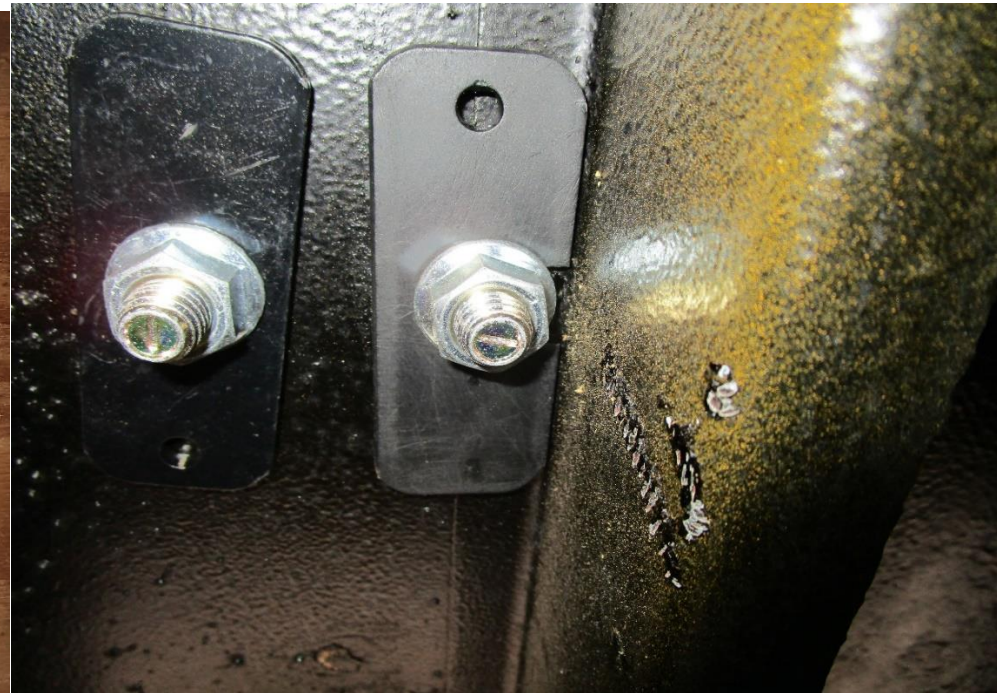
Photo 3-Notched Washer Installed
