# Thor Motor Coach Recall Repair Instructions

Recall #	<b>20V-424 2020-338</b>		
Description/Title:	<b>20A/AT Dinette Seatbelt Length</b>		
Affected Product Line(s):	<b>Certain model year 2020/2021 20A/AT Sequence and Tellaro motorhomes</b>		
Service Campaign # :	<b>RC000198</b>	Released Date:	<b>MM/DD/YYYY</b>
Repair Code:	<b>Inspect Only: TMCRC80490Y</b>  <b>Inspect &amp; Repair: TMCRC80490V</b>	Document Date:	<b>MM/DD/YYYY</b>
Time Allowed:	<b>Inspect Only: 0.1 Inspect &amp; Repair: 0.3</b>	Document Revision:	<b>A</b>

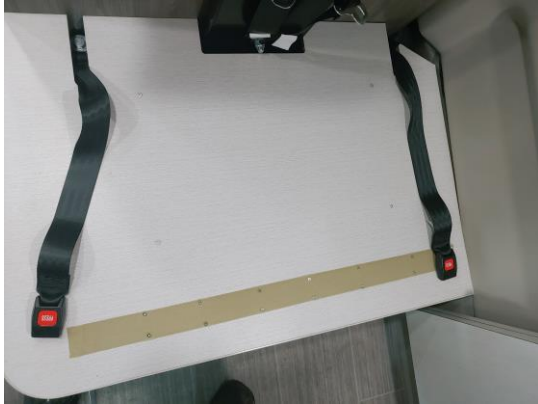
3. Remove screws from base of seat. (Be sure to keep screws to re-install.)
4. Remove wooden seat lid.

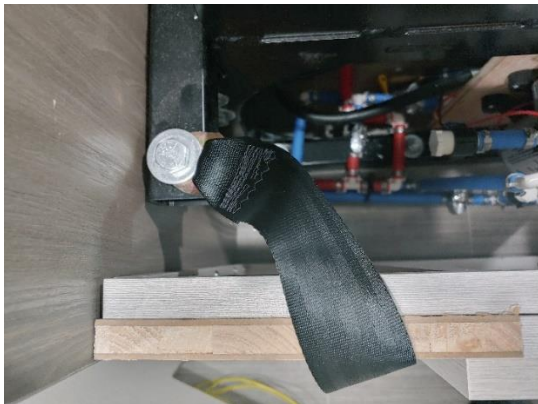
5. Remove outside bolts from female tether portion of seatbelt and replace with a new 24" tether. Tighten to 30ft.-lbs. (Repeat on other side.)

6. Be sure belts are sitting in slots at top of back prior to screwing base back on. Screw base back on into its position.
7. Reinstall back and bottom cushions onto velcro strips.
