October 1, 2021

Version 5

Safety Recall: 2018 – 20 Odyssey Sliding Door Outer Handle CablesSupersedes 20-024, dated July 9, 2021, to revise the information highlighted in **yellow**.**AFFECTED VEHICLES**

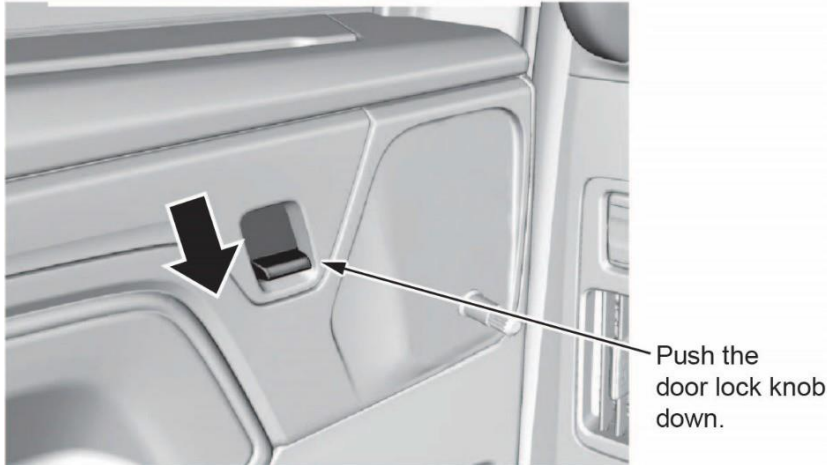
6. With the sliding door open, push the door lock knob down to the locked position to prevent it from being damaged when removing the door panel.

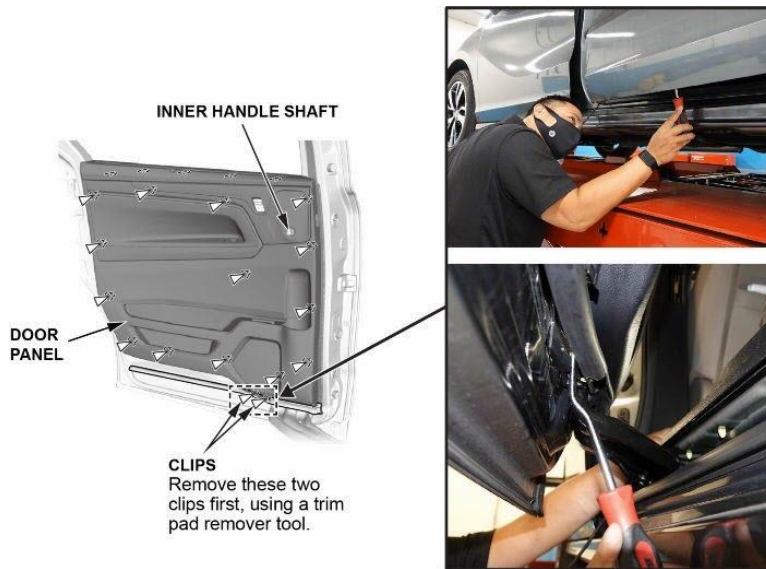
7. Remove the two clips at the bottom of the door panel first with a trim pad remover to release the lower door seal from the door panel

NOTE: Removing the two clips prevents pulling the door seal off the door as the door panel is lifted and removed.

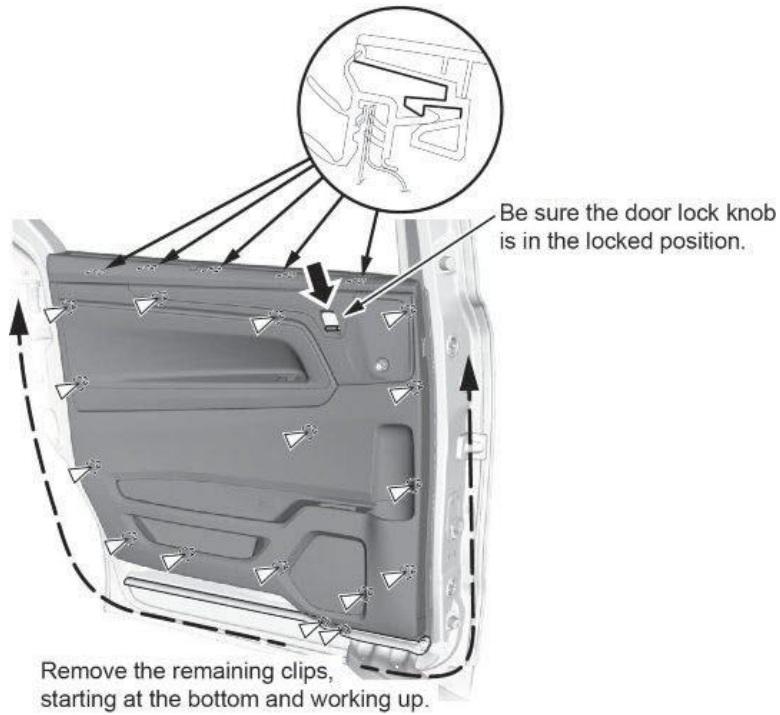
- Starting at the bottom of the door panel, remove the remaining clips with a commercially available trim pad remover.

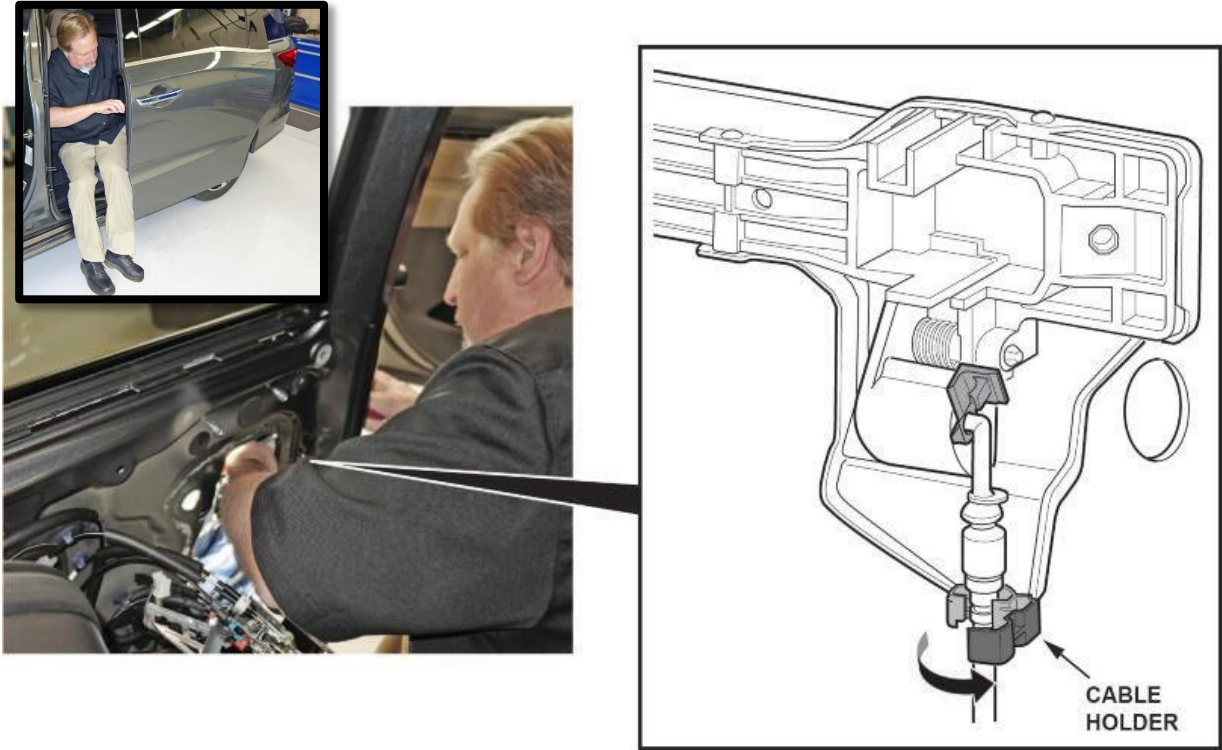
16. Sit in the sliding door opening with both legs in front of the lower roller as shown to avoid straddling the lower roller, then detach the cable holder.

Be careful when getting into position or exiting the vehicle. Avoid accidentally kicking and possibly damaging the sliding door articulating harness.

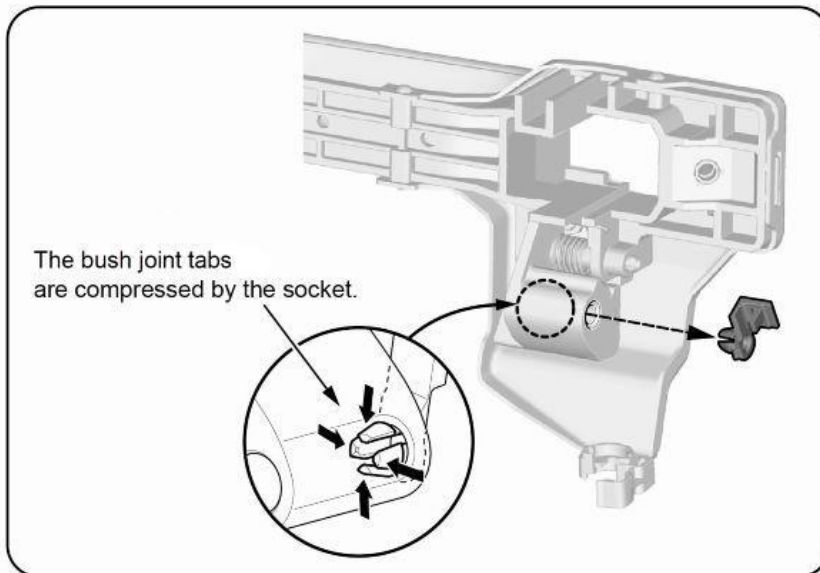
20. Insert 90° needle nose pliers through the plug opening to hold the bush joint. Insert a 1/4" drive, 6 point, 7 mm socket into the back of the bush joint cavity to compress / release the bush joint tabs, and remove the bush joint from the handle base.

NOTE: Be careful not to drop the bush joint into the door.

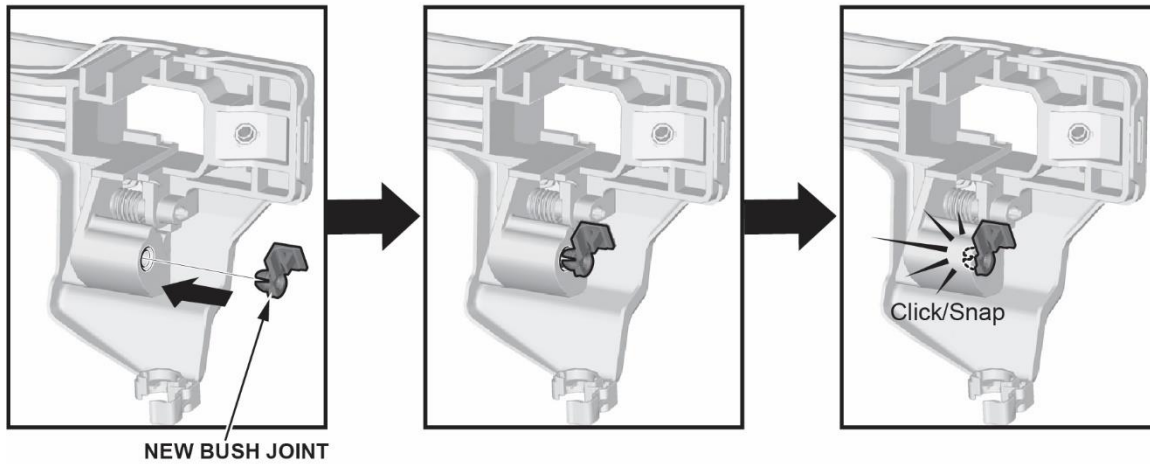
21. Use the 90° needle nose pliers to insert the new bush joint. Make sure it snaps into place and fully sets.

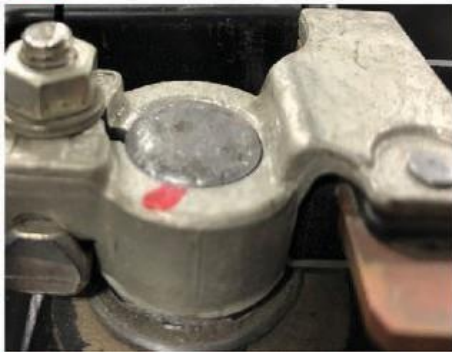
GOOD

26.2. Make sure the battery terminals are correctly attached as shown.

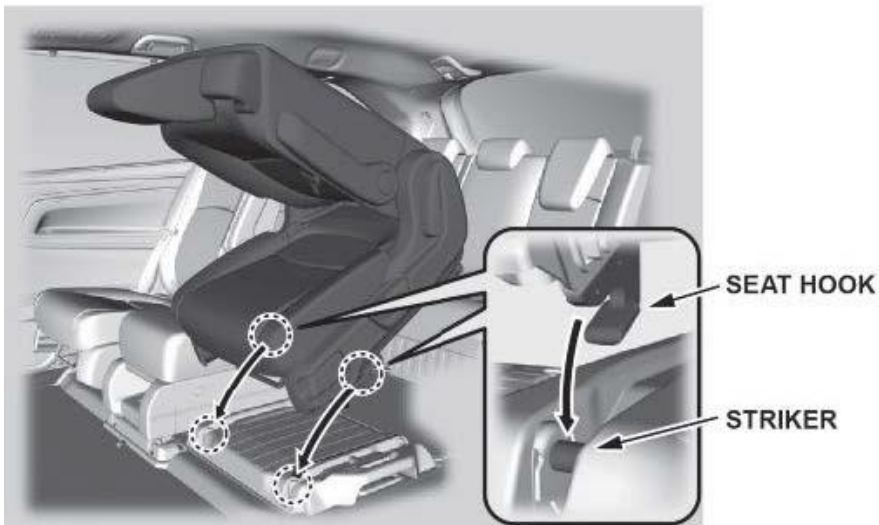
29.1 Insert the front seat hooks into the front floor strikers.
